CHALLENGES OF THE SUPERSTRUCTURE “ÄLVSBACKA BRIDGE”

Peter Jacobsson
Martinsons Träbroar AB
Skellefteå, Sweden
peter.jacobsson@martinsons.se

In the late summer 2011 this new cable stayed pedestrian bridge passing over the river of Skellefteå in Skellefteå city was taken into use, named “The Älvsbacka Bridge”.

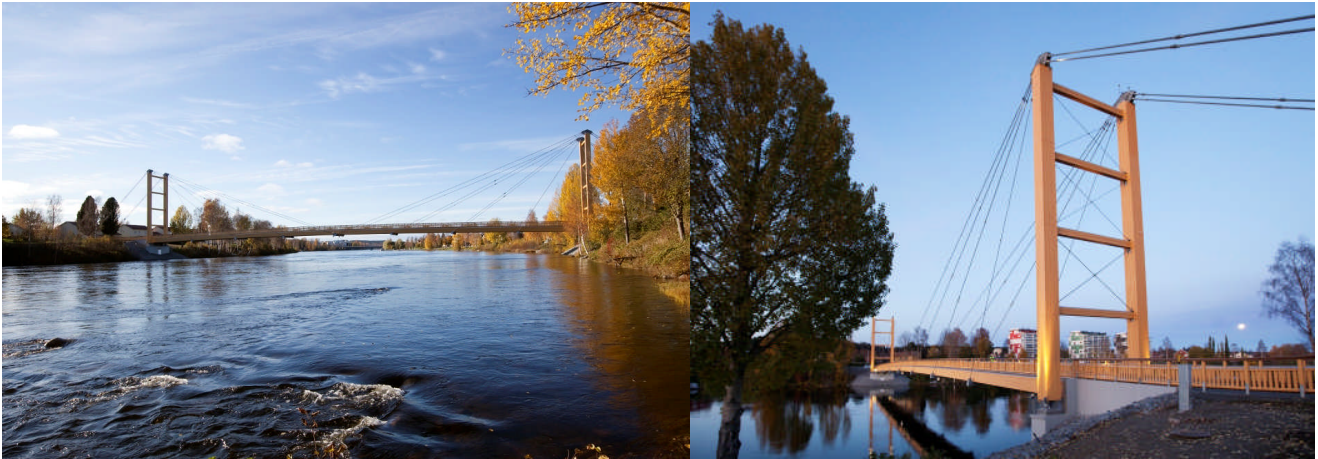
Fig. 1: Views of the final result of “The Älvsbacka Bridge”

Distance between pylons, span length: 130 m, total length 182 m.

Free width of decking: 4 m

Height of pylons: 24 m

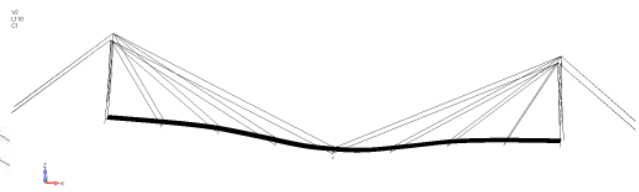
The dynamic analysis indicated that the bridge was relatively weak. The first horizontal mode had a natural frequency 0.6 Hz and the first vertical mode had frequency 1.4 Hz

Fig. 6: Vertical mode, $f = 1.4$ Hz

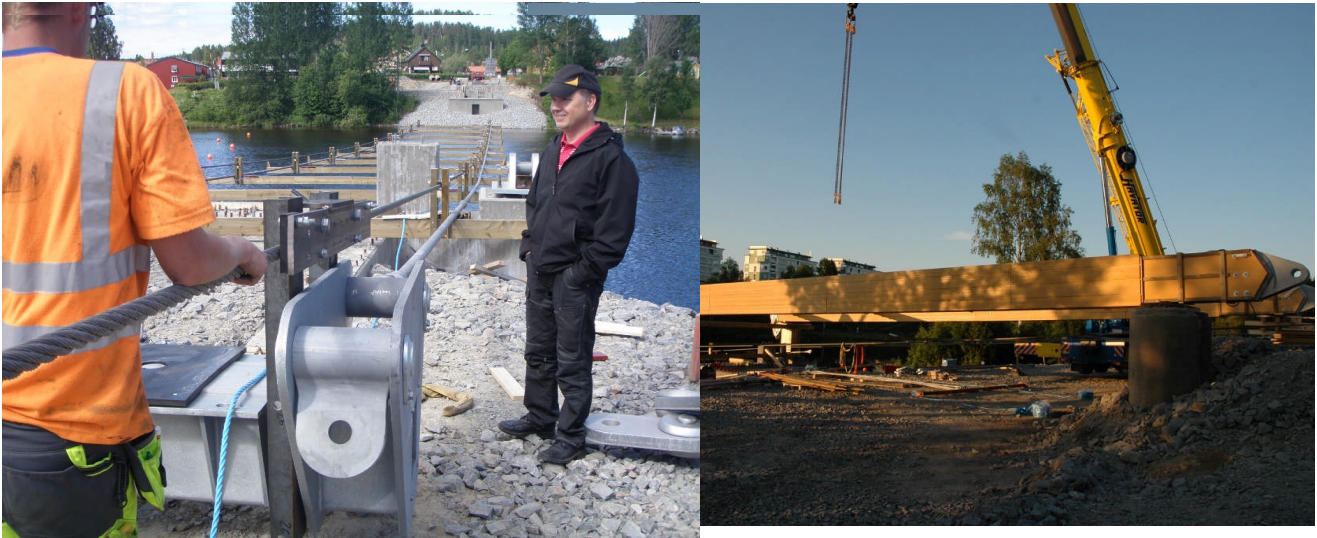
After preparations on both sides with temporary supports, mobile crane surfaces, establishing the barge and stressing up the temporary wires the work with permanent parts could start. Initially the longest bars with the “mid transverse beam” were pulled out with help of the temporary wires. Work continued with putting together prefabricated parts of the pylon. See Fig: 12.

Fig 12: Long bars on their way out (left picture) and assembling of pylon.

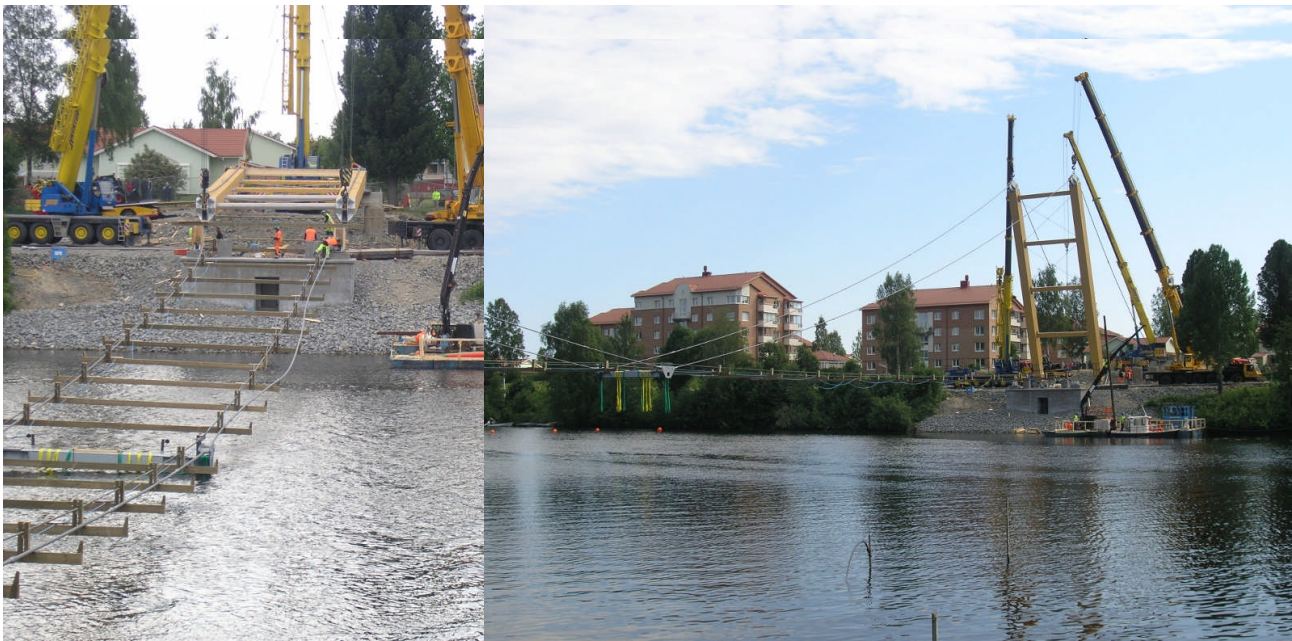
After four days work it was time for one of the most critical moments in the erection process, to lift the pylons with the longest bar to its permanent vertical position. This was done with the equipment of five mobile cranes, three tow trucks and the barge.

Fig 13: Start lifting pylon (left picture) and pylons almost in final position (right picture)

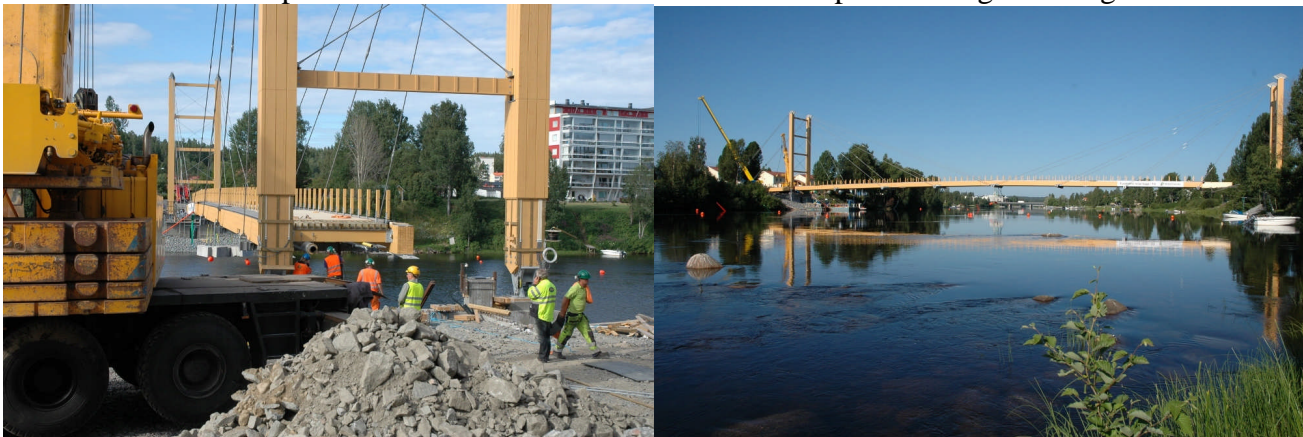
The assembling work continued with pulling out the rest of the 12 bars and six transverse beams. Then the hole system with bars had to be stressed up which were done with horizontal temporary bars between transverse steel beams and stressed against the pylon foundations at ends. With this performance the system was ready to act like support when pulling out the five 27 m long bridge deck parts. The main equipment in this stage was two mobile cranes in the south end of the bridge and one tow truck in the north end pulling all the five parts from south end and heading north. The first deck part, the one ending up in the north end had an elongation of the permanent beams acting like noses that made it possible to pass the transverse beams in an effective way. The noses had also a lifting device that was an important function. This operation was successful and was performed during 3 days. One critical issue during this operation was weather conditions and especially the wind and how it easily can generate oscillations transverse the bridge. This risk had been considered and the bridge was secured with wires from the transverse beams to anchors in the bottom of the river up streams and down streams and at several places along the bridge.

Fig. 14: Bridge on its way out in left picture and almost in final position in right picture.

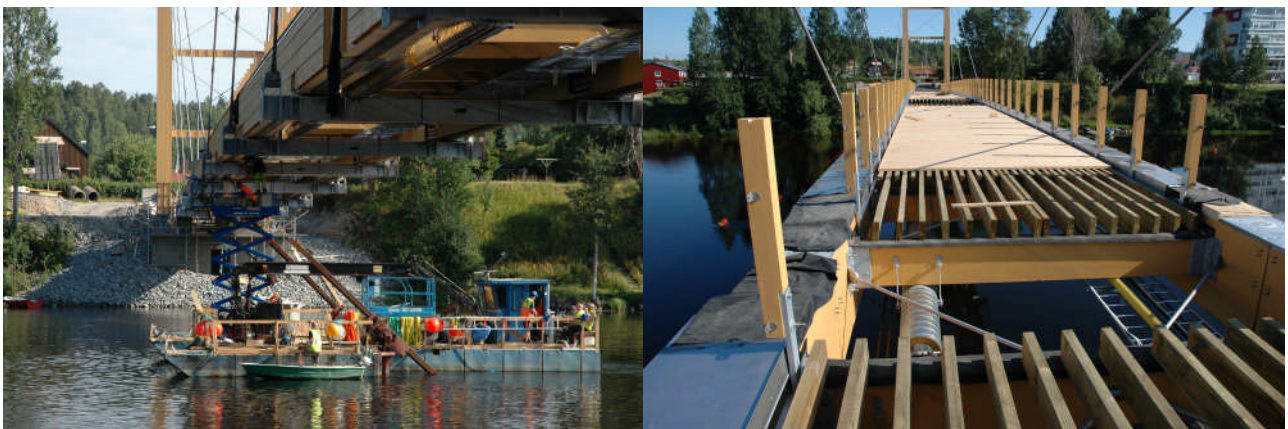
When all five pieces were in right length position the work with adjustment and permanent locking of connections took place during a couple of days parallel with the concluding work with removing temporary material, put on missing cladding and installation of the electricity equipment and the water tube.

Figure 15: Finishing construction work after pulling out all the bridge decks.
