# Historical Performance Evaluation of Iowa Pavement Treatments Using Data Analytics

**Final Report  
January 2017**

IOWA STATE UNIVERSITY  
Institute for Transportation

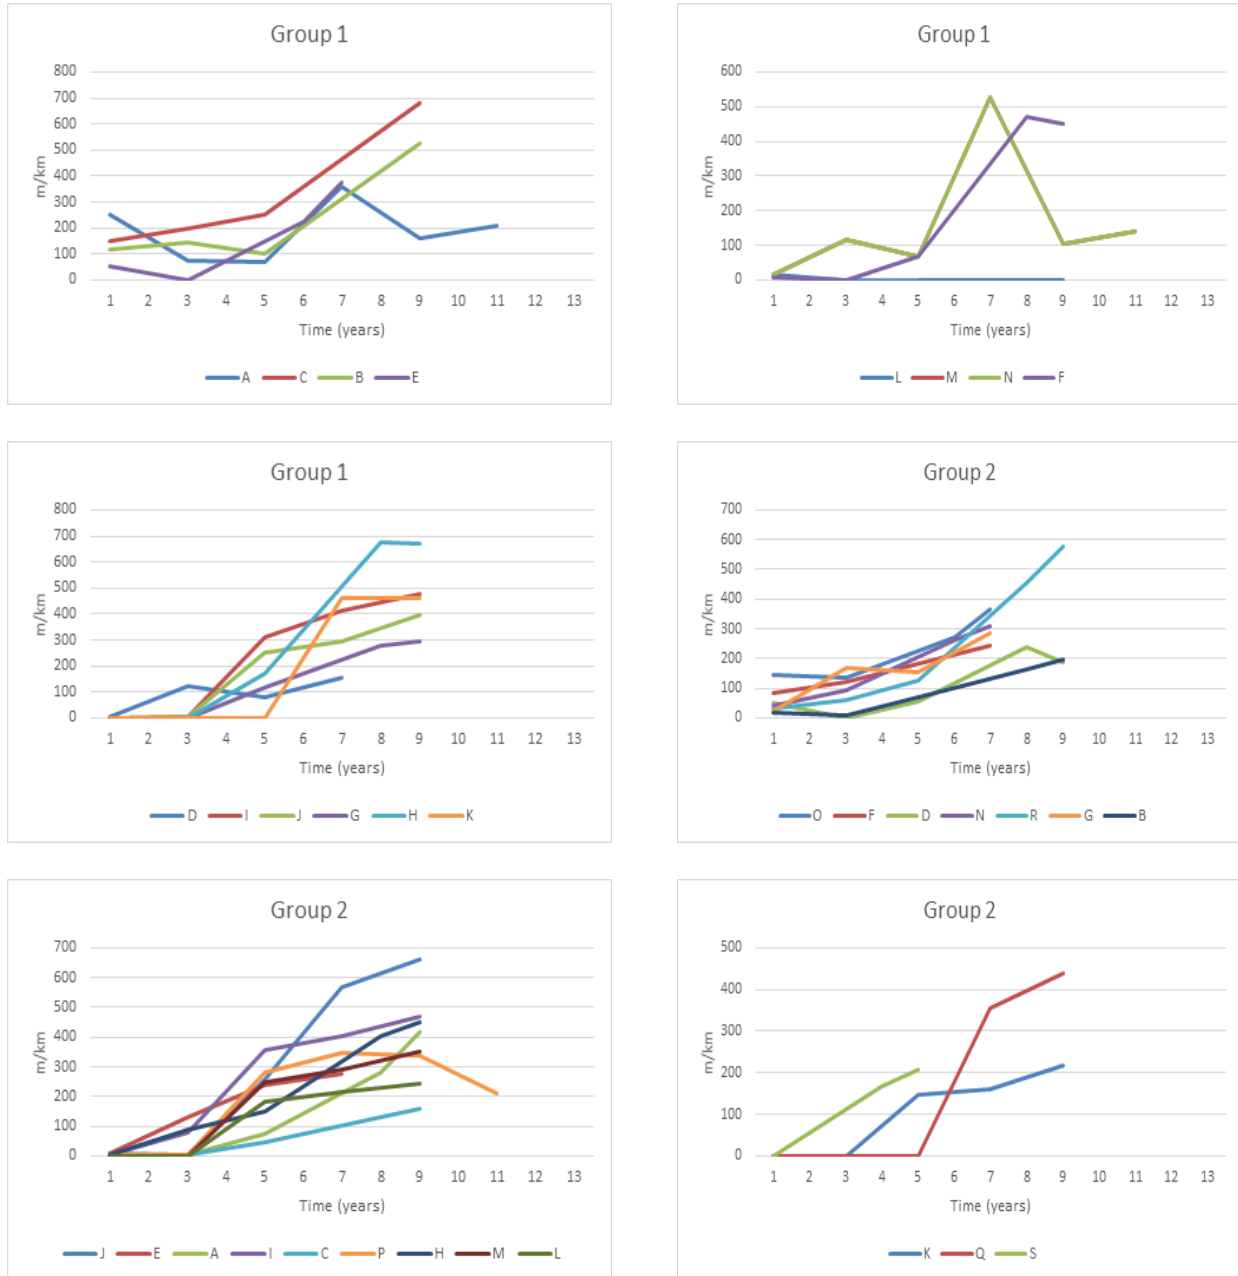
**Figure 5. Low transverse cracking deterioration for Groups 1 and 2**

Similarly, the performance of pavement segments for all distress levels was analyzed. Figures 5 and 6 show the deterioration of low transverse cracking over time.

In terms of distress propagation, it was observed that the majority of segments analyzed did not exhibit short-term performance jumps in terms of low transverse cracks (see Figures 5 and 7).

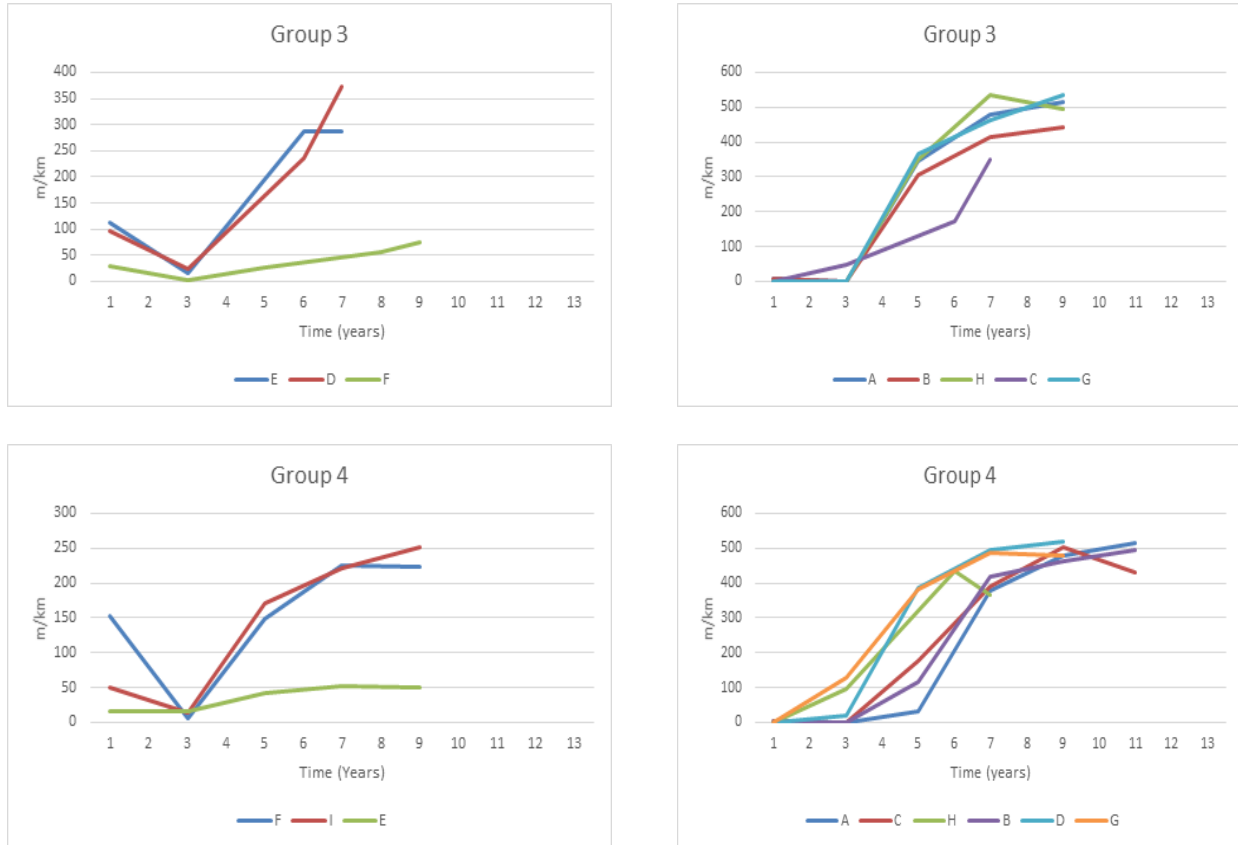
**Figure 6. Low transverse cracking deterioration for Groups 3 and 4**

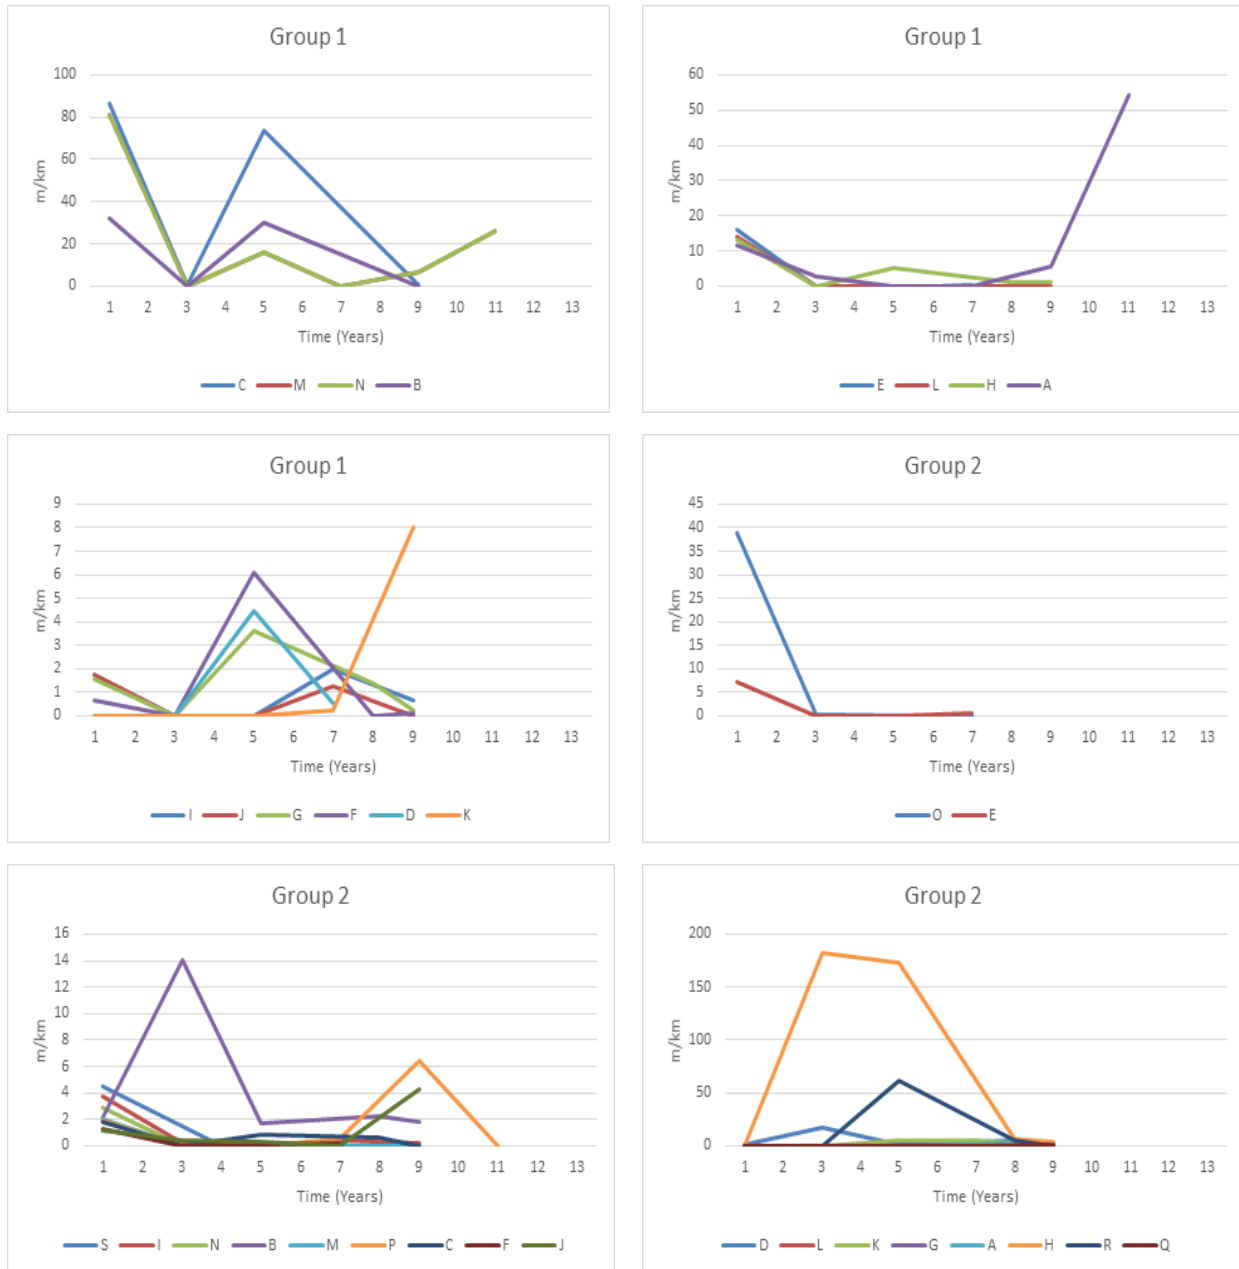
**Figure 9. High transverse cracking deterioration for Groups 1 and 2**

Similarly, the propagation of high severity transverse cracks was monitored over time. Figures 9 and 10 show the deterioration pattern for high severity transverse cracks. A reduction in the transverse cracking amount was observed after treatment application. However, segments did not

have a regular long-term performance pattern because of the sudden performance jumps. It is also worth noting that the majority of segments exhibited good performance since the level of extent did not exceed 50 m/km.

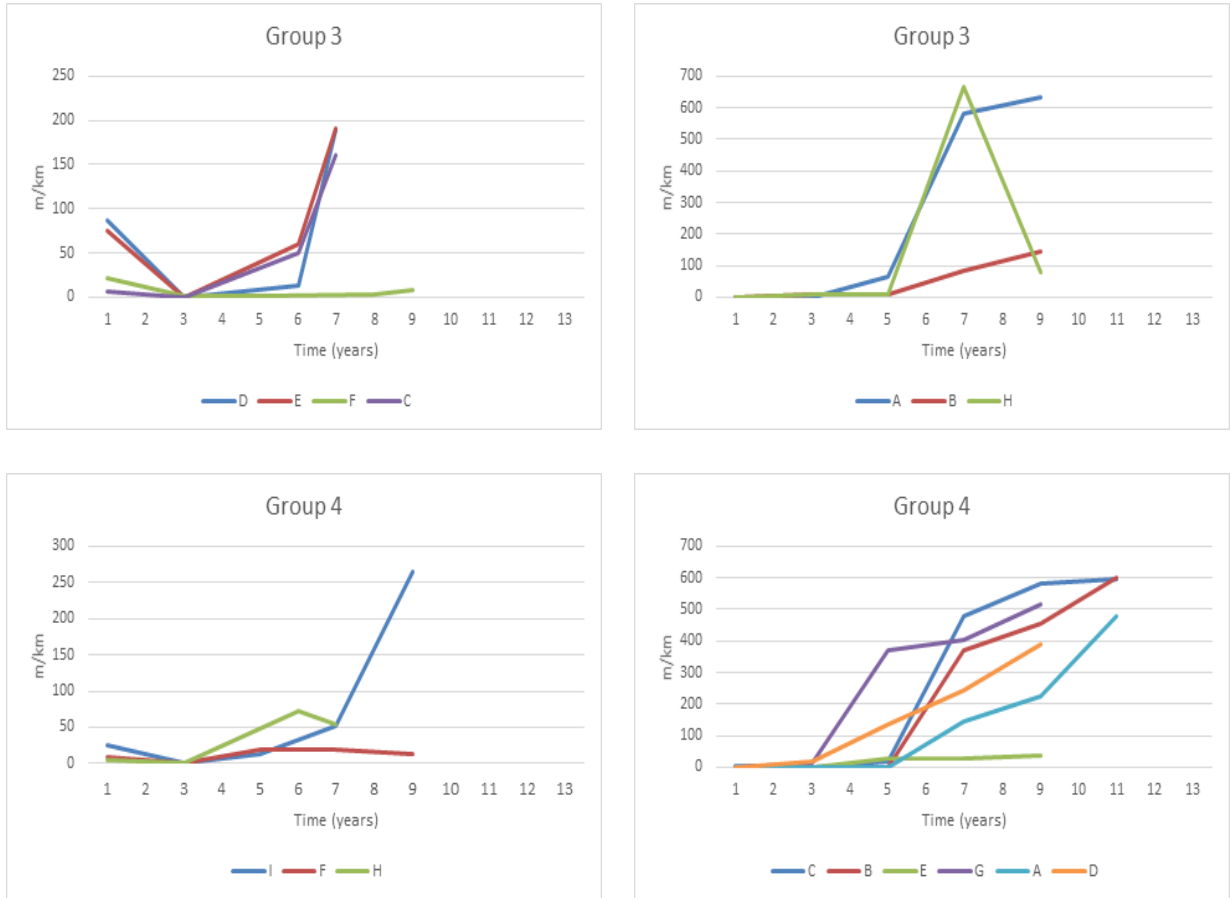
**Figure 12. Low longitudinal cracking deterioration for Groups 3 and 4**

The performance of pavements, in terms of longitudinal cracking propagation, was monitored before and after treatment application for each severity level. Figures 11 and 12 show the deterioration of low severity longitudinal cracks.

Longitudinal cracks had a similar deterioration issue when compared with the deterioration of transverse cracking. However, short-term performance jumps for many segments were observed in terms of low severity longitudinal cracks. Also, it was observed that the rate of low severity longitudinal crack propagation significantly increased after five years of treatment application for Group 2 (see Figure 11) and three years for Group 3 (see Figure 12).

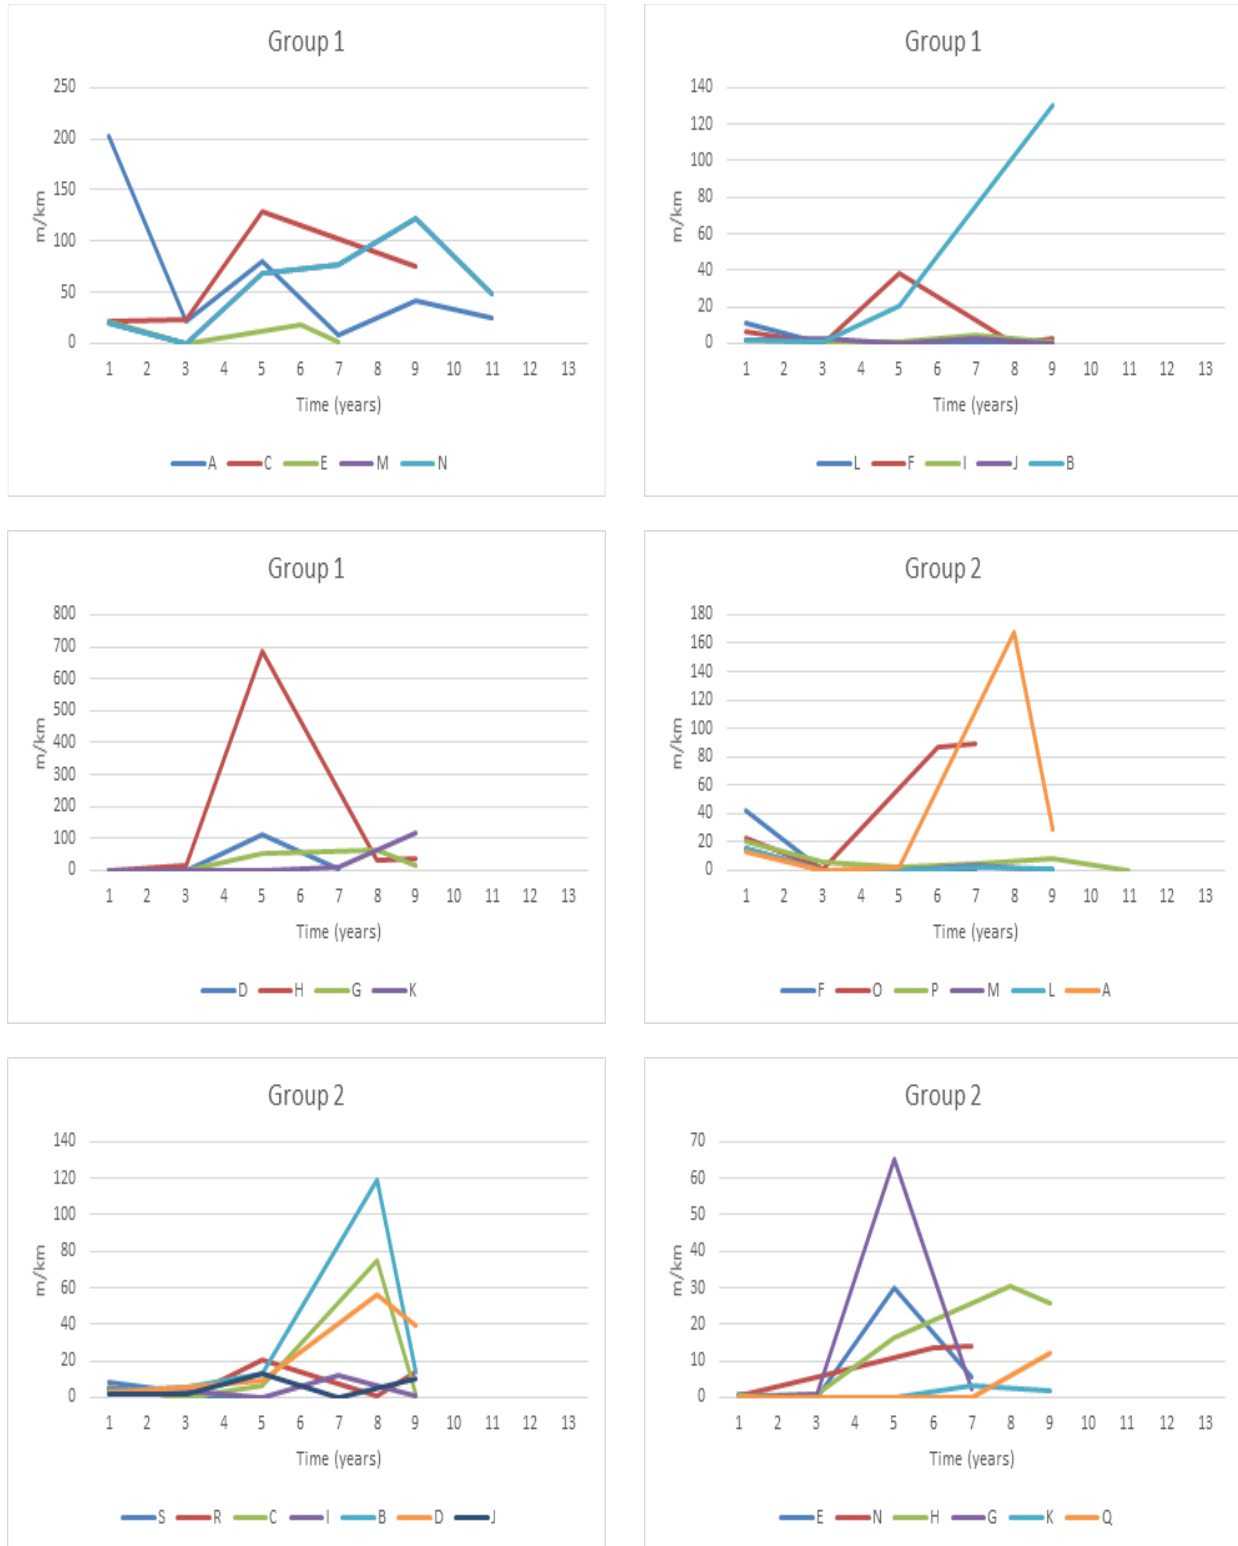
**Figure 13. Moderate longitudinal cracking deterioration for Groups 1 and 2**

Similarly, moderate severity longitudinal cracks propagation was monitored over time. Figures 13 and 14 show the deterioration pattern for moderate severity longitudinal cracks. It was observed that the majority of segments analyzed had a relatively low extent level of moderate severity longitudinal cracks. However, a clear immediate performance jump and irregular long-term deterioration patterns were observed.

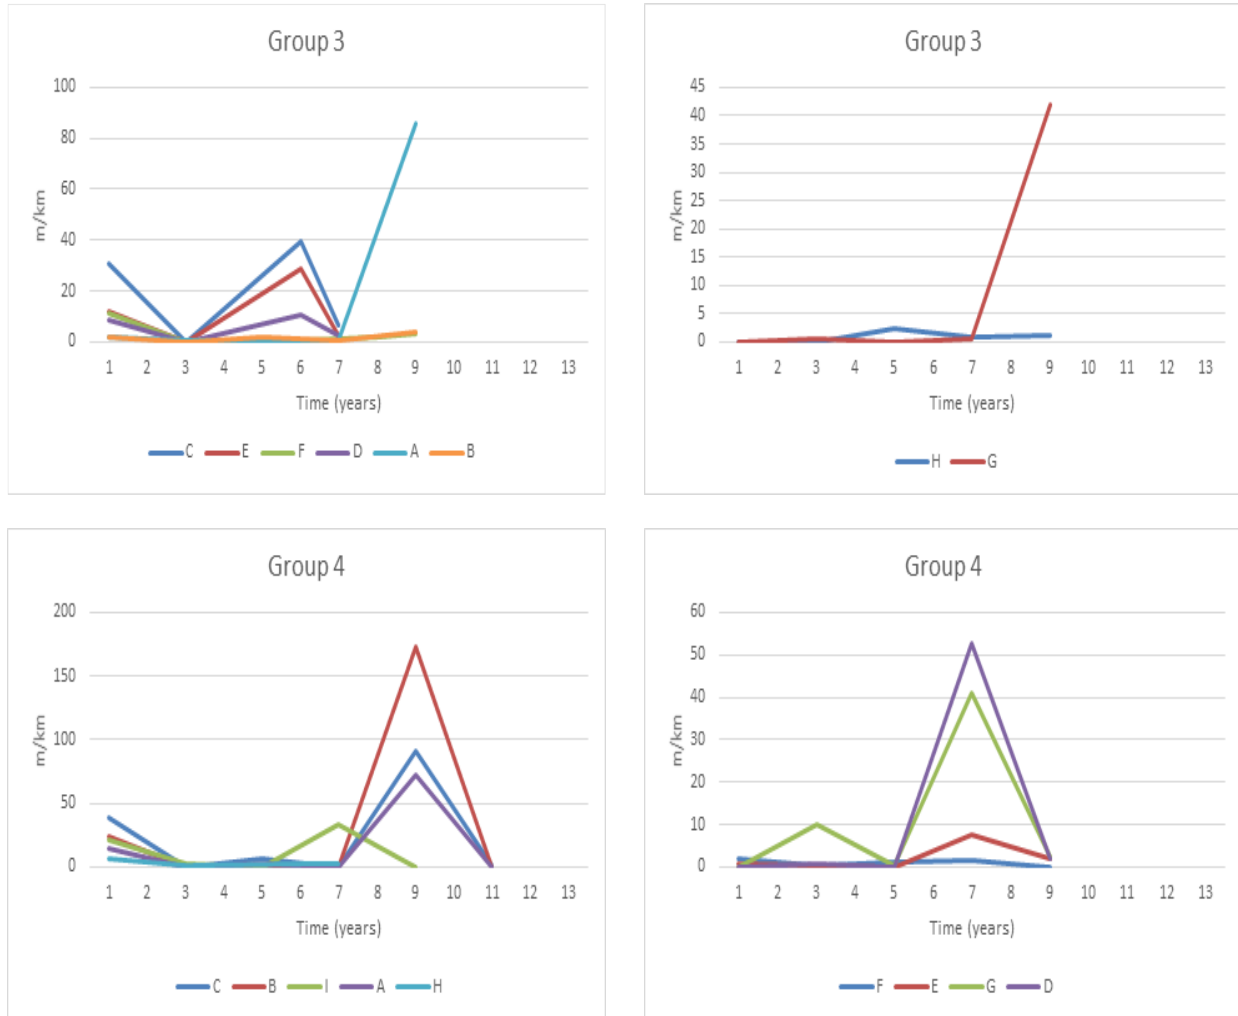
**Figure 14. Moderate longitudinal cracking deterioration for Groups 3 and 4**

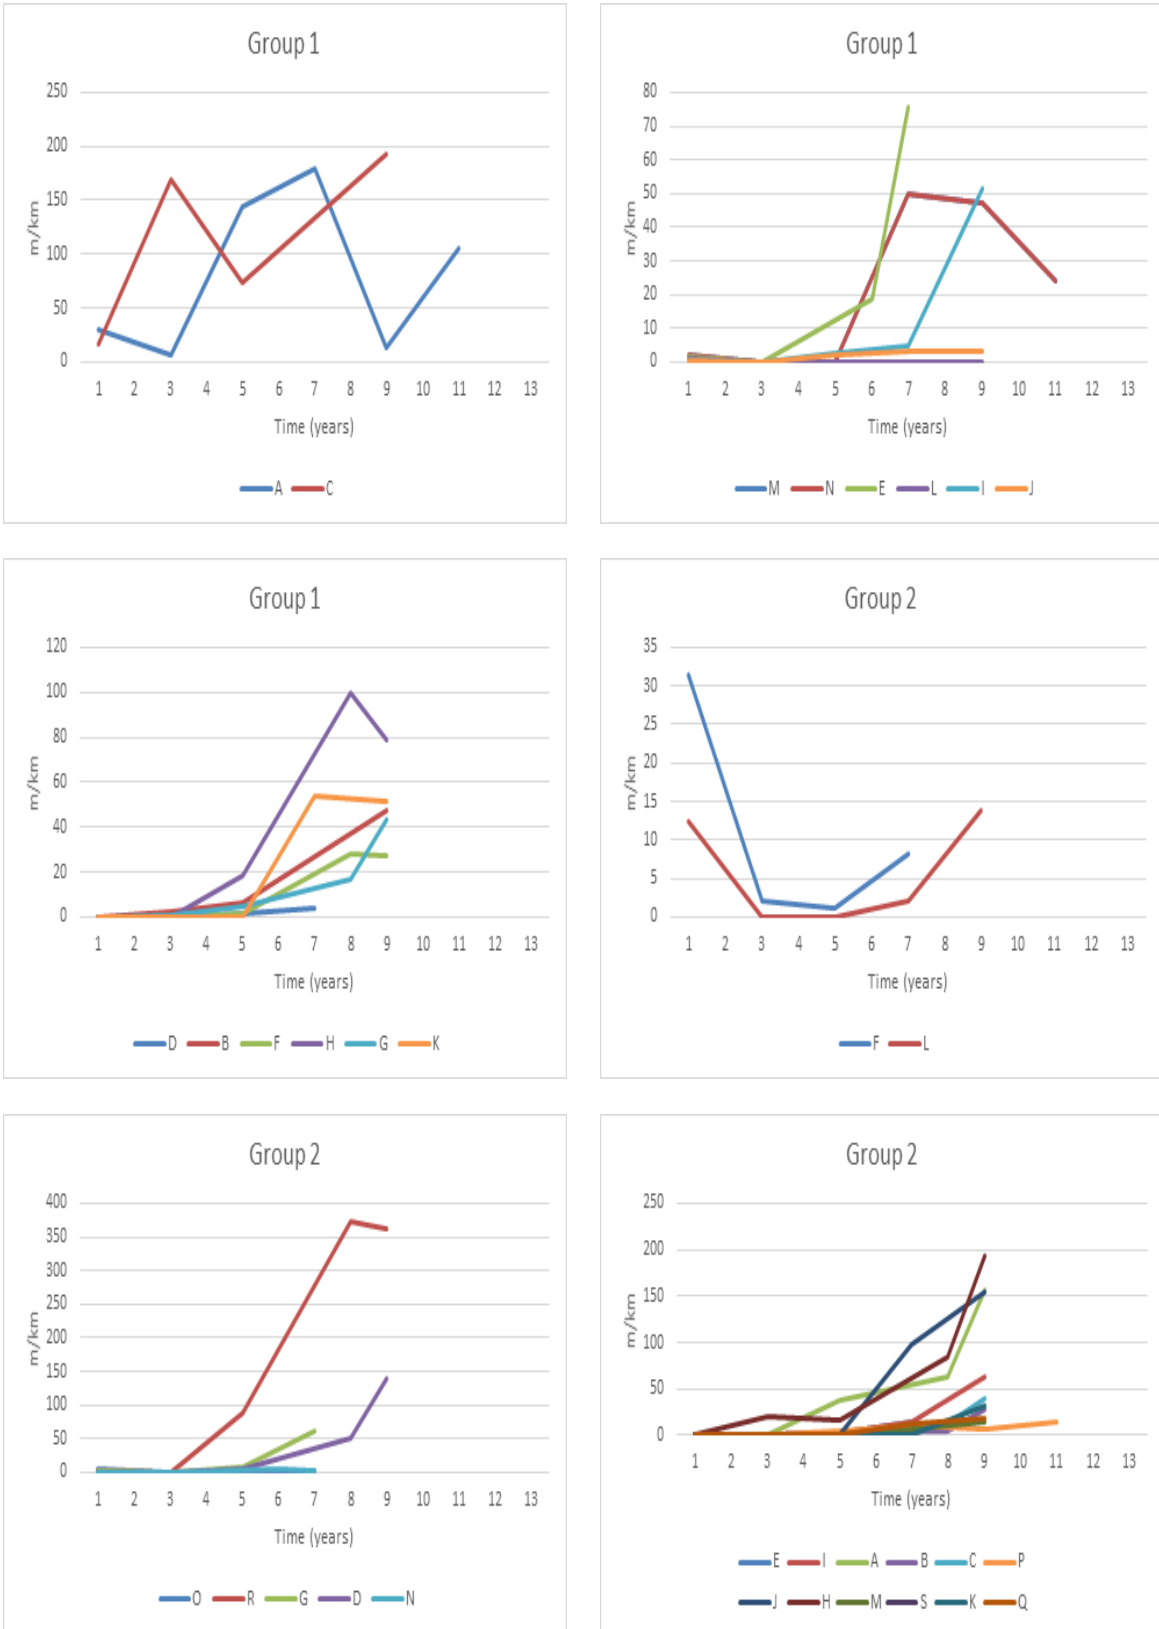
**Figure 17. Low longitudinal cracking deterioration on wheelpath for Groups 1 and 2**

The performance of pavements, in terms of longitudinal cracking on wheelpath propagation, was also monitored before and after treatment application for each severity level. Figures 17 and 18 show the deterioration of low severity longitudinal cracks on the wheelpath.

As for low severity longitudinal cracks on the wheelpath, few segments had abrupt performance jumps after treatment application. However, the deterioration pattern was closely linked with the alligator cracking deterioration pattern. For instance, Segment A in Group 1 had significant performance increases in terms of longitudinal cracking on the wheelpath and alligator cracks (see Figures 4 and 17). On the other hand, Segments A, B, C, and D in Group 2 had significant decreases in alligator cracking and significant increases in longitudinal cracking on the wheelpath.

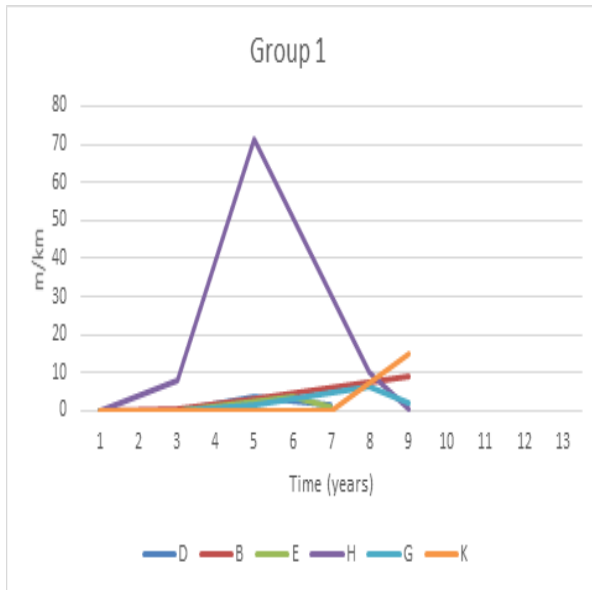
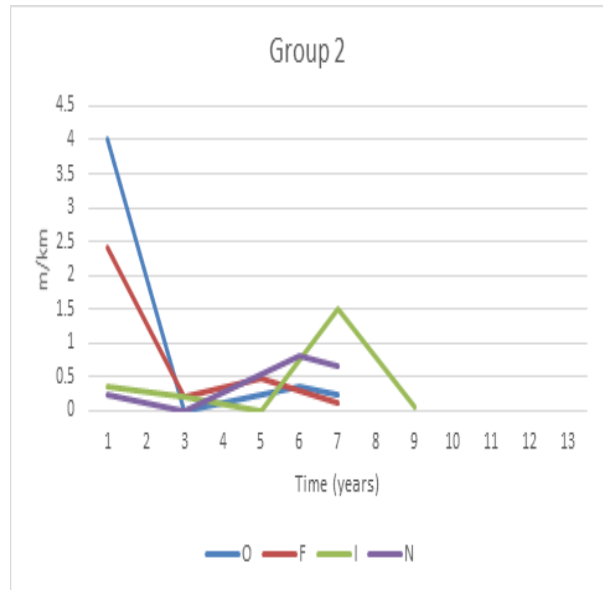
**Figure 19. Moderate longitudinal cracking deterioration on wheelpath for Groups 1 and 2**

Similarly, moderate severity longitudinal cracking propagation was monitored over time. Figures 19 and 20 show the deterioration pattern for moderate severity longitudinal cracks on the wheelpath. Observations regarding the long-term and short-term performance are very similar to the previous distresses.

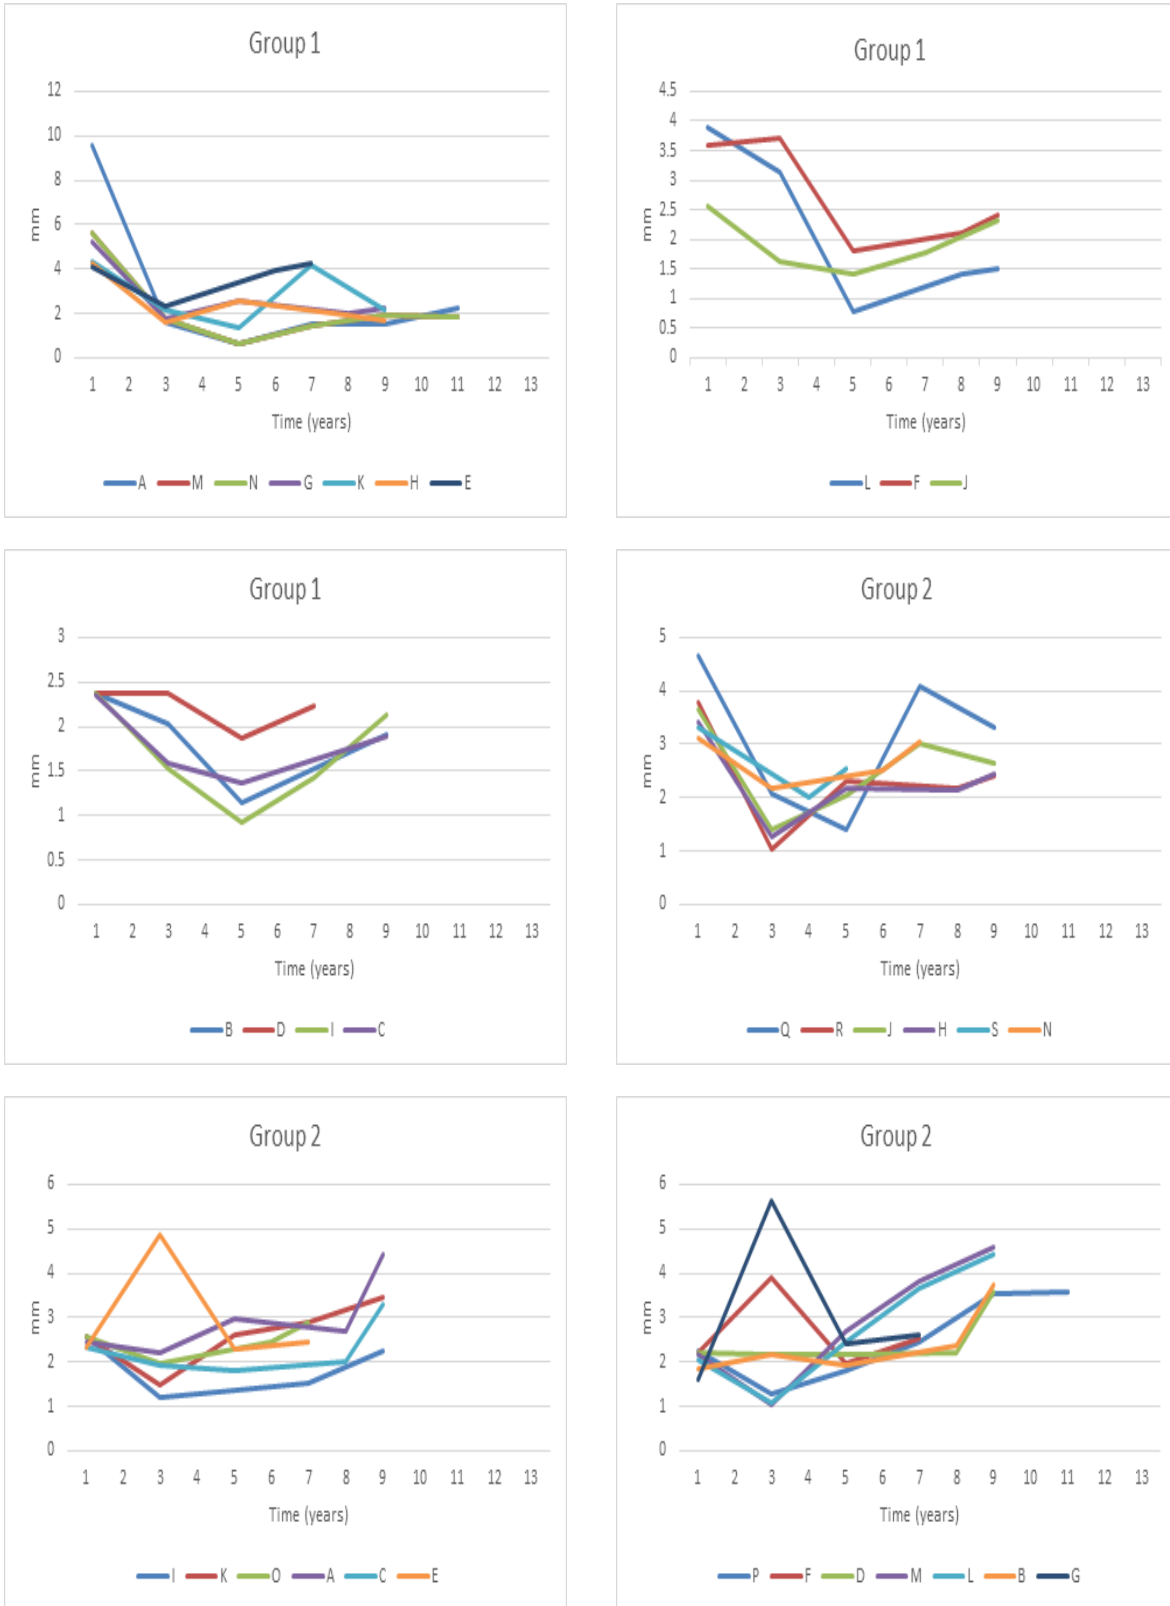
**Figure 24. Rut depth for left wheelpath deterioration for Groups 1 and 2**

Similarly, rutting rate of deterioration for both left and right wheelpaths were monitored before and after treatment application. Figures 22 through 25 show the rate of deterioration for rutting. It was observed that fewer segments had inconsistent performance patterns when compared to the other previous distresses. Additionally, the majority of the segments analyzed had a clear performance jump immediately after treatment application and regular deterioration over time.

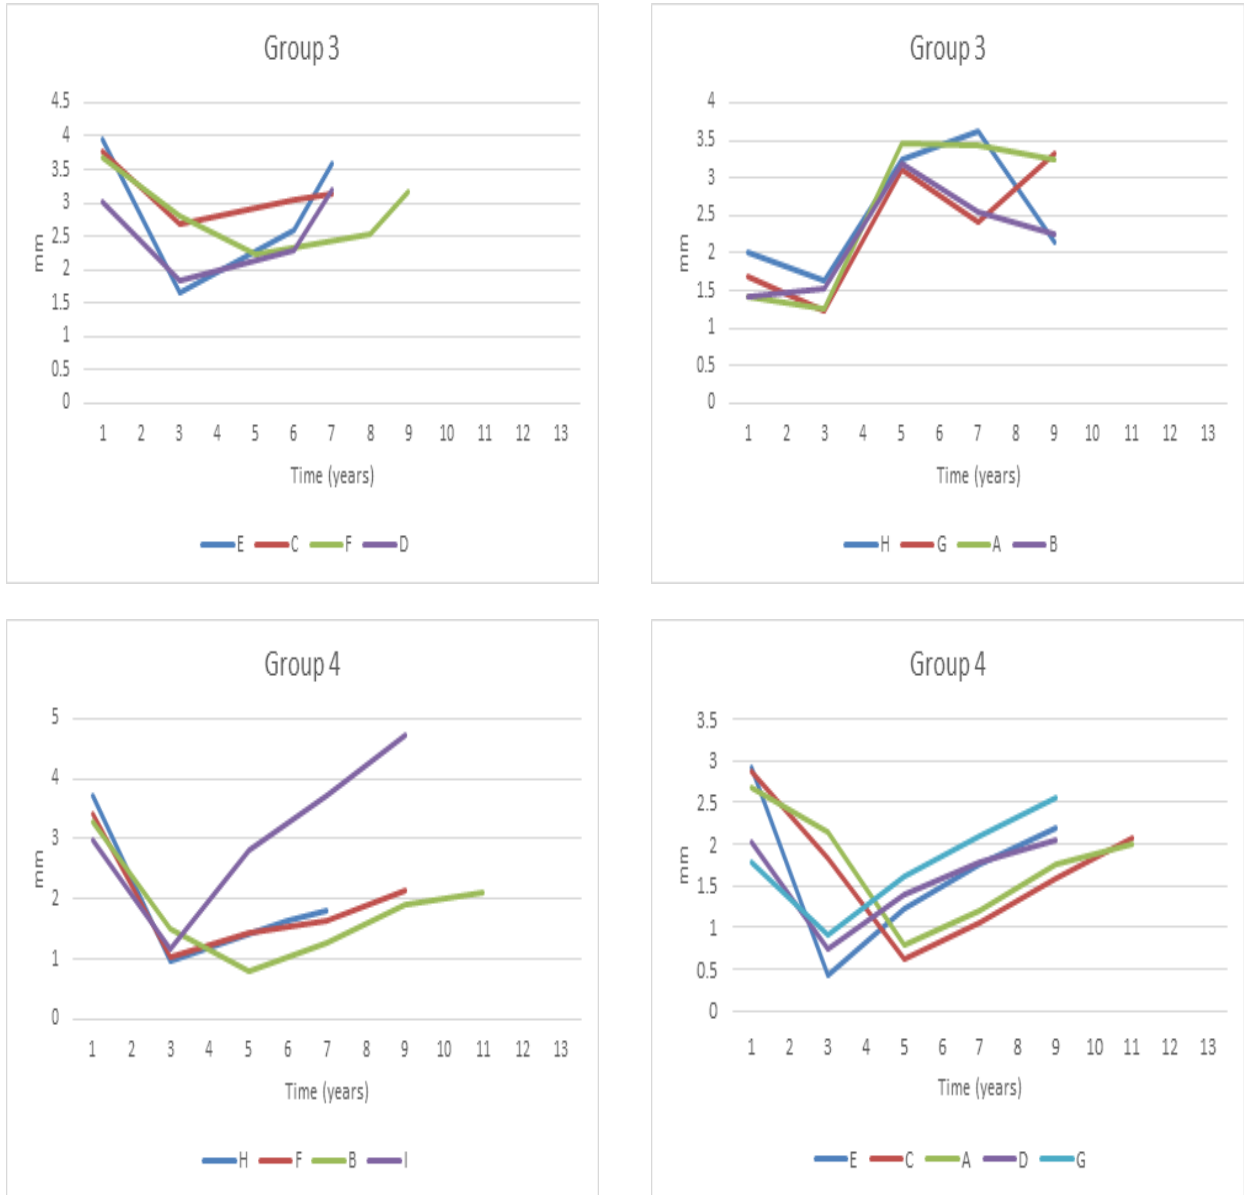
**Figure 25. Rut depth for left wheelpath deterioration for Groups 3 and 4**

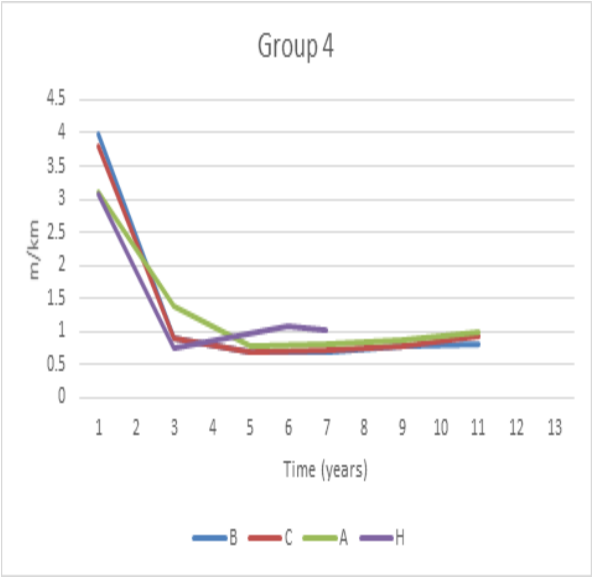
**Figure 27. IRI for left wheelpath deterioration for Groups 2, 3, and 4**

Similar to rutting, performance of road roughness was monitored for both the left and right wheelpaths. Figures 26 through 28 show the rate of deterioration for IRI on the left and right wheelpaths. It was observed that IRI was the most consistent performance measurement since the majority of segments had clear short-term and long-term performance patterns.

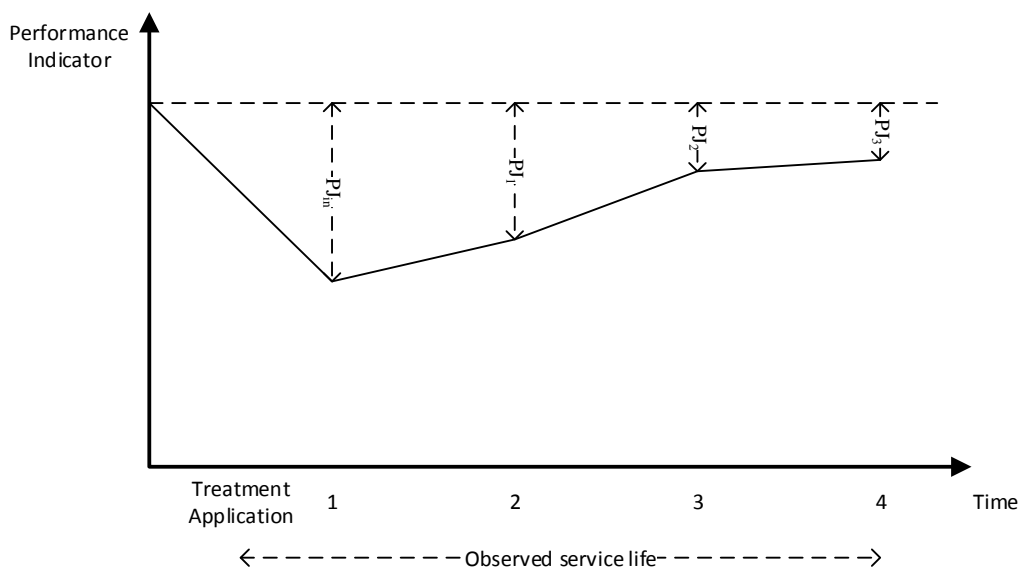
**Figure 29. Performance jumps for performance indicators and observed service life**

In order to visualize the performance evaluation concept and terminology, Figure 29 shows the typical pattern of observed performance jumps for rutting and IRI.
