**National Open House  
Two-Lift Concrete Paving  
October 15 – 16, 2008  
Salina/Abilene, KS – Interstate 70**

**National Concrete Pavement  
Technology Center**

## Introduction

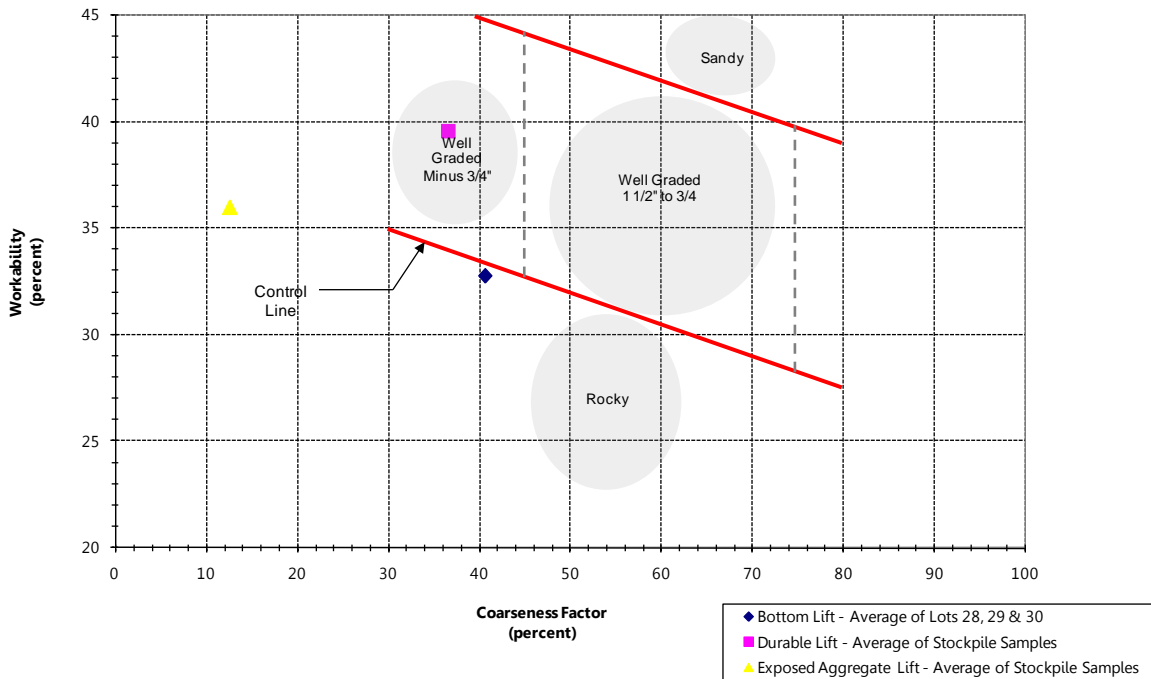
Figure 7 Workability and Coarseness Factors

**I-70 2-Lift Project  
Workability Factors & Coarseness Factors**

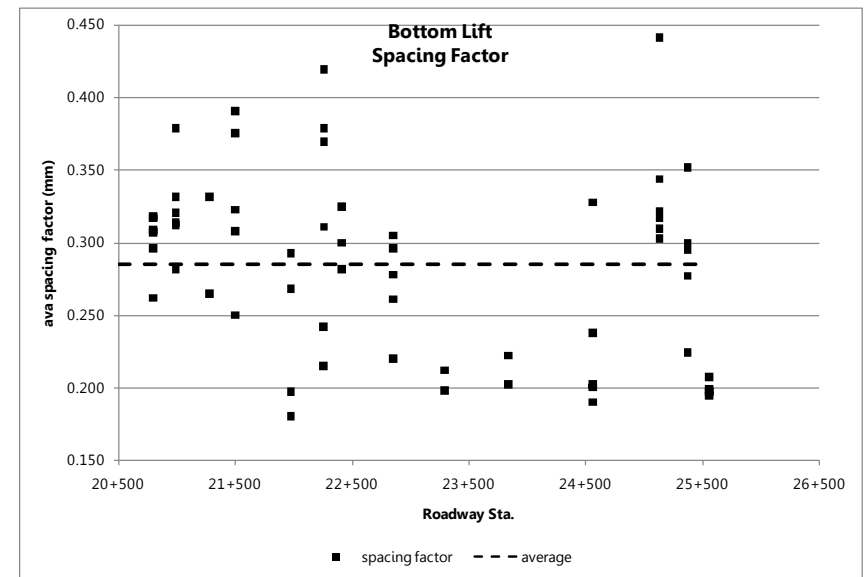
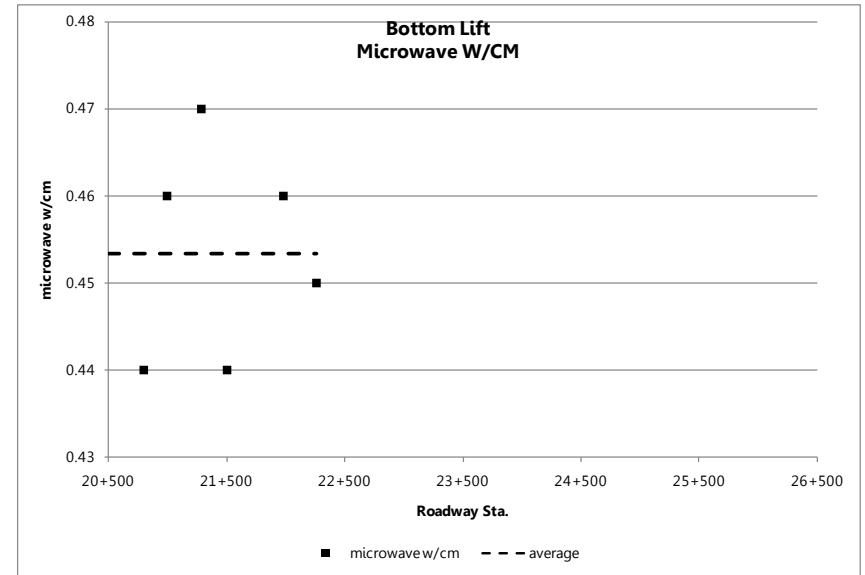
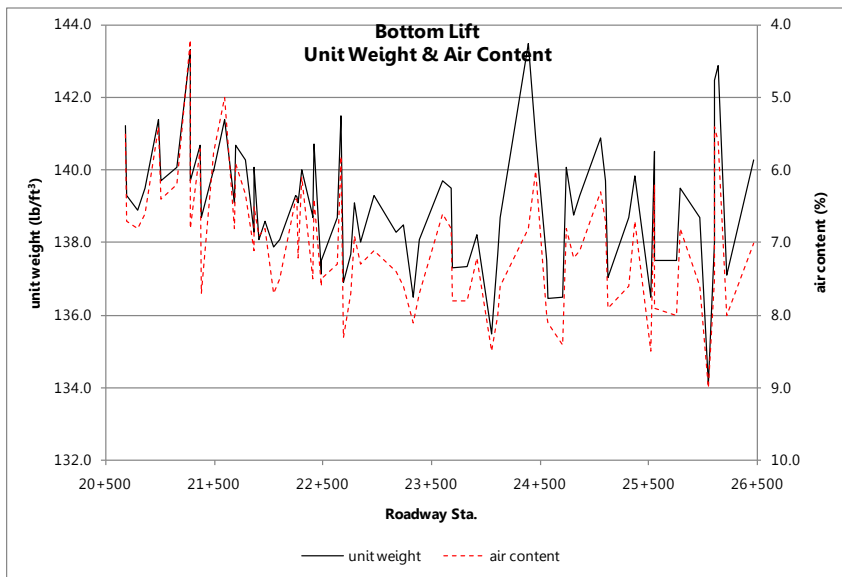
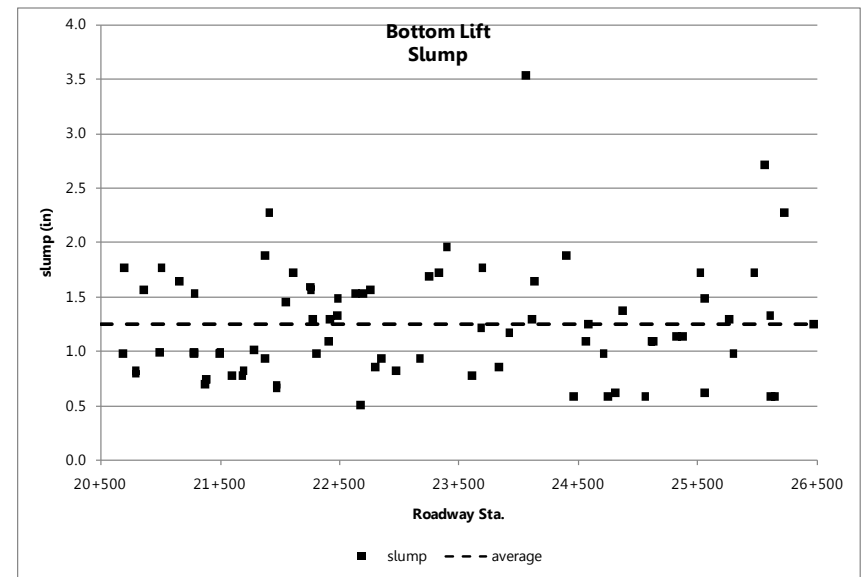
### Bottom Lift (Table 2 and Figures 8 through 13):

Figure 8 Bottom Lift Pressure Air Content

Figure 9 Bottom Lift AVA Spacing Factor

Figure 10 Bottom Lift Unit Weight

Figure 11 Bottom Lift Microwave W/CM

Figure 12 Bottom Lift Unit Weight and Air Content

Figure 13 Bottom Lift Slump

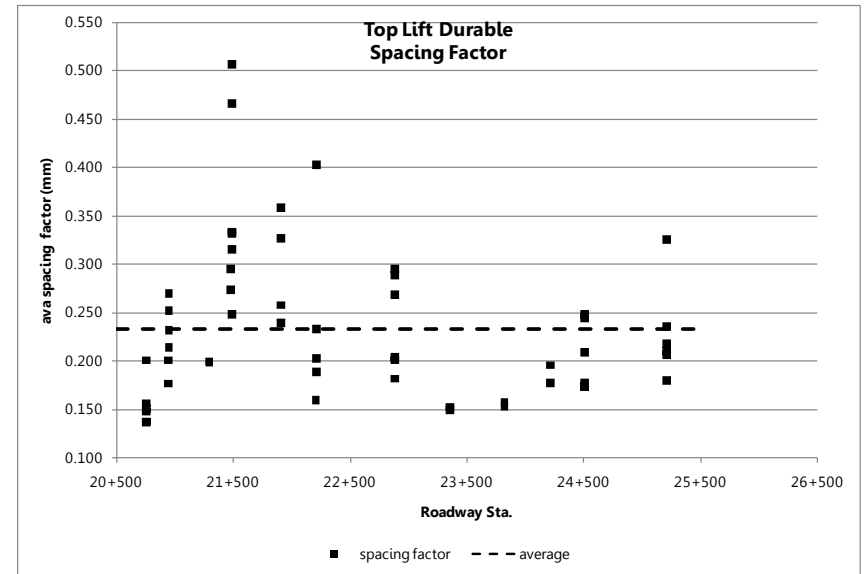
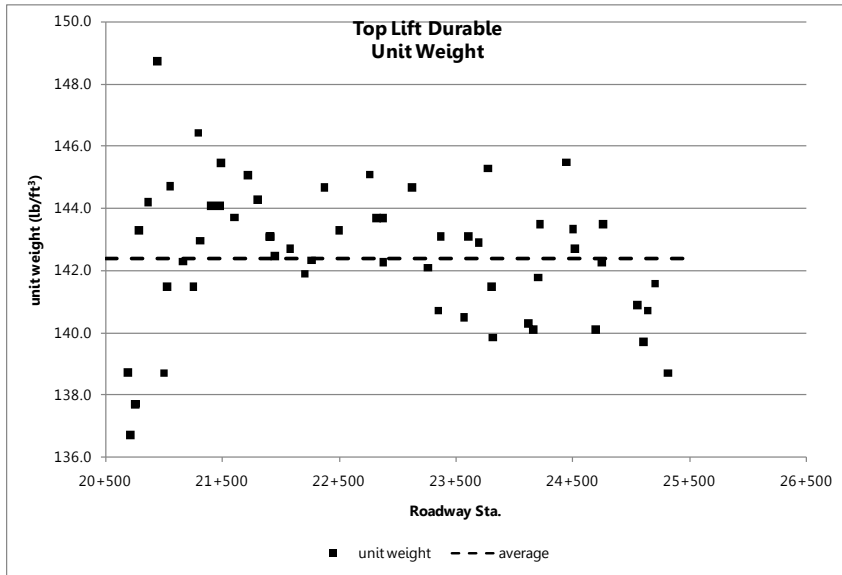
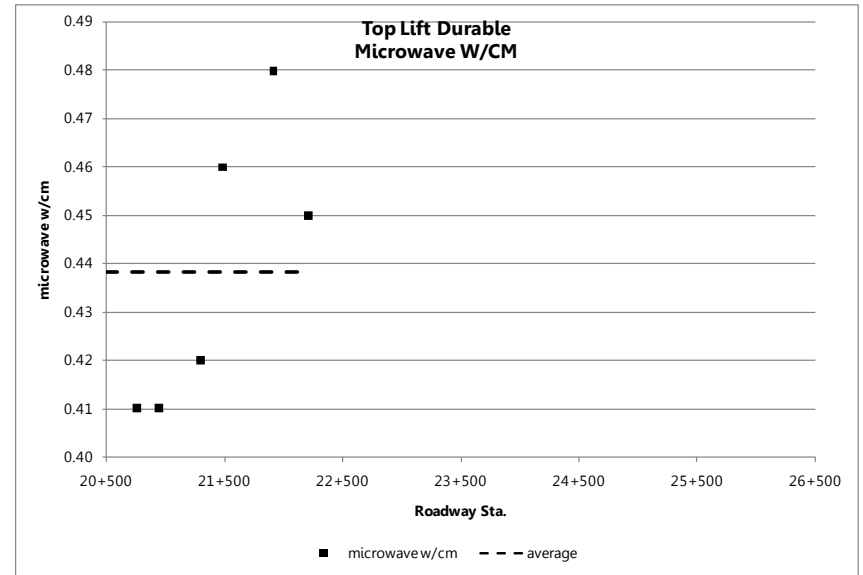
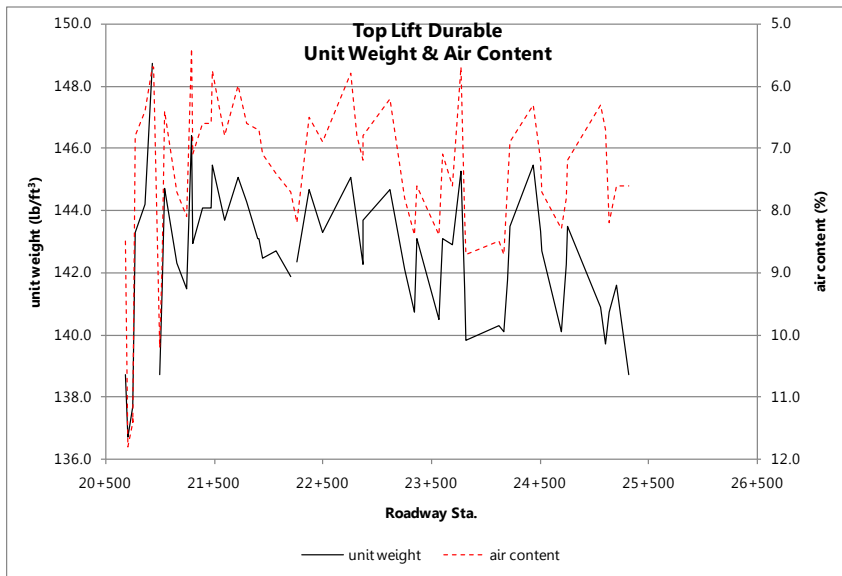
**Durable Lift (Table 3 and Figures 14 through 19):**

Figure 14 Durable Lift Pressure Air Content

Figure 15 Durable Lift AVA Spacing Factor

Figure 16 Durable Lift Unit Weight

Figure 17 Durable Lift Microwave W/CM

Figure 18 Durable Lift Unit Weight and Air Content

Figure 19 Durable Lift Slump

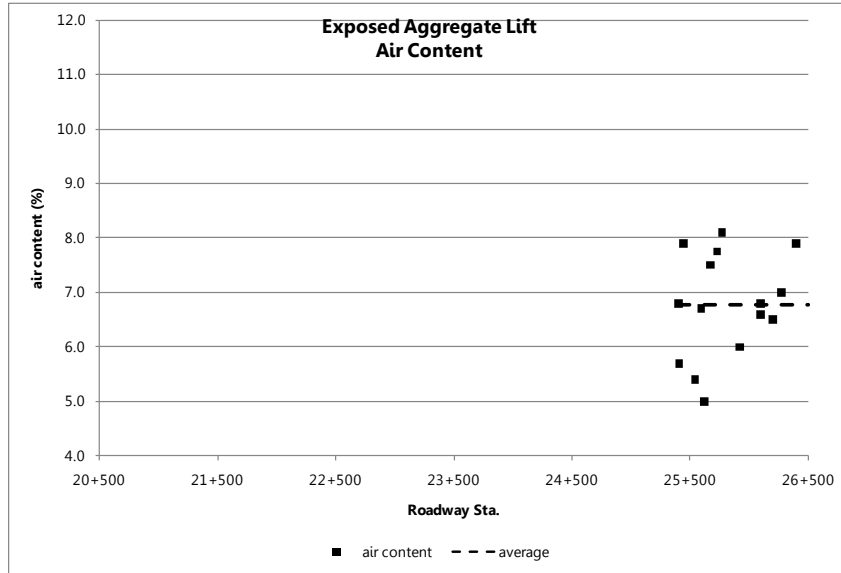
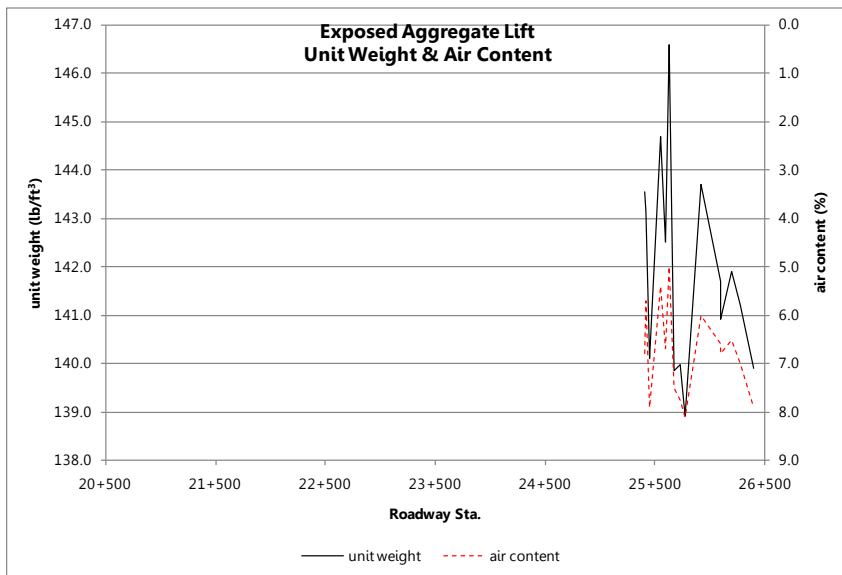
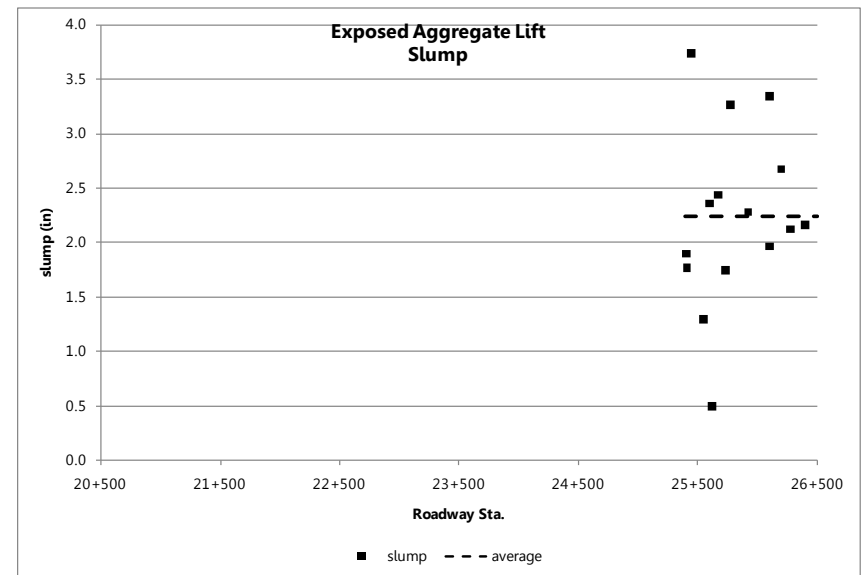
**Exposed Aggregate Lift (Table 4 and Figures 20 through 25):**

Figure 20 Exposed Aggregate Lift Pressure Air Content

Figure 21 Exposed Aggregate Lift AVA Spacing Factor

Figure 22 Exposed Aggregate Lift Unit Weight

Figure 23 Exposed Aggregate Lift Microwave W/CM

Figure 24 Exposed Aggregate Lift Unit Weight and Air Content

Figure 25 Exposed Aggregate Lift Slump

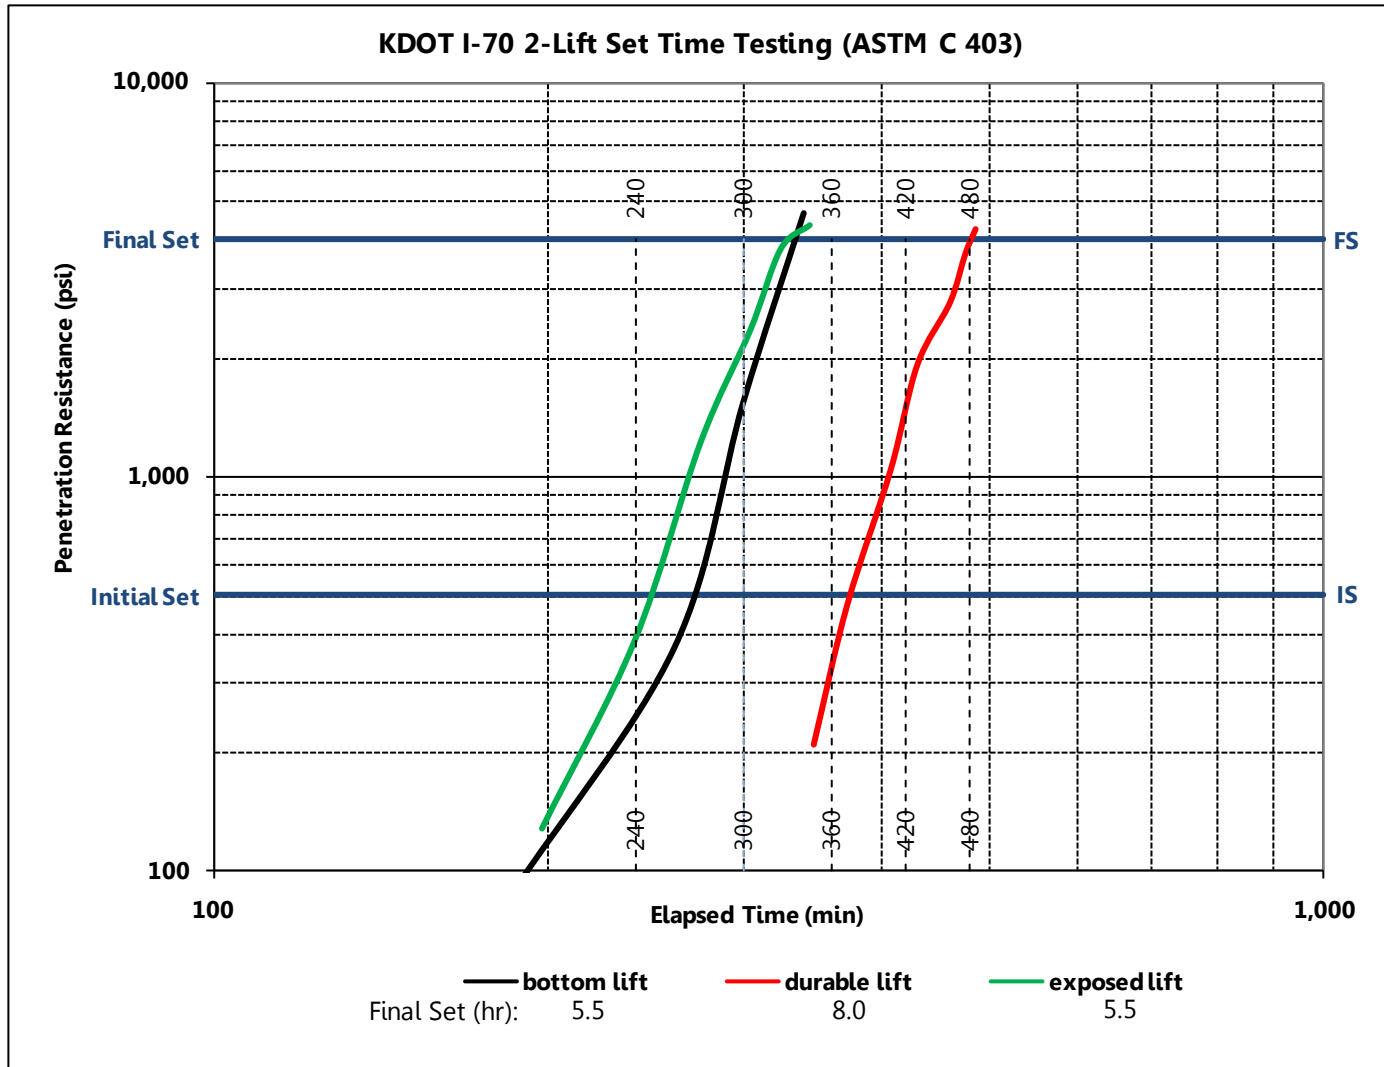
A series of tests was performed in an attempt to relate the time when sweeping for the exposed aggregate surface treatment commenced to the time of final set. The most widely used method for determining set time is penetration resistance of a mortar specimen (ASTM C 403) (Figure 26). Test results for the durable lift are included for information only.

Figure 26 Set Time Test Results (ASTM C 403)

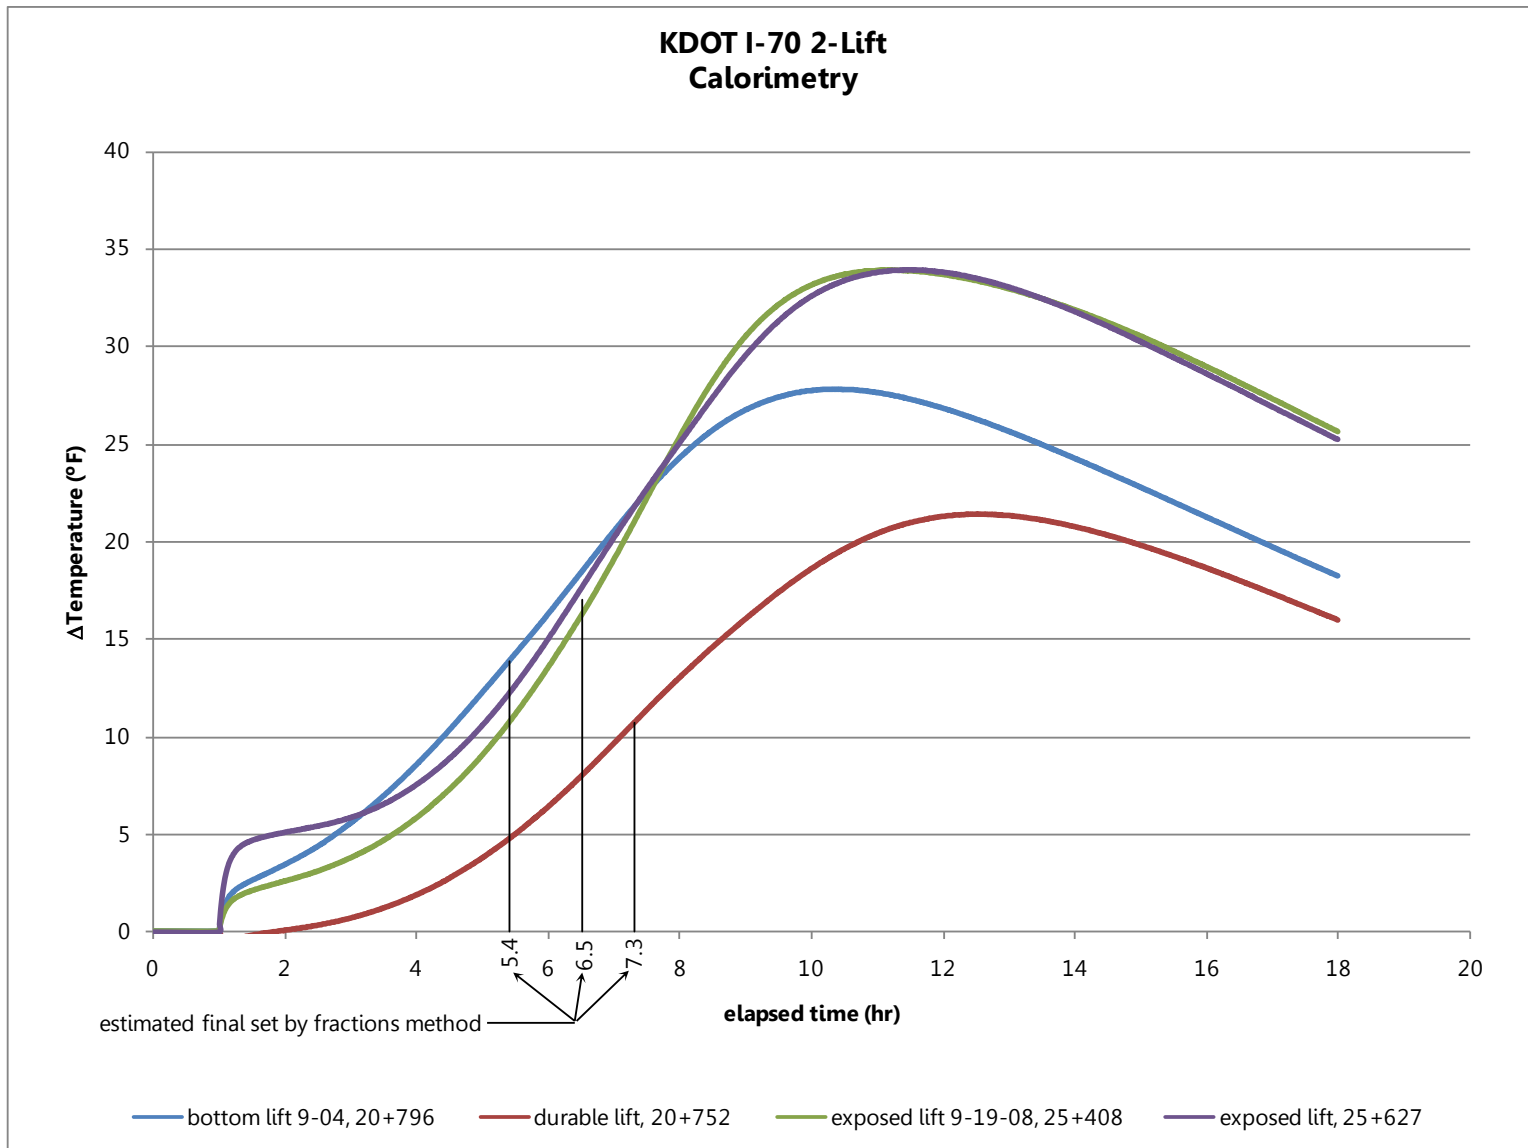
Calorimeters were used to estimate set times using the fractions method (Figure 27).

Figure 27 Concrete Mixture Heat Signature Curves and Estimated Final Set Times (Fractions Method)

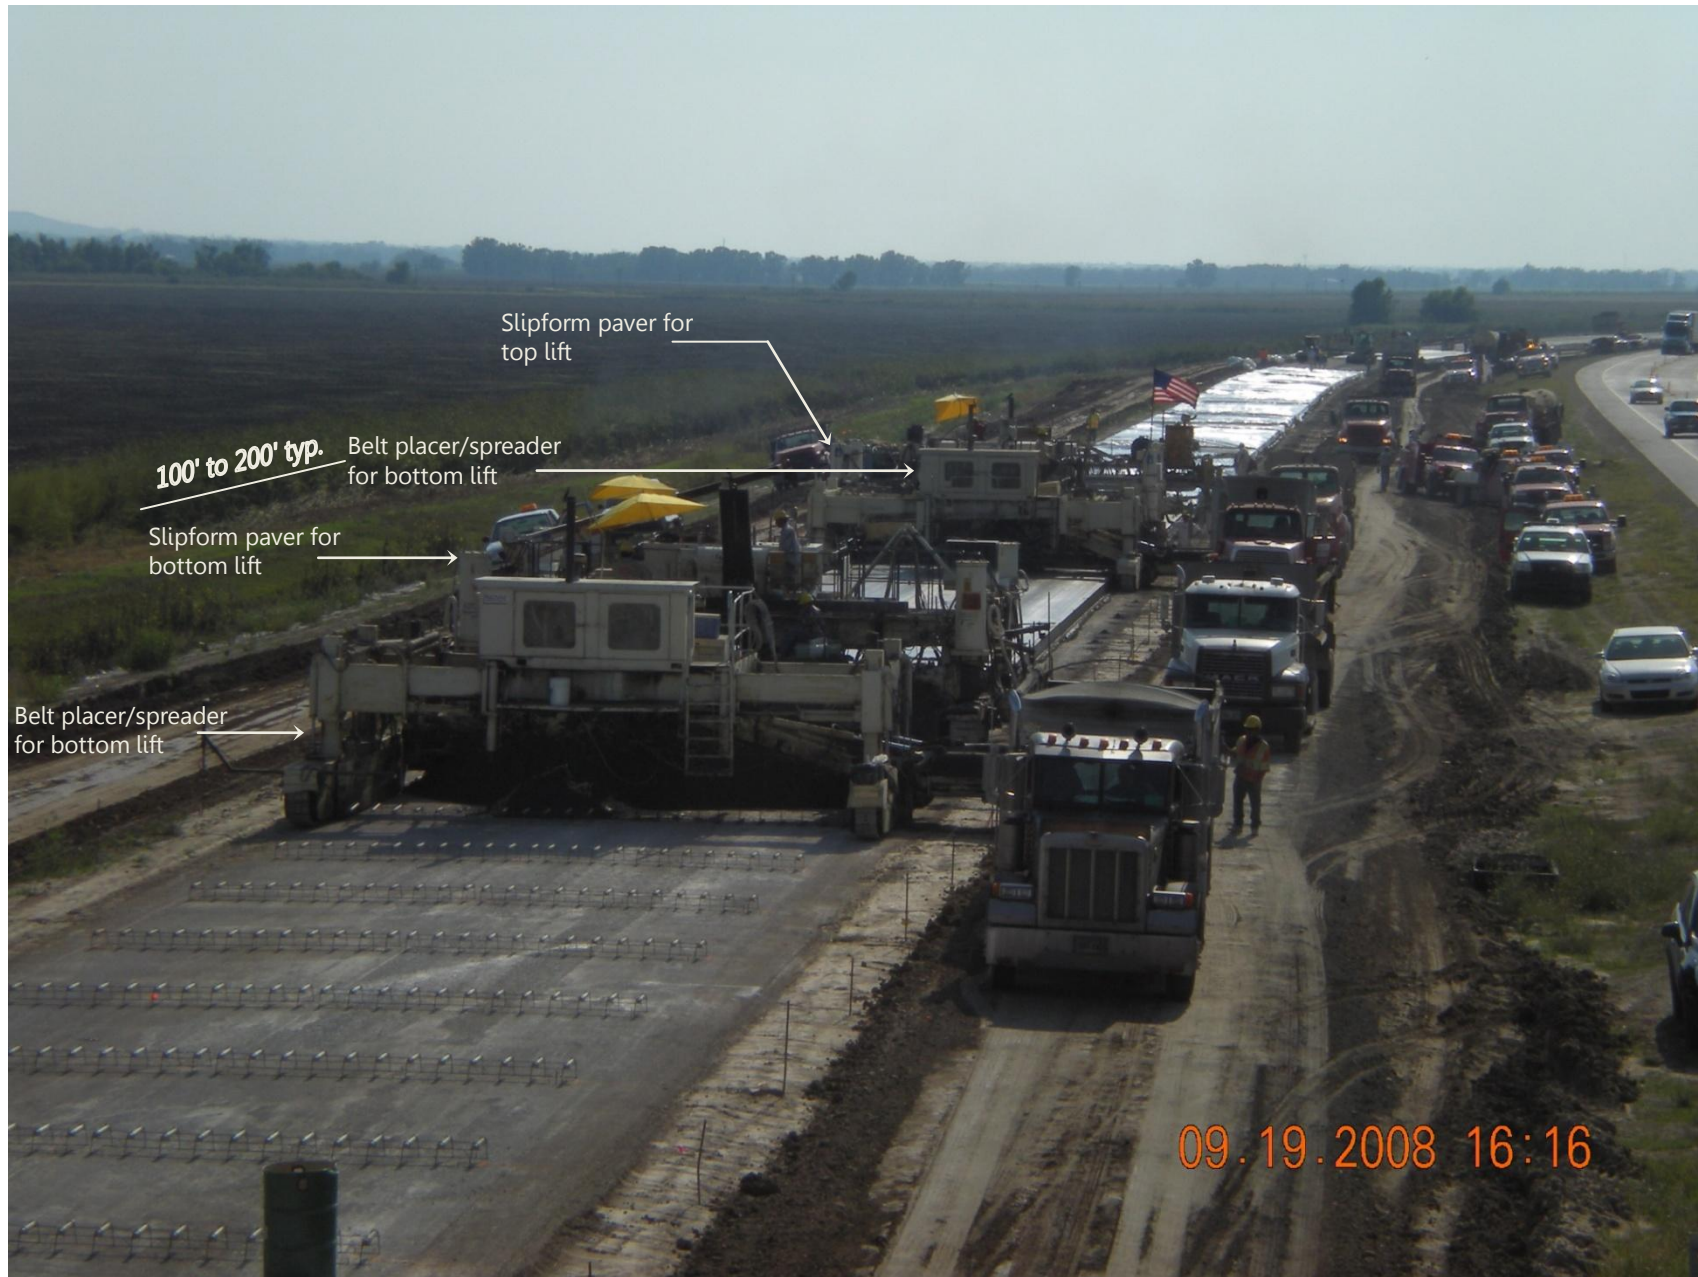
The paving train consisted of the following equipment (Figures 29 through 33):

- Belt placer/spreader for the bottom lift.
- Slipform paver for the bottom lift. Paver width was set approximately 1" to 1½" narrower than the second paver width.

- Belt placer/spreader for the top lift. This spreader was modified slightly with the addition of a grid fabricated from square steel tubing that was placed under the discharge end of the belt to reduce the potential for deformation of the bottom lift while concrete was being unloaded from the belt on to the bottom lift.

- Slipform paver for the top lift. Vibrators were raised above the elevation of the extrusion pan to avoid co-mingling of the two concrete mixtures during consolidation. Maintaining consistent horizontal alignment between the two pavers was also a detail that required extra attention. If the steering would drift slightly to one side or the other, edge problems were observed behind the second paver.

- Burlap drag, astro-turf drag and cure/texture equipment and processes were identical to single lift paving procedures.

Figure 29 I-70 Two-Lift Paving Equipment Train

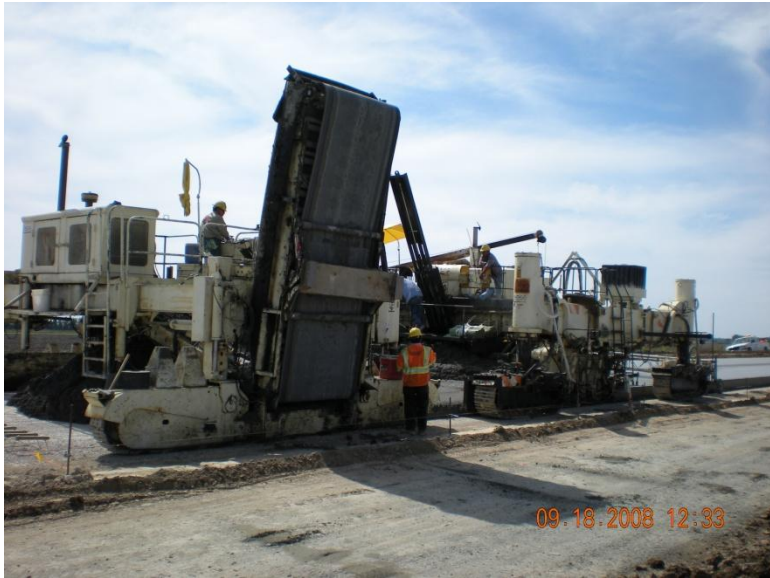
Figure 30 Bottom Lift Belt Placer/Spreader and Paver

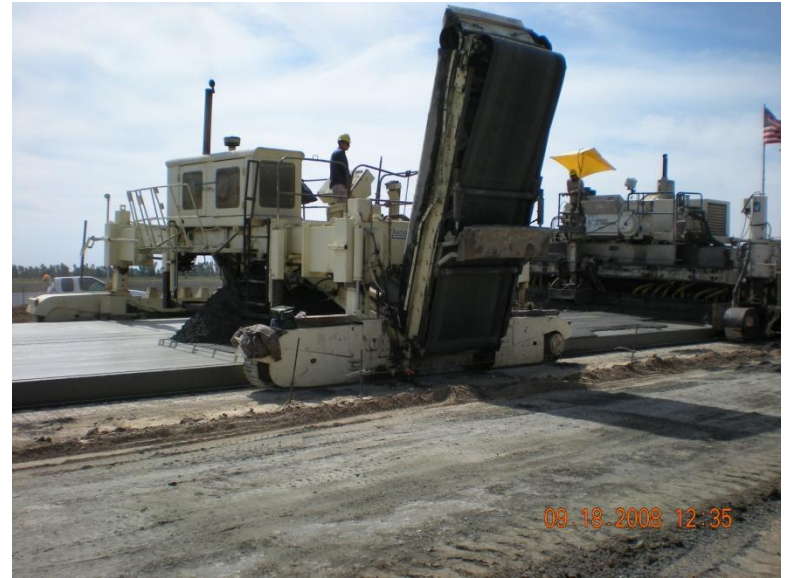
Figure 31 Top Lift Belt Placer/Spreader and Paver

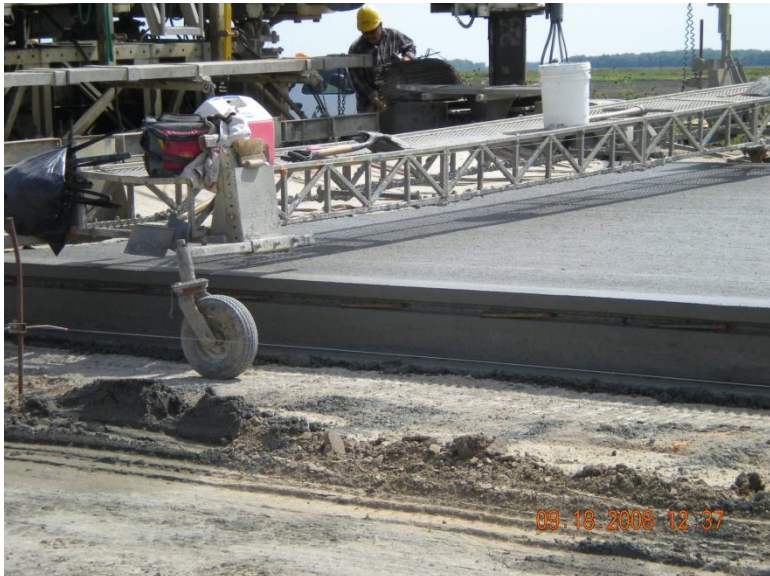
Figure 32 Initial Burlap Drag Following Top Lift Paver

- Finishing – a burlap drag was attached to the float pan of the top lift paver. Normal finishing procedures were used for the tined and astro-turf drag sections. Minimal finishing (primarily edging and transverse mop) was performed on the ground and exposed aggregate sections.

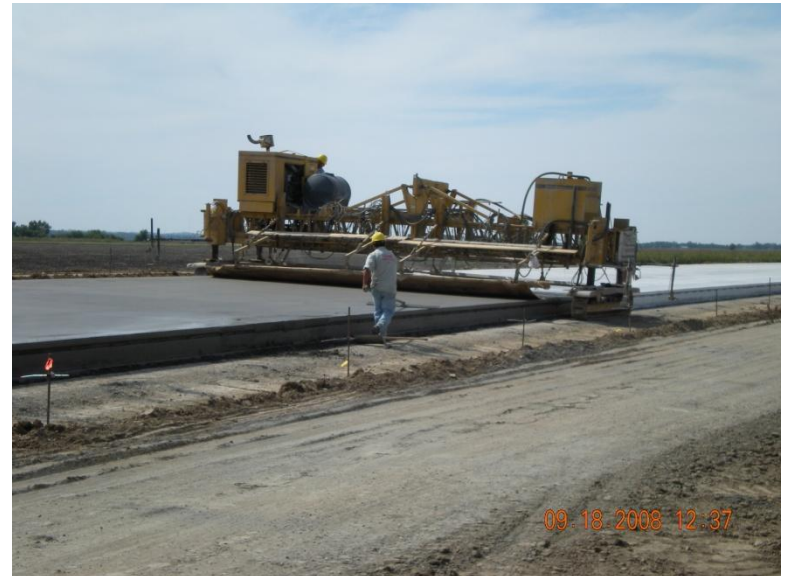
Figure 33 Texture/Cure Machine Following Final Finishing

- Final burlap drag attached to the texture cure machine.
- Curing compound applied by a texture/cure machine, except for the exposed aggregate section which was sprayed with retarder and initially cured with polyethylene sheeting then final cured with curing compound after sweeping.

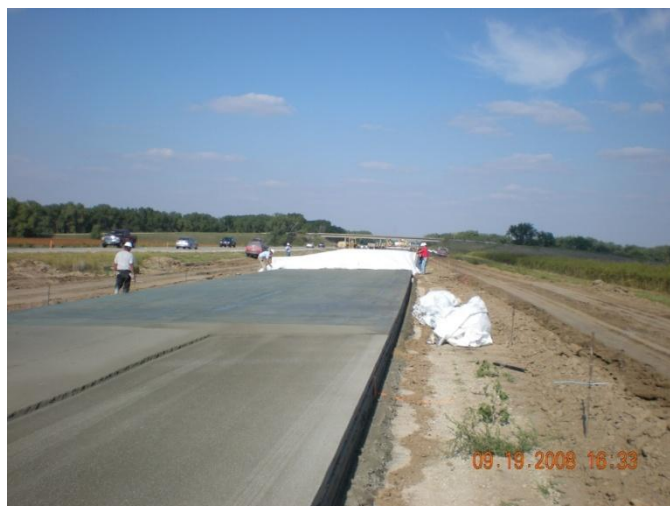
- Retarder was sprayed on the surface with a texture/cure machine at coverage rate of approximately 150 to 170 ft<sup>2</sup>/gal.
- Polyethylene sheeting was unrolled and used to cover the pavement for initial curing.
- After approximately 5 hours polyethylene sheeting was removed in 100' segments (Figure 34) and a wire bristled brush was used as an indicator of when sweeping should commence; typically 5 to 6 hours after initial placement.

Figure 34 Removing Polyethylene Sheeting in 100' Segments

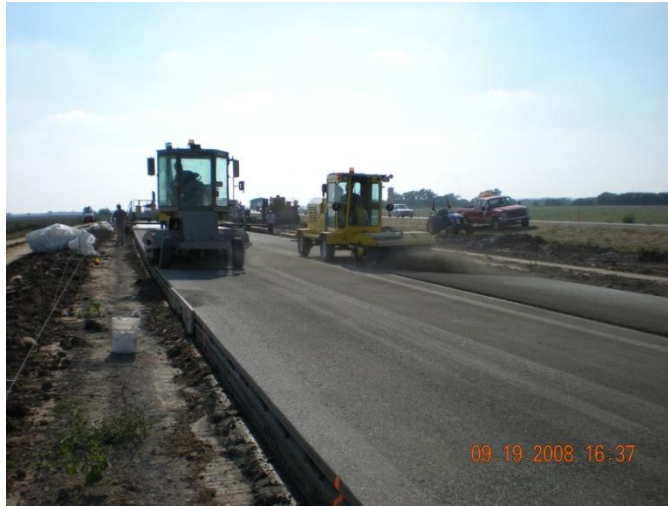
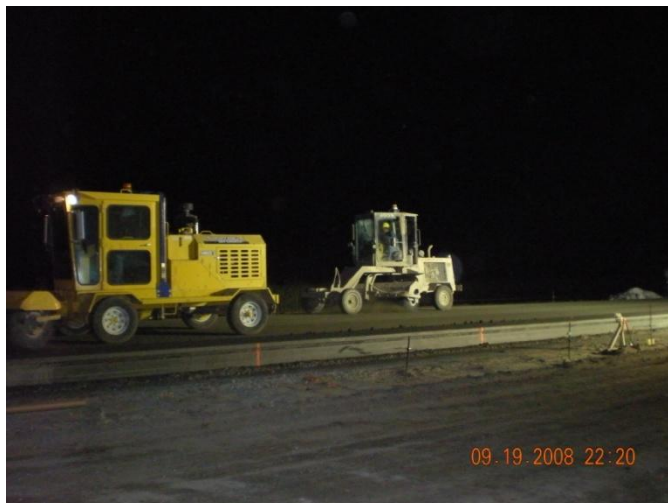
- Sweeping was accomplished in approximately 100' segments with two power brooms (Figures 35 through 37).

Figure 35 Sweeping Operations

Figure 36 Nighttime Sweeping Operations

- Exposed aggregate surface treatment section – sweeping was accomplished with two power brooms equipped with wire bristles. The initial broom was a front mounted sweeper and the second broom was a mid-mounted sweeper. Approximately 5 to 6 hours elapsed between the finishing operations and the start of the sweeping process.

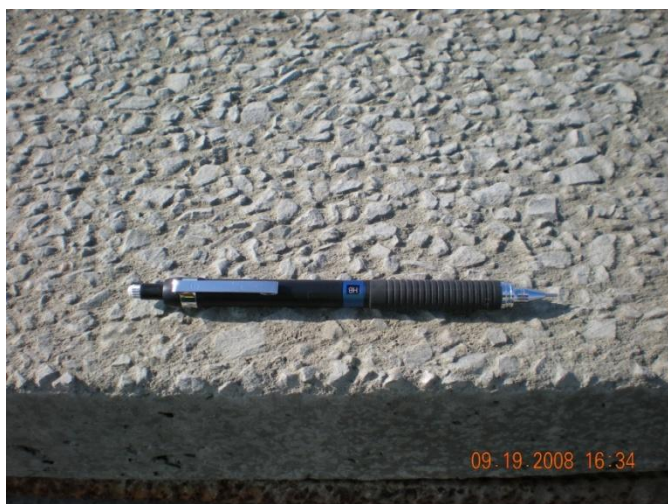
Figure 37 Exposed Aggregate Surface
