Evaluation of a Timber Bridge for the Secondary Road System Using FRP Reinforced Glued-Laminated Girders

Delaware County, Iowa is taking a step in that direction through the construction of a 64 ft. long bridge comprised of fiber-reinforced polymer (FRP) reinforced glued-laminated timber girders and a transverse glued-laminated timber deck. The bridge was designed by Matt Smith of Laminated Concepts, Inc. of New York state with technical guidance provided in the design and fabrication of the FRP reinforced girders by the University of Maine. The bridge was fabricated by Alamco Wood Products, Inc. of Albert Lea, MN. Prior funding for the design, construction (including materials), and monitoring/evaluation of this project has been obtained through the IBRC program with the assistance of Curtis Monk, Division Bridge Engineer with the Iowa Division of the FHWA.

This report summarizes the monitoring and evaluation of the structure conducted immediately following the construction of the bridge and throughout the first couple years after construction.

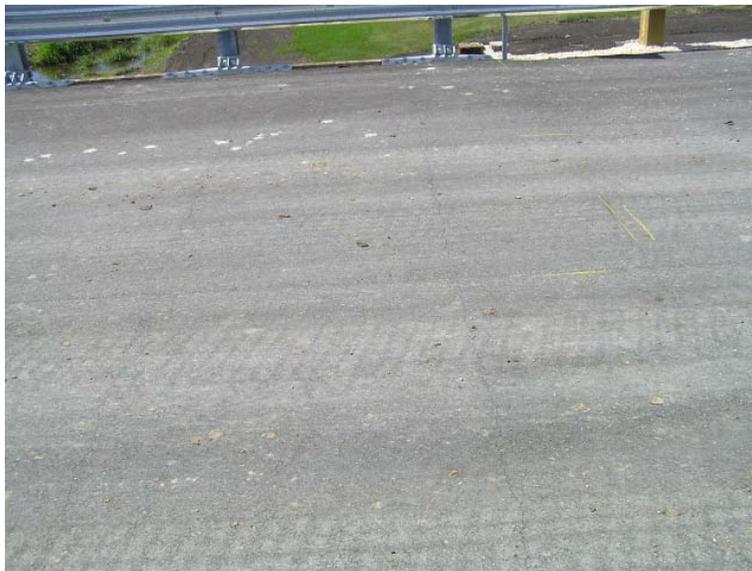
Figure 3. Delaware County Bridge wearing surface

Currently, only one inspection has been completed on the asphalt wearing surface on the Delaware County Bridge. This initial inspection, conducted immediately before load testing of the bridge, resulted in some interesting findings.

First, there appeared to be no moisture-blocking membrane placed between the glued-laminated deck and the wearing surface to prevent moisture from coming in contact with the deck and underlying girders should there be a break in the wearing surface. Second, the wearing surface did not cover the entire deck surface but, instead, terminated just inside the metal base plates used to attach the guardrail posts to the deck, leaving approximately 1 ft. of the deck surface exposed. Third, the wearing surface was measured as approximately 3 in. in depth at centerline and tapered to approximately 1 in. in depth at the guardrail. Lastly, evident at each panel joint and at both abutments were small, noticeable, transverse cracks in the asphalt wearing surface. Figure 9 attempts to illustrate these cracks, although they are difficult to identify. As alluded to previously, these cracks will allow for infiltration of moisture to both the deck panels and girders, which may lead to further problems in the future.
