Road Safety Audit for the US 61/ Harrison Street and West Locust Street Intersection in Davenport- Scott County, Iowa

Final Report
October 2008

Sponsored by
the Iowa Department of Transportation

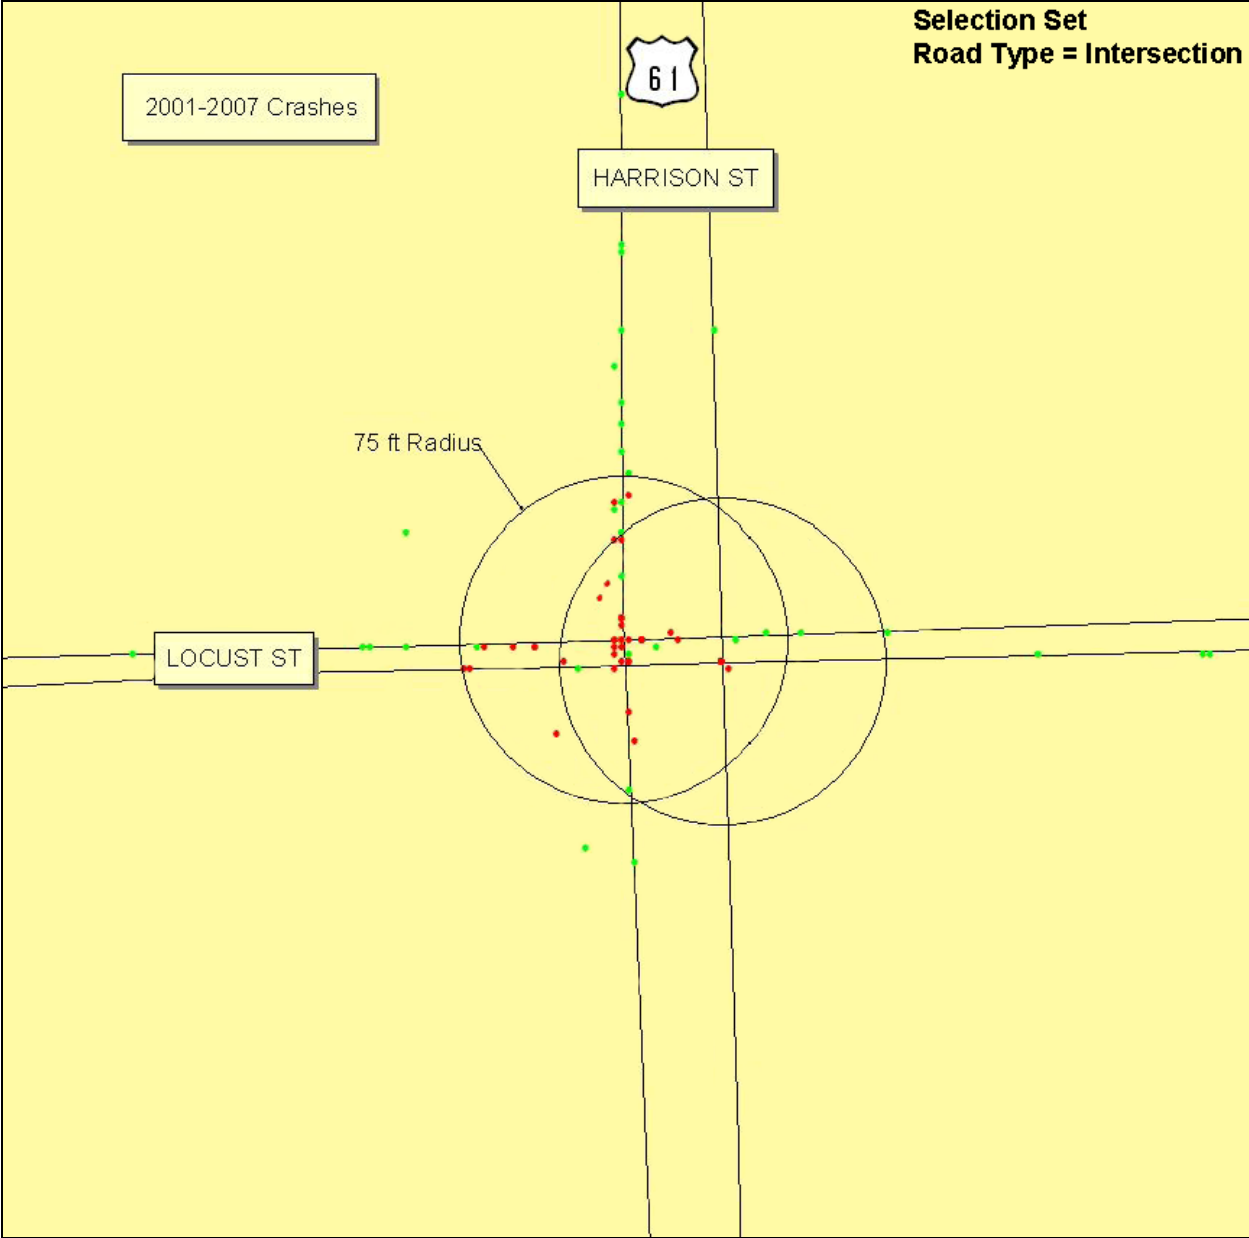
Figure B.1. Crash locations for the intersection, 2001–2007

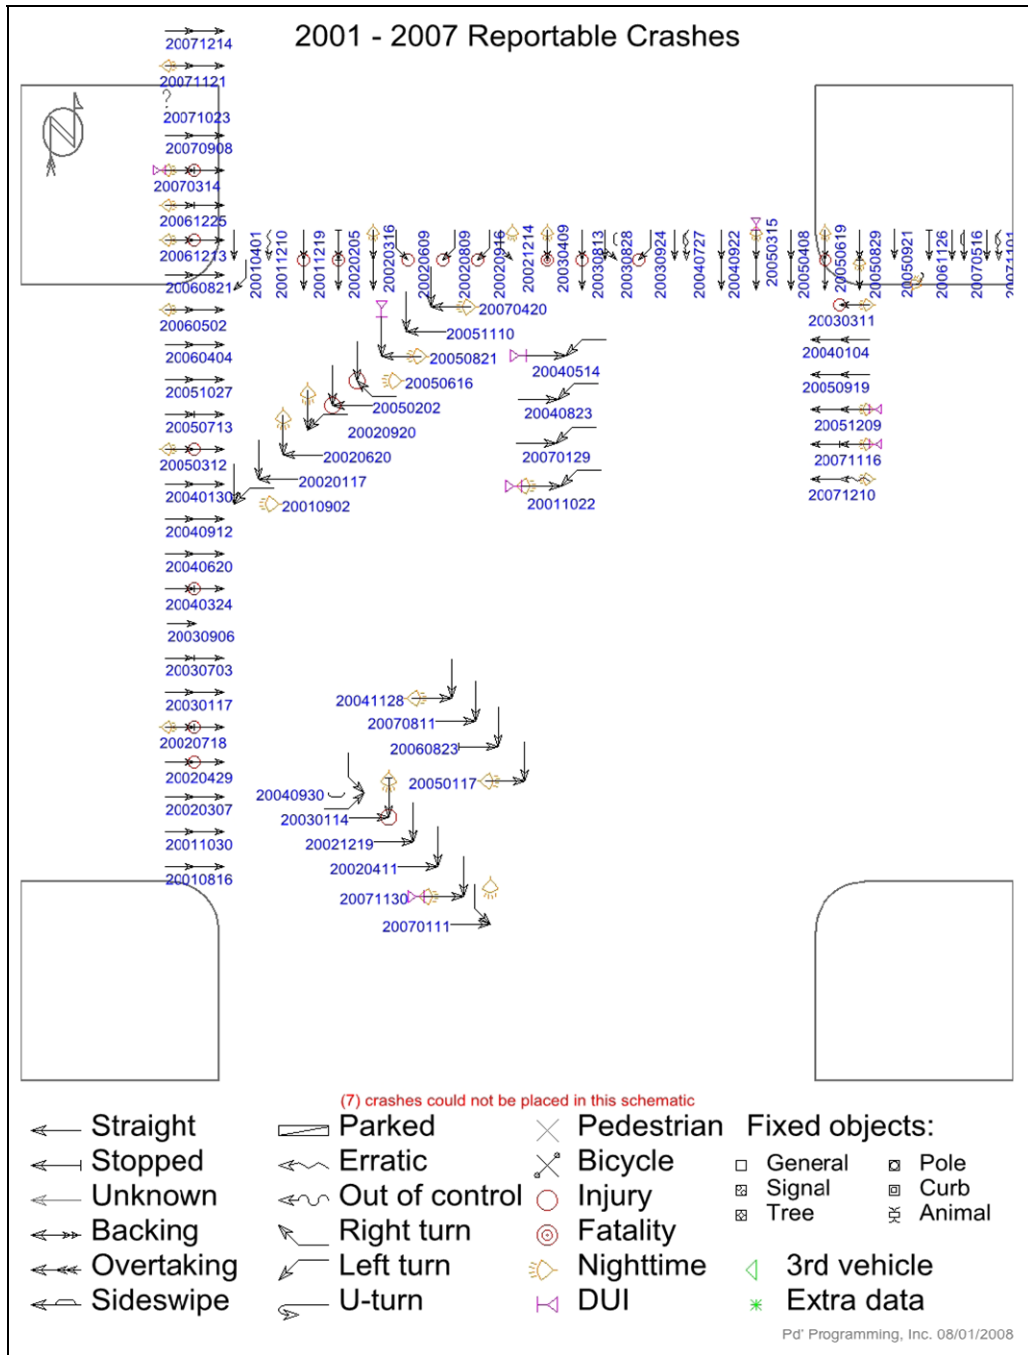
Figure B.2. Diagram of crashes for the intersection, 2001–2007

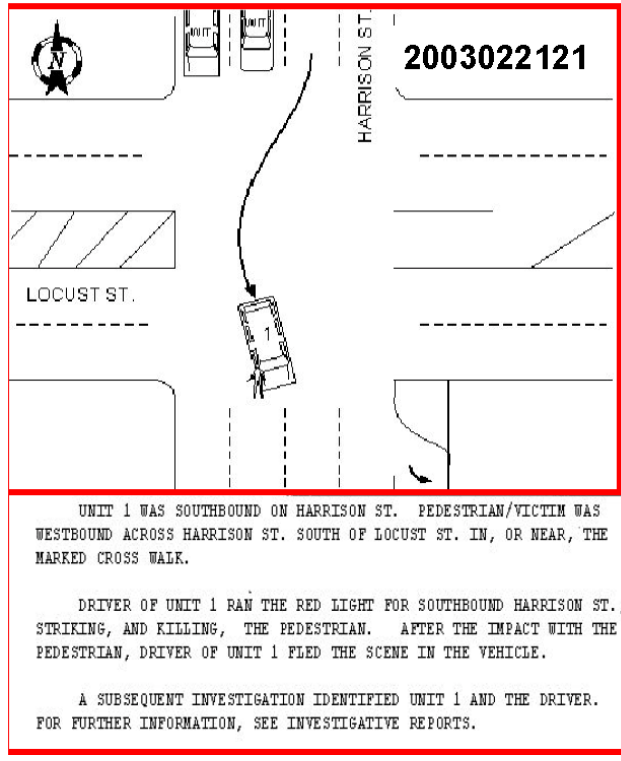
UNIT 1 WAS SOUTHBOUND ON HARRISON ST. PEDESTRIAN/VICTIM WAS WESTBOUND ACROSS HARRISON ST. SOUTH OF LOCUST ST. IN, OR NEAR, THE MARKED CROSS WALK.

DRIVER OF UNIT 1 RAN THE RED LIGHT FOR SOUTHBOUND HARRISON ST., STRIKING, AND KILLING, THE PEDESTRIAN. AFTER THE IMPACT WITH THE PEDESTRIAN, DRIVER OF UNIT 1 FLED THE SCENE IN THE VEHICLE.

A SUBSEQUENT INVESTIGATION IDENTIFIED UNIT 1 AND THE DRIVER. FOR FURTHER INFORMATION, SEE INVESTIGATIVE REPORTS.

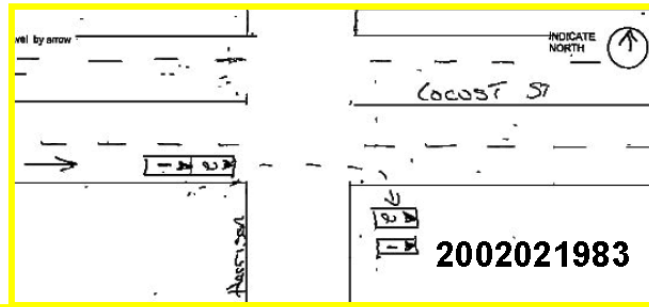
Describe what happened (refer to vehicles by number) UNIT 2 was stopped at the intersection of Locust & Harrison waiting for the light to turn green. UNIT 1 also heading eastbound on Harrison. UNIT 1 attempted to stop but was unable to & struck UNIT 2 in the rear.

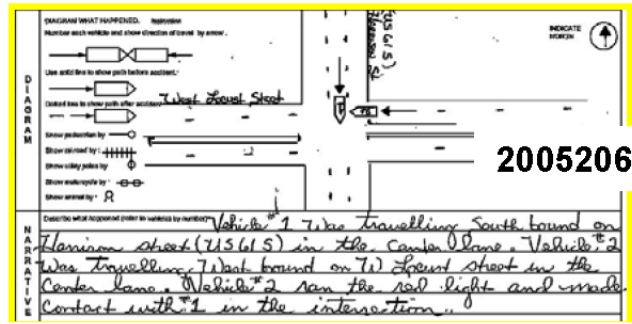
Describe what happened (refer to vehicles by number) Vehicle 1 was travelling south bound on Harrison street (US 615) in the center lane. Vehicle 2 was travelling west bound on Locust street in the center lane. Vehicle 2 ran the red light and made contact with 1 in the intersection.

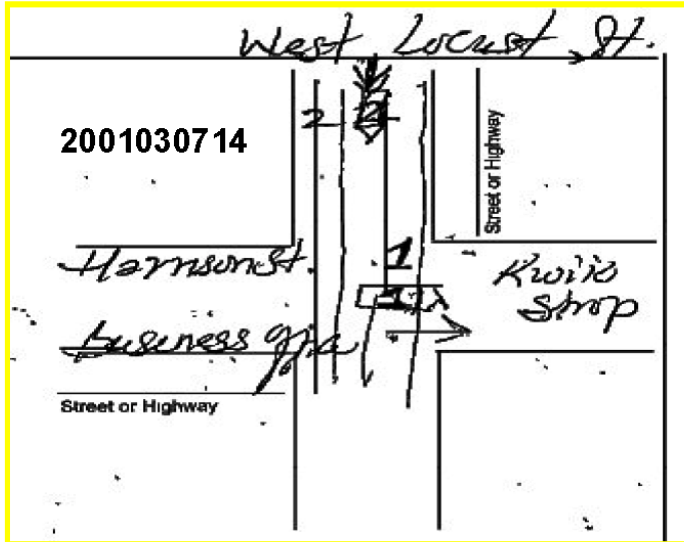
Description
 I was travelling west bound on Locust, I had just passed the Inter section (Locust/Harrison). When the other vehicle came out of Eye Line suddenly, attempting to cross Locust. I locked up my Brakes. I could not turn left or right with out possible damage to more vehicles. (going into oncoming traffic on my left) or hit by other vehicles on my right.

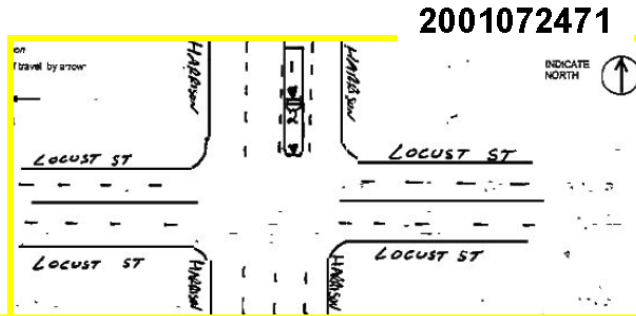
Description
 I was driving vehicle #1, stopped at a red light and was rear-ended by vehicle #2.

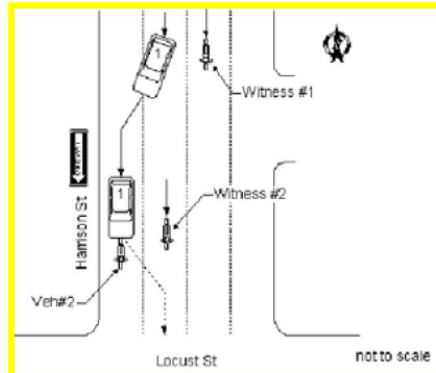
2005227671

VEH #1, VEH #2, WIT #1 AND WIT #2 WERE SOUTHBOUND ON HARRISON ST APPROACHING LOCUST ST. VEH #1 APPARENTLY ACCELERATED RAPIDLY, LOST CONTROL, THEN STRUCK THE REAR OF VEH #2.

VEH #2 WAS A MOTORCYCLE OCCUPIED BY ONE SUBJECT WHO WAS THROWN FROM THE MOTORCYCLE, CAUSING NON-LIFE THREATENING INJURIES.

VEH #1 THEN FLED FROM THE SCENE.

THE OWNER OF VEH #1 WAS LATER CONTACTED AND ALLEGED HER CAR WAS STOLEN AT THE TIME OF THE INCIDENT.

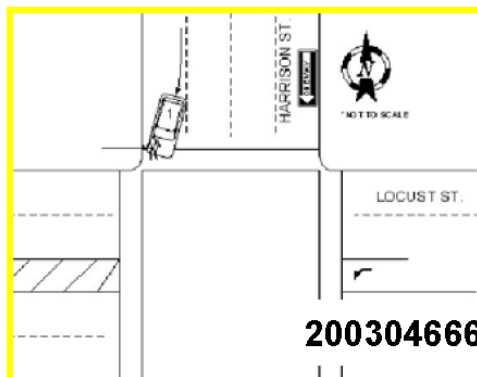
2003046664

UNIT 1 WAS SOUTHBOUND ON HARRISON ST. DRIVER OF UNIT 1 HAD STOPPED FOR RED LIGHT AND WAS WAITING TO MAKE A RIGHT/WEST TURN ON TO LOCUST ST.

THE DRIVER OF UNIT 1 WAS UNINJURED, AND UNIT 1 DID NOT RECEIVE ANY VISIBLE DAMAGE. DRIVER OF UNIT 1 WAS CITED FOR FTYROW PEDESTRIAN IN
