Utility Cut Repair Techniques— Investigation of Improved Cut Repair Techniques to Reduce Settlement in Repaired Areas

Final Report
December 2005

Sponsored by
the Iowa Highway Research Board (IHRB Project TR-503)

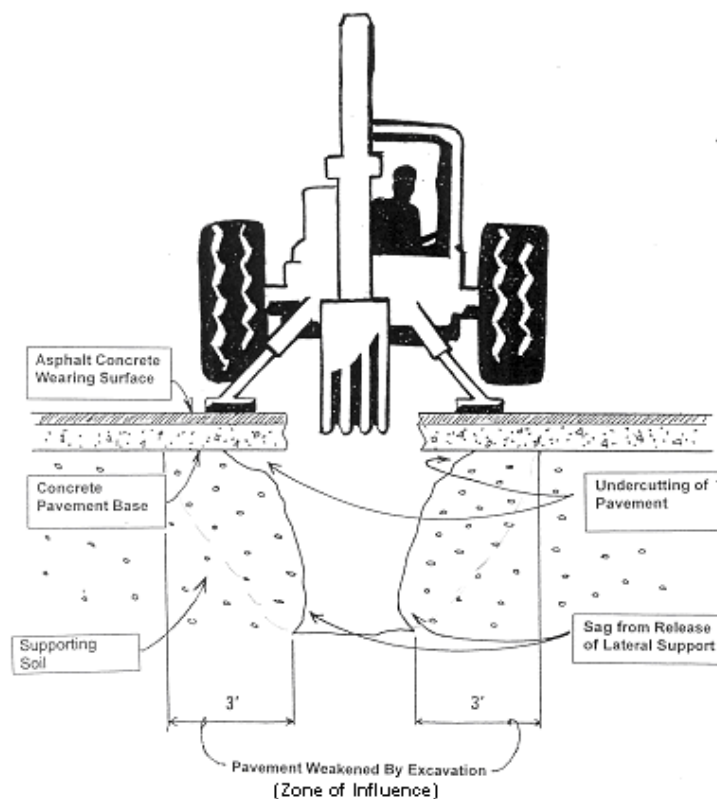
3. The pavement adjacent to the utility patch starts settling and fails, leading—in time—the patch itself to fail. This condition normally results when the natural soil adjacent to the utility trench and the overlying pavement section has been weakened by the utility excavation, as shown in Figure 9. This weakened zone around the utility cut excavation

is called the “zone of influence” and extends up to 3 feet (1 m) laterally around the trench perimeter (The Department of Public Works City and County of San Francisco 1998).

Figure 9. Overstressing of the pavement and natural materials adjacent to the trench (modified from the Department of Public Works City and County of San Francisco 1998)

The zone of influence, illustrated in Figure 9, plays a critical role in road deterioration around utility cuts. Traffic loads produce a greater deflection in this critical area as a result of a decreased amount of support from the soil surrounding the excavation perimeter and therefore inducing early pavement deterioration (Arudi et al. 2000). A study conducted in Kansas City, Missouri concluded that in two years, the structural capacity around the perimeter of the trench decreased 50% to 65%, with respect to the central region of the

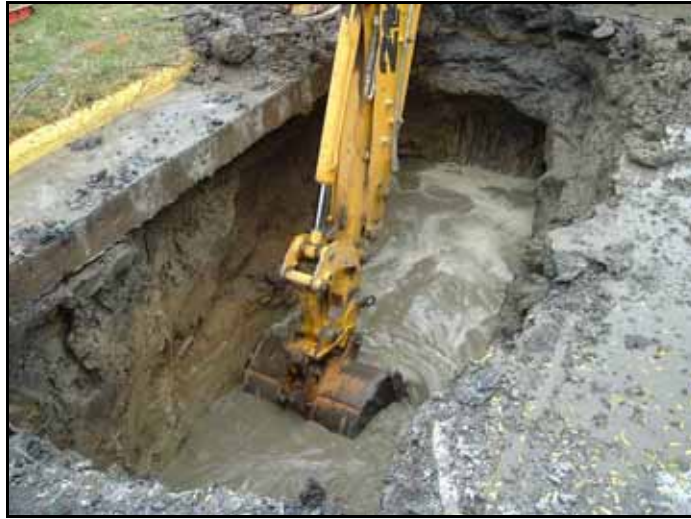
The restoration of a water main break on 20th Street south of Hayes Avenue occurred on October 18, 2004. The excavation and construction of this trench was completed by the city of Ames. The trench is sixteen feet (5 m) long, six feet (2 m) wide and about ten feet (3 m) deep, excluding the cutback region. Figure 23 shows the excavation of the trench as it approaches the broken water main and illustrates the tough working conditions that exist. A dewatering device was used to pump excess water from the break into inlets on the street. This was done by immersing the pump, which was placed in the backhoe bucket, into the trench, and pumping soiled water through a hose into the street. As the excavation proceeded and additional water was removed during the dewatering process, saturated material along the perimeter of the trench began to slough off (see Figure 24). Cavities continued to develop around the perimeter of the trench until the broken water main was reached.

Figure 23. Trench excavation

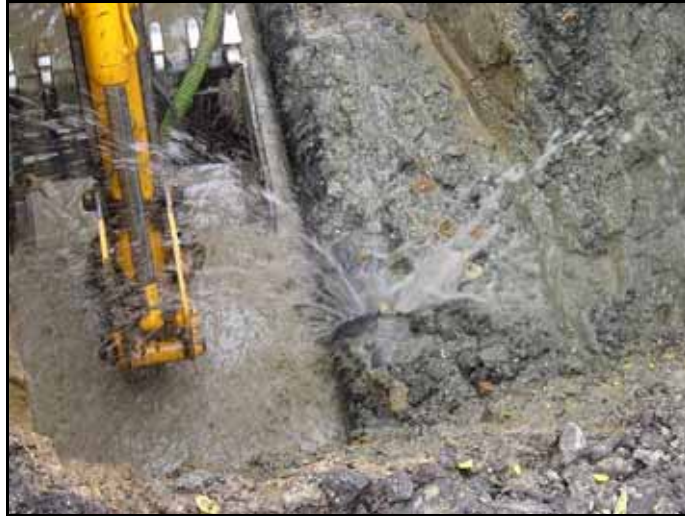
The water main break was reached at a depth of about ten feet (3 m) into the trench. After the trench was dewatered, construction crew members were able to repair the break. Figure 25 shows the break in the pipe as water sprayed out, and Figure 26 shows the shoring box being placed into the excavation. This shoring box acts as a support brace from the surrounding soil, which protects workers from material caving in during break repairs. The break was repaired with a pipe sleeve and the shoring box removed.

Figure 25. Ames water main break

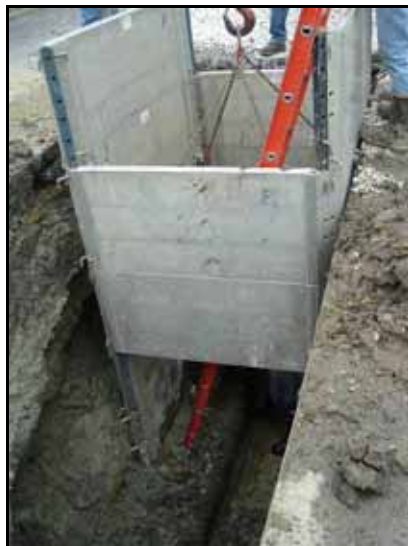
Figure 26. Shoring box placed into trench

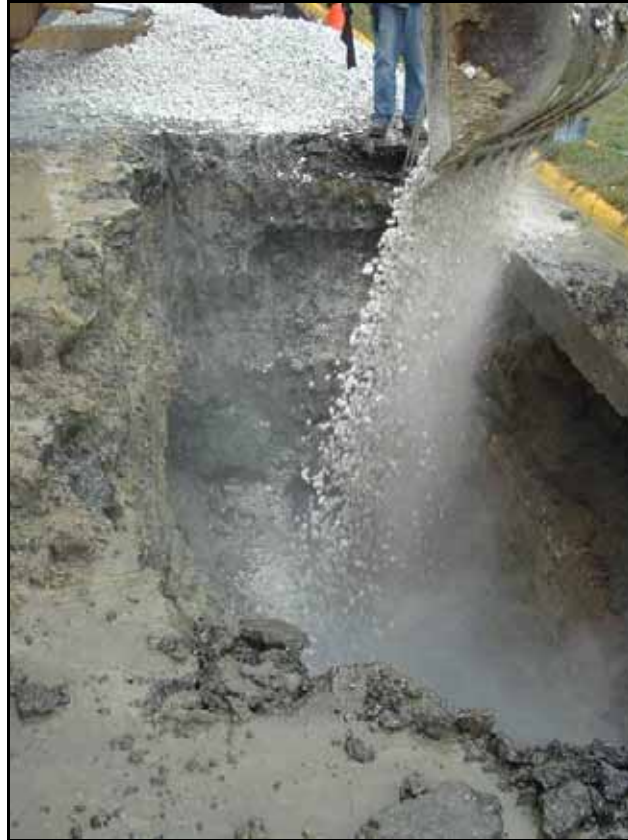
Approximately four feet (1.2 m) of one-inch limestone was placed as a bedding and backfill material up to two feet (0.6 m) above the pipe crown. This bedding material was compacted in two-foot (0.6 m) layers with a vibrating plate. Figure 27 shows the bedding material being dumped into the trench. A material referred to as 3/8 minus was then used as a backfill material extending from the top of the bedding material to the surface of the excavated area. This material was also compacted in about two-foot (0.6 m) layers with a vibrating plate. Figure 28 shows the compaction of the 3/8 minus material using the vibrating plate connected to the end of the backhoe. As a result of the construction, saturated material and debris from the excavation and surrounding area were shoveled into the trench during the backfilling process (see Figure 29).

Figure 27. Bedding material dumped into trench

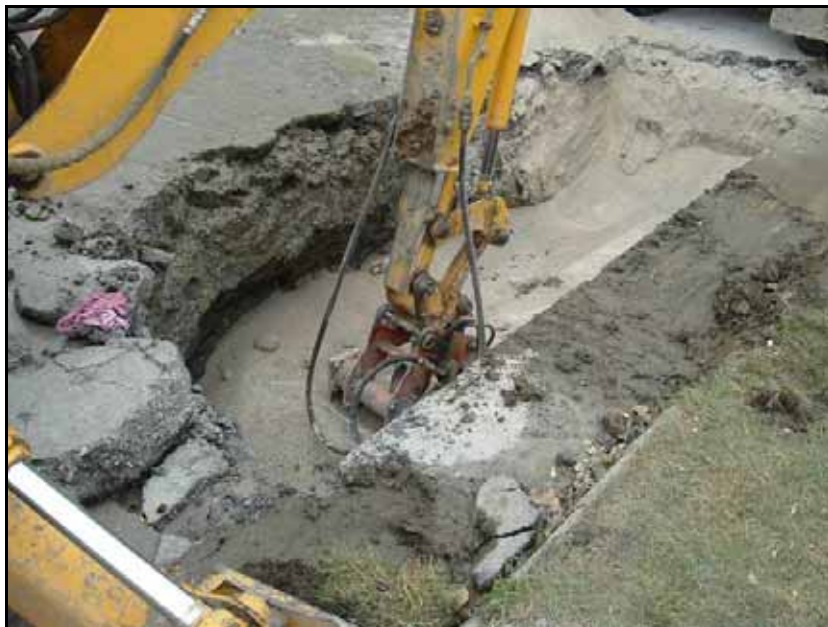
Figure 28. Compaction of backfill material

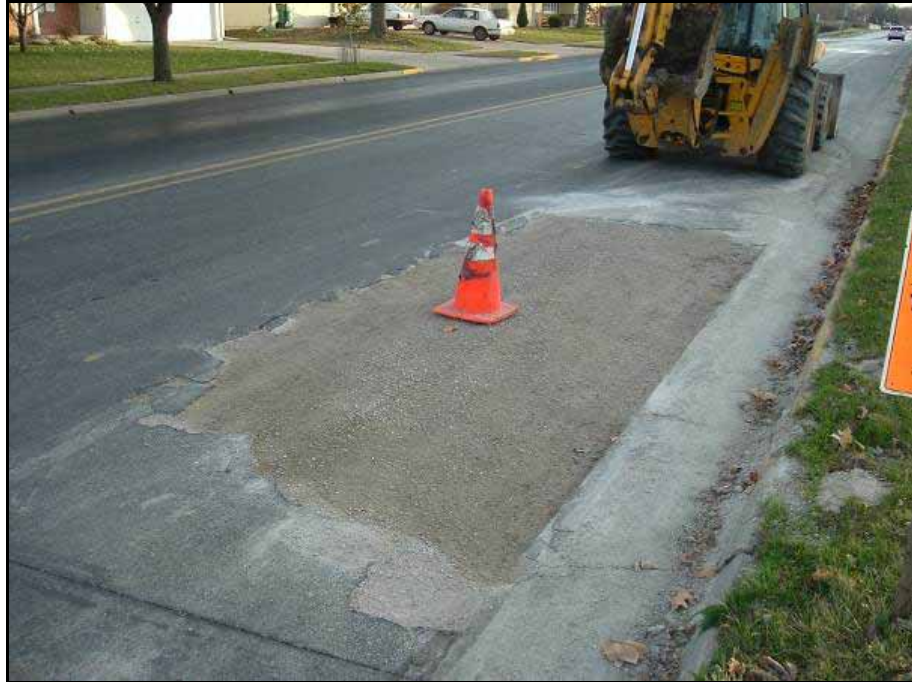
The final lift was compacted with excess material on the top and leveled off with the backhoe bucket. The final compaction was completed by rolling over the constructed trench with the backhoe. Figure 30 shows the completed utility cut. The utility cut was then left open and unpaved for about two weeks, allowing traffic to further compact the material.

Figure 30. Utility cut left open for two weeks

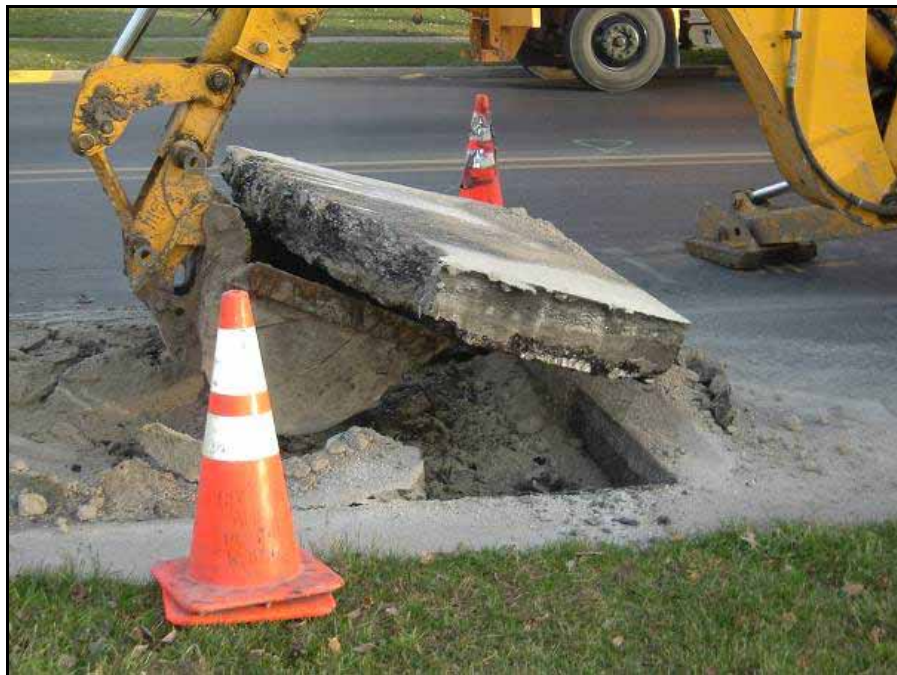
After the two week period, the pavement was cut back and removed to about 2.5 feet (0.8 m) from the edges. This pavement removal, in most cases, was standard in Ames because during the initial excavation, pavement was broken up with the backhoe bucket, leading to a non-uniform edge. Therefore, this cut in the pavement was made because of a need for straight edges in surfacing the trench. Once the cut was made, excess pavement was removed and hauled away. As stated before, the purpose of leaving the trench unpaved for two weeks was to reduce future settlement, however during this pavement removal process conducted by the backhoe, backfill material was disturbed and loosened (see Figure 31). After this backfill material disturbance, no additional compaction equipment was brought in to compact this area. Instead, the backhoe leveled off excess material and then completed several passes with the weight of the backhoe and patting the material with the backhoe bucket as a method of compaction (see Figure 32). Figure 33 shows the completed trench in Ames.

Figure 31. Pavement removal

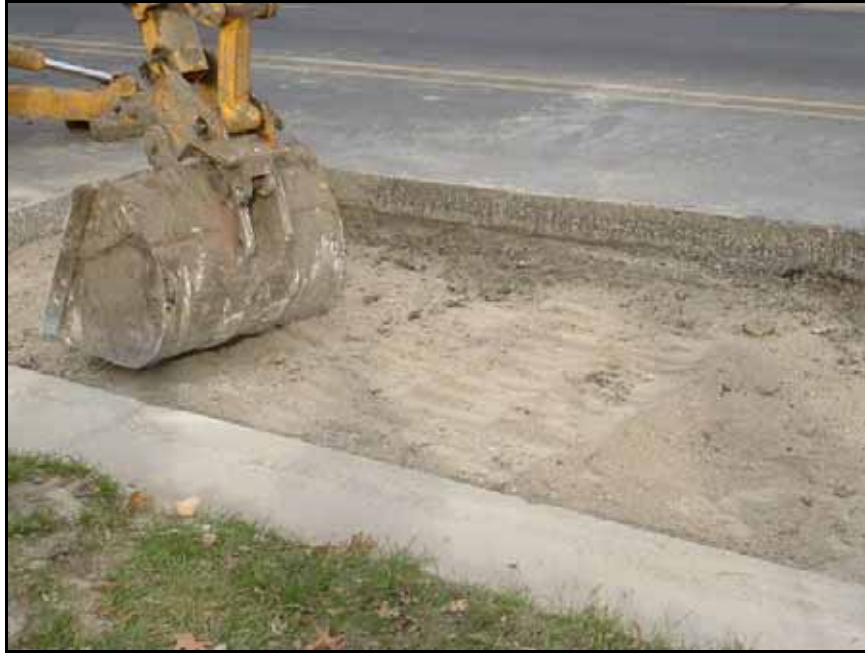
Figure 32. Backhoe bucket compaction

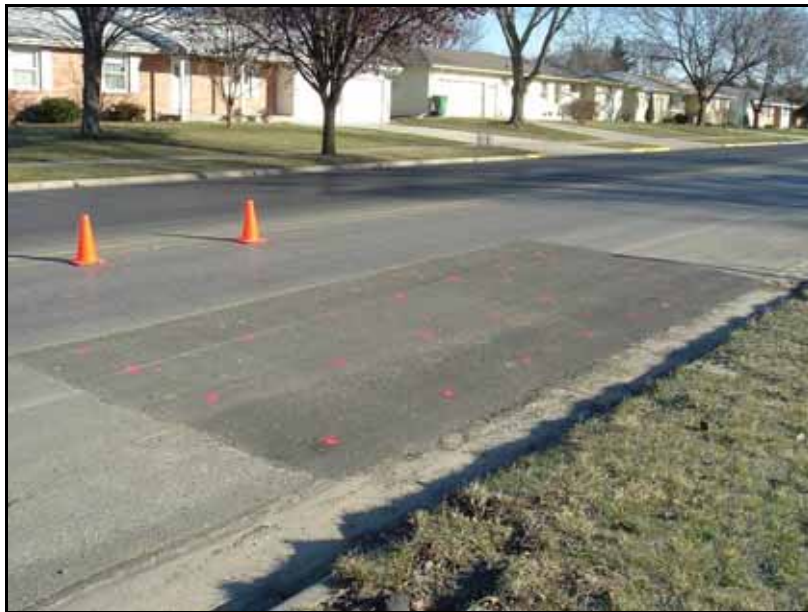
Figure 33. Ames site completed

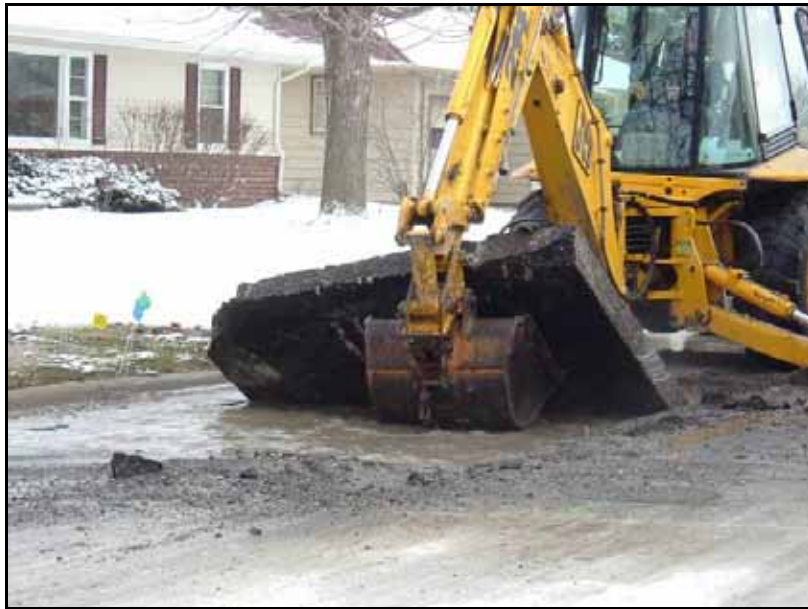
This winter water main break in Ames occurred near the intersection of Marston Avenue and 16th Street on February 7, 2005, where water was temporarily turned off. The excavation on the site was 7.5 feet (2.3 m) long, and 8.5 feet (2.6 m) wide, with a depth of 6 feet (1.8 m). This utility cut was constructed by the city of Ames, in pavement consisting of 10 inches (0.3 m) of asphalt. The removal of pavement from the trench can be seen in Figure 34.

Figure 34. Pavement removal from Ames winter break site

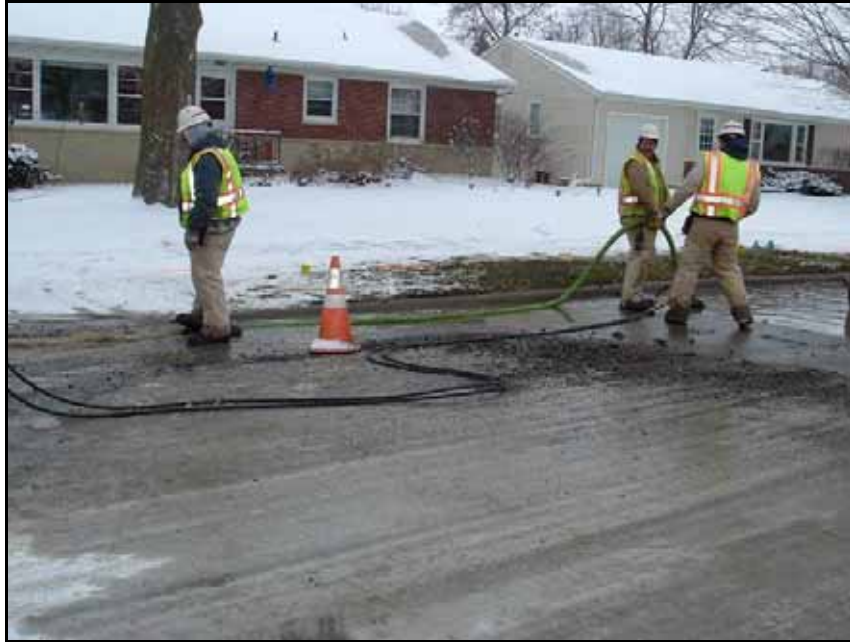
After pavement was removed from the surface, dewatering of the trench began. The trench was dewatered before excavation began (see Figure 35). While the water level was lowering, saturated material was excavated from the trench. Figure 36 shows the saturated material being excavated and the damage that has resulted to the surrounding pavement. Once the break was located the pipe was cut and repaired. Backfill material, which consisted of the SUDAS specification and 1.5-inch limestone, as a bedding material, was then added to the trench. The SUDAS backfill material segregated in the dump truck, therefore coarse material was placed near the center of the excavated trench and fines on the top. Figure 37 shows the backfill material being dumped and placed into the trench. Again, near the end of construction, saturated material was incorporated into the trench to clean the area up (see Figure 38). The completed unpaved trench is shown in Figure 39. The following day the trench had an asphalt cold patch placed on it until spring when the asphalt plant reopens.

Figure 35. Dewatering the trench

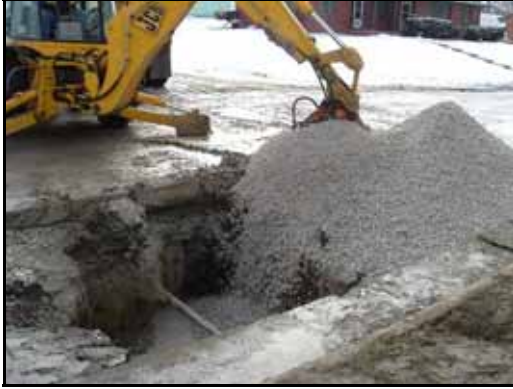
(a) Pushing in backfill material

Figure 37. Addition of SUDAS backfill specification

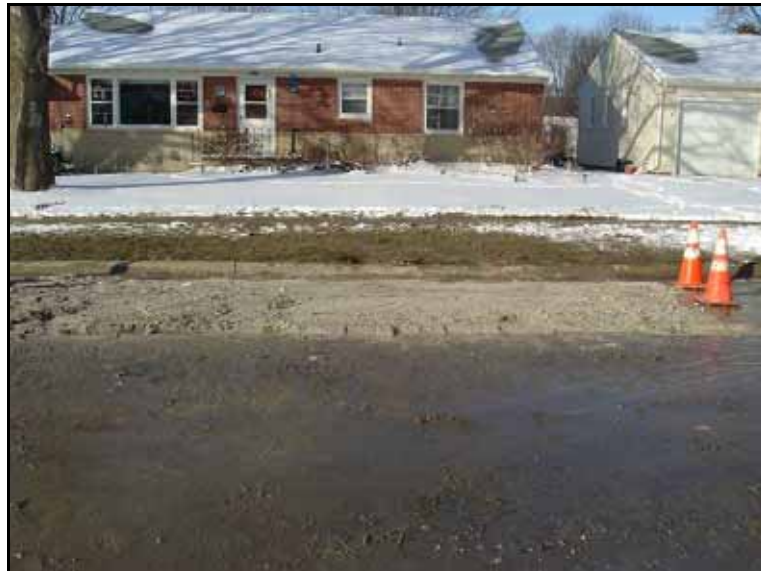
Figure 39. Trench ready for cold patch

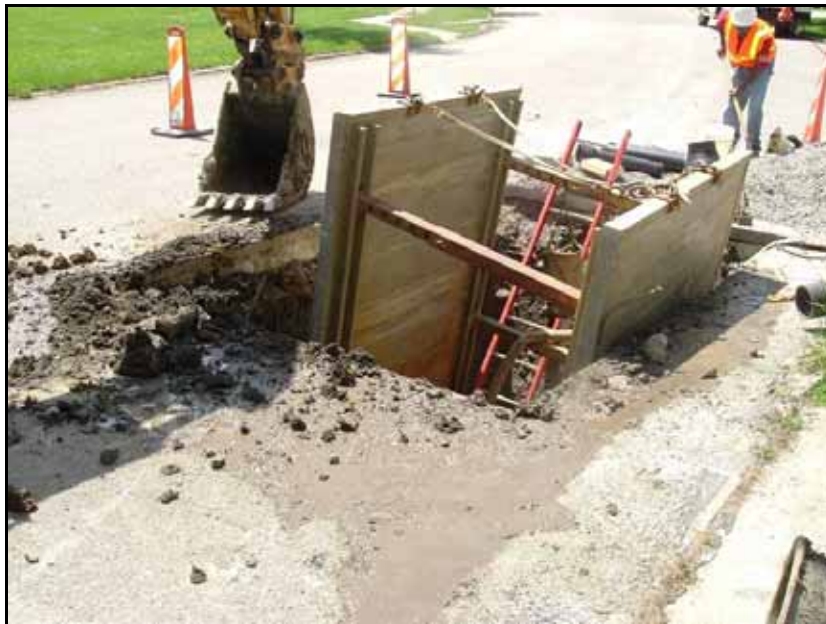
A standard vertical cut was made in the pavement and excavation of the native material began. At the completion of the excavation a shoring box was placed into the trench (see Figure 40). The leaking valve was repaired and a 2" x 4" block of wood and concrete block was placed beneath the pipe for support. The pipe was also wrapped with black plastic wrap for protection against corrosion.

Figure 40. Shoring box in place

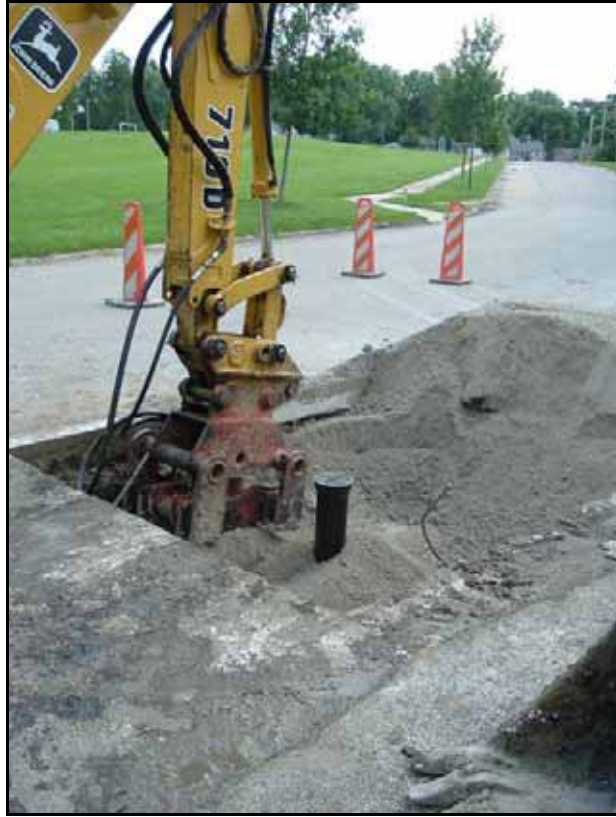
A 1-inch clean material was then used as a bedding material around the pipe, where this material was worked around the pipe and block with a shovel. A recycled crushed concrete backfill material classified with particle sizes 3/4-inch or less was imported from the landfill where it has been reclaimed from previous concrete pavement excavations. This site was backfilled with two lifts of material dumped about three to four feet (0.9 m to 13.1 m) deep each, and was tamped with a vibrating plate for about three to four seconds in no specific compaction pattern. Figure 41 shows a lift of the material being tamped in place. The pavement surface consists of 6 inches of concrete and 2 inches of asphalt overlay. As a result of the backhoe rolling over the edge of the trench during the backfill compaction process, the surrounding composite pavement was damaged (see cracked pavement in Figure 42).

Figure 41. Backfill compacted into trench

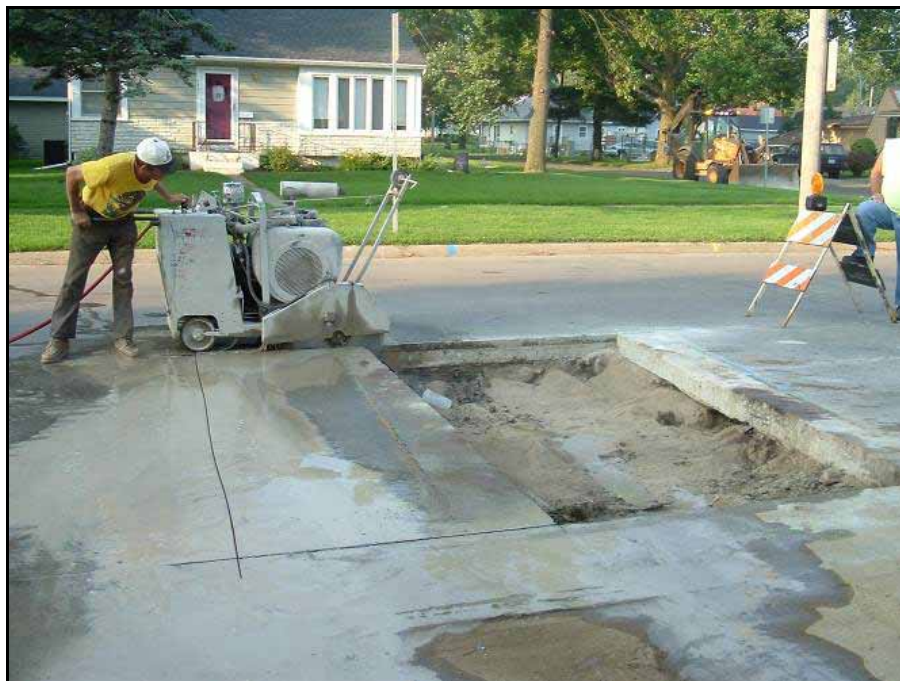
Excavation and construction of the trench began on June 30, 2004. The sewer main break repair was completed by a contractor in Des Moines and is located east of E. 28th Street and Grand Avenue. This site was excavated, filled, and plated the day before the research team arrived, therefore documentation of the construction procedures were not made. The site was covered with a metal plate since surfacing was unable to be placed the following day. When the plate was removed, the manufactured sand (crushed limestone) used as backfill material had begun to settle along the trench edges, likely as a result of traffic vibrations (see Figure 45). Therefore, the concrete pavement was cut back to compensate for these cavities (see Figure 46).

Figure 46. Concrete pavement cut being made

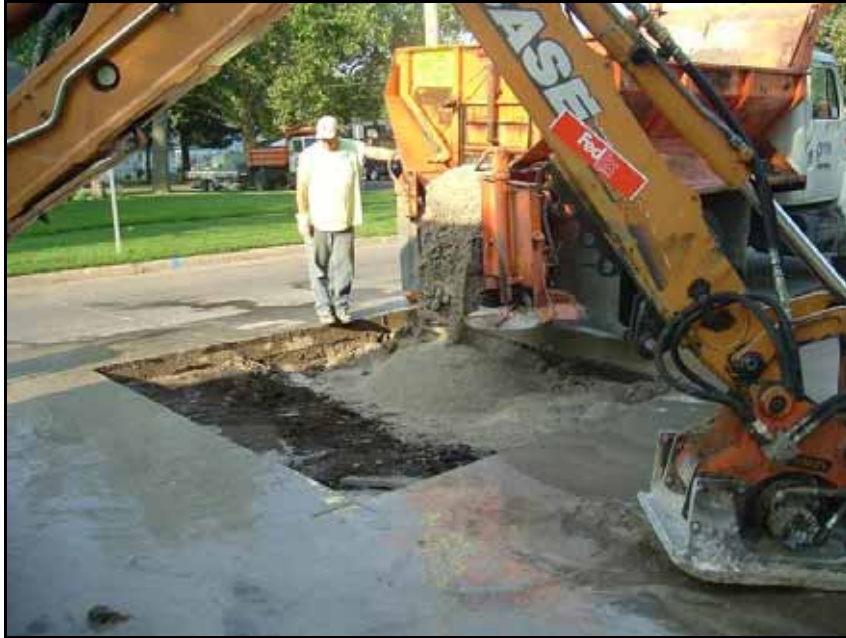
Figure 47. Adding additional manmade sand to the trench

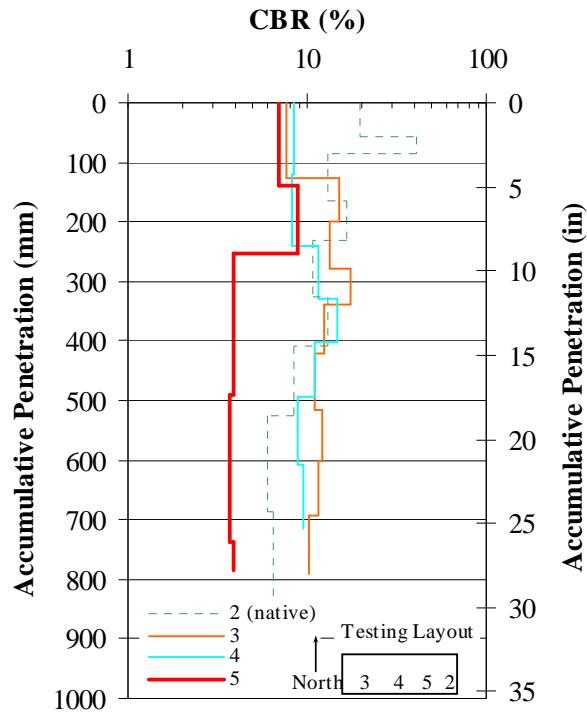
The CBR values of all testing locations in imported material using the DCP indicate high and low values of 17.4% and 3.7% (see Figure 52). According to Table 17 in the literature review, typical CBR values for an SM classified material ranges from 20% to 40%, indicating the values obtained from the field are lower than these typical values. Based on Figure 52, the CBR results appear to be relatively consistent throughout the trench. The native material in the cut back region indicates a stiffer response near the surface, but with depth, these results had a similar stiffness response with the imported material. This may be an indication of the loss in lateral support during the excavation.

Figure 52. CBR profile for Ames

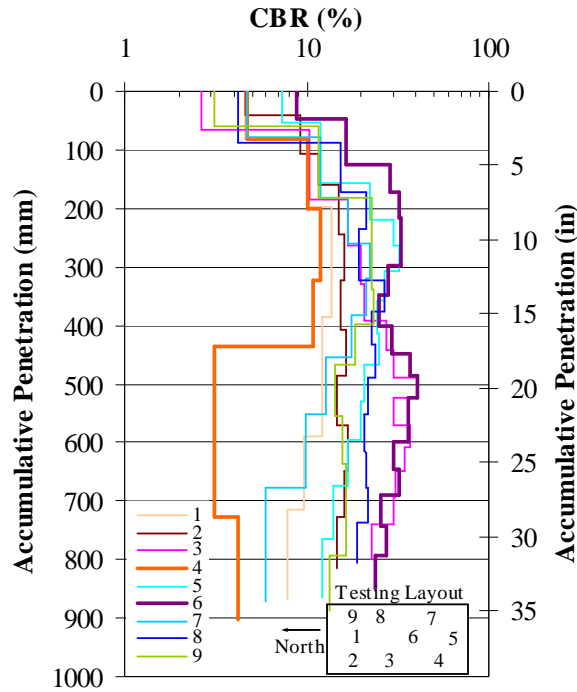
DCP results directly obtained from the field (i.e., no DCPI weighted average value) indicate a high CBR value of 40.5% and low of 2.6% (see Figure 53). When comparing these values to typical values stated in Table 12 of the literature review, this SC material had values above and below these the typical 10% to 20% CBR values. The results from Figure 53 indicate a higher CBR value near the center of the trench, to a low CBR value near the edge. Again, the CBR values are relatively consistent though the trench.

Figure 53. CBR profile for Cedar Rapids

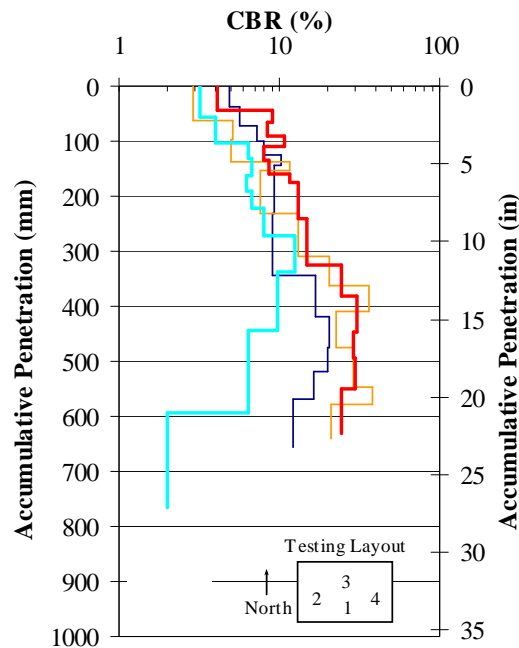
DCP results directly obtained from the field indicate a high CBR value of 37.8% and low of 2% (see Figure 54). When comparing these values to typical GC classified materials values of 20% to 40% stated in Table 12 of the literature review, values resulted at or below this typical range. Figure 54 indicates a stiffer response with depth and again the CBR values were fairly uniform with depth, except location four where stiffness decreased.

Figure 54. CBR profile for Davenport
