# **ACCELERATED IMPLEMENTATION OF INTELLIGENT COMPACTION TECHNOLOGY FOR EMBANKMENT SUBGRADE SOILS, AGGREGATE BASE, AND ASPHALT PAVEMENT MATERIALS**

Project Report

Route 4, Kandiyohi County, Minnesota  
June 14-17, 2008

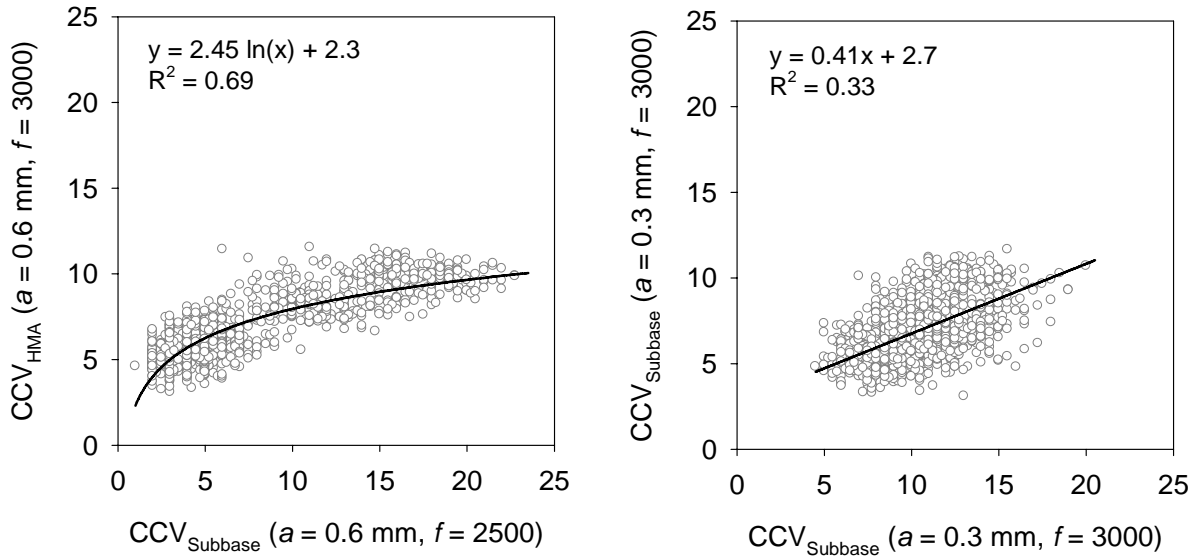
**Figure 15. Simple regression relationships between CCV measurements on subbase and HMA non-wearing course layer**

Figure 13 shows CCV maps of the HMA non-wearing course layer and the underlying subbase layer for a 210 m (700 feet) long section with heterogeneous subbase. Figure 14 compares CCV measurements (raw data and 5 m moving average) on HMA non-wearing course and subbase layers over a 1300 m (4000 feet) long section along the SB pavement lane. CCV measurements on subbase layer obtained at  $a = 0.3$  mm and  $a = 0.6$  mm setting are presented in Figure 14 for comparison. Figures 13 and 14 show locations of high CCV and low CCV areas on the subbase layer (measured at  $a = 0.6$  mm) reflecting on CCV measurements on the HMA layer. Measurements obtained at  $a = 0.3$  mm setting did not clearly differentiate soft/hard zones on the subbase layer. Data presented in Figure 14 is further analyzed using regression analysis as presented in Figure 15. Regression relationships in Figure 15 indicate statistically strong relationship between CCV measurements obtained on the HMA non-wearing course layer and subbase layer at  $a = 0.6$  mm setting with  $R^2$ -value of about 0.7. CCV measurements obtained on the subbase layer at  $a = 0.3$  mm show relatively poor correlation to CCV measurements on the HMA layer.

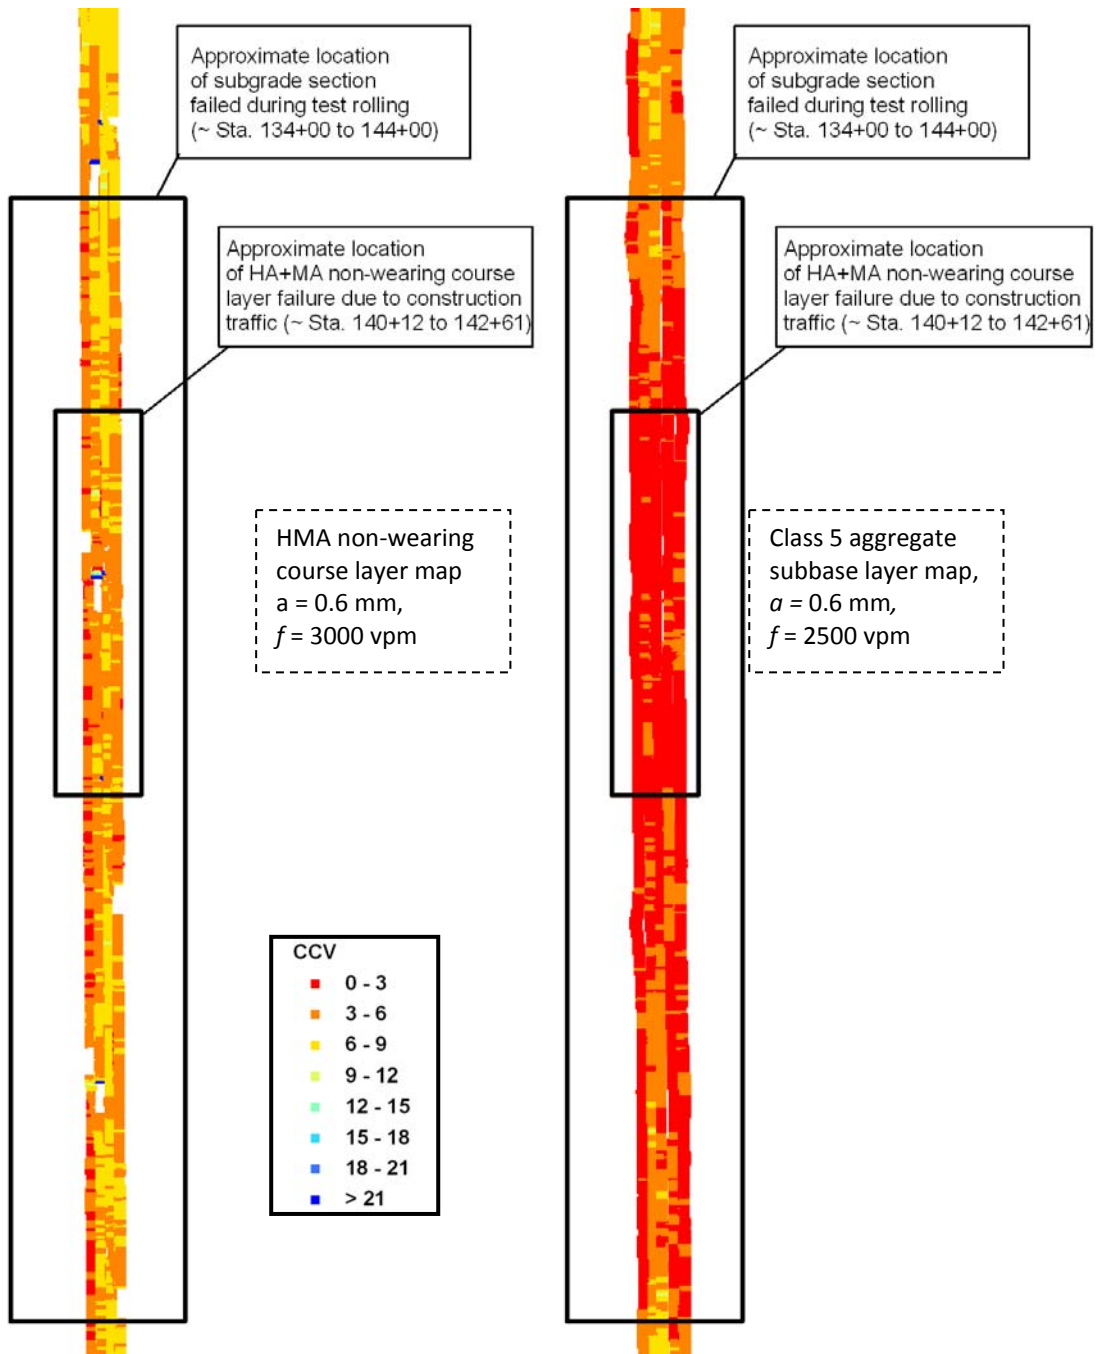
Figure 17. Comparison of HMA non-wearing course layer and subbase layer maps

Following compaction operations on the HMA non-wearing course layer on the SB lane, premature “failure” cracks were observed over a 200 feet long section (Sta 140+12 to 142+61) on the HMA layer under construction traffic (Figure 14). To further evaluate the condition, the CCV measurements on the HMA wearing course layer and the subbase layer in this area were compared as shown in Figures 17 and 18. The data shows average CCV = 2.5 for the subbase layer which is considerably lower than the project average CCV = 7.5. Average CCV on the HMA wearing course in the area was about 5.2, which is also lower than the project average of about 6.9. This area is located within the area where the subgrade layer reportedly “failed” under test rolling in Summer 2007 (Sta. 134+00 to 144+00). Again, the underlying natural soils in this section were identified in the soil survey as consisting of peat/muck soil deposits (see Figure 4).
