# The Deleterious Chemical Effects of Concentrated Deicing Solutions on Portland Cement Concrete

Larry Sutter Michigan Tech

# Research Objectives

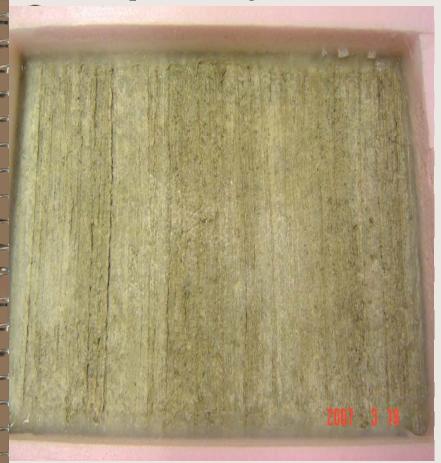
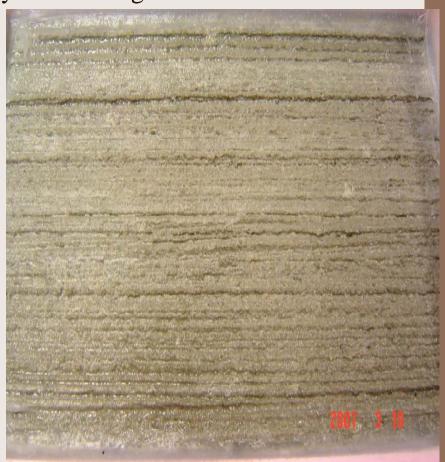
### Concrete slabs at cycle 0

Pre-exposed to high concentration 1 year - scaling test at low concentration

23% NaCl + 3% NaCl

22% CaCl<sub>2</sub> + 4% CaCl<sub>2</sub>

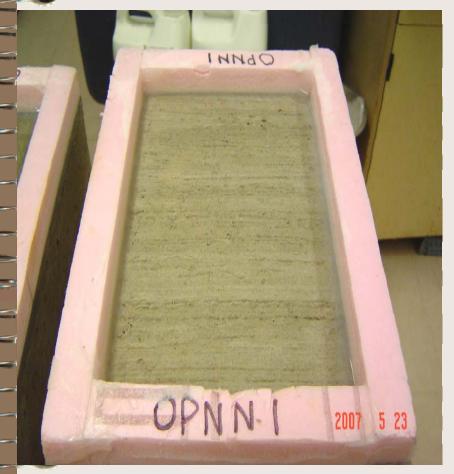
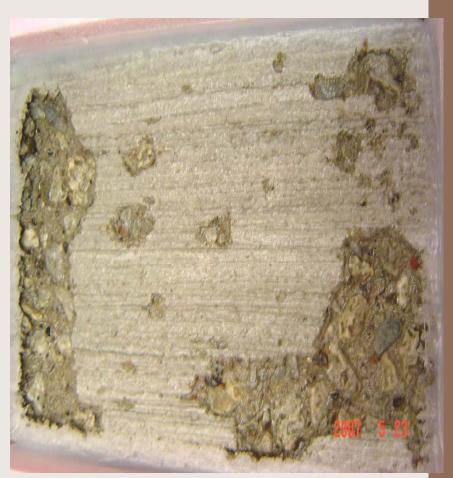
### Concrete slabs at cycle 50

23% NaCI + 3% NaCI

22% CaCl<sub>2</sub> + 4% CaCl<sub>2</sub>

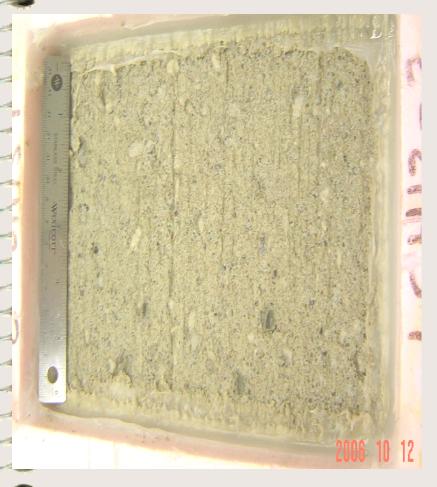
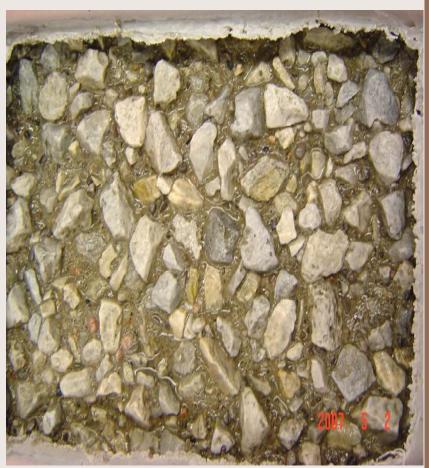
### Concrete slabs at cycle 100

23% NaCI + 3% NaCI

22% CaCl<sub>2</sub> + 4% CaCl<sub>2</sub>
