The Use of Eastern Cottonwood for Stress-Laminated Sawn Lumber Bridges in Iowa

Paula Hilbrich Lee Michael Ritter

This case study presents information pertaining to 3 stress-laminated sawn lumber timber bridges constructed from Eastern Cottonwood in Iowa.

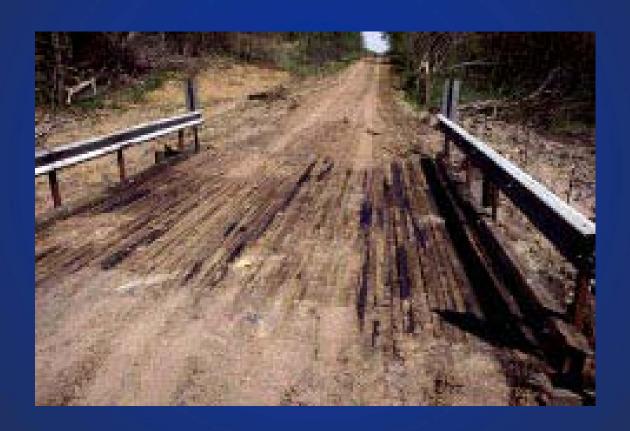
Beginning	End	
Dean	24%	24%	
Hibbsville	24%	24%	2 to 3% fluctuations throughout monitoring
Decatur	21%	26%

The primary contributing factor to the continued high moisture content was the absence of a watertight membrane over the surface of the deck. The gravel wearing surfaces inhibit drying of the deck surface.

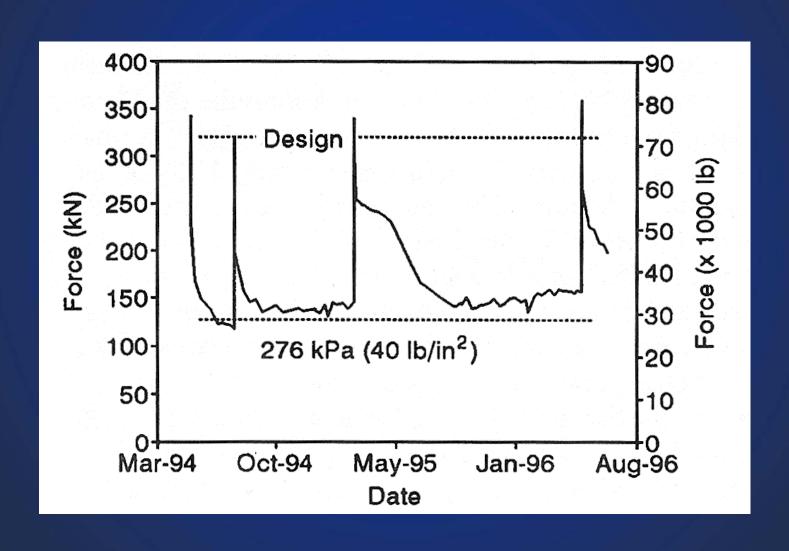
Bar Force – Dean

The majority of the bar force loss is attributed to stress relaxation of the lumber laminations, augmented by the high moisture content of the laminations.
