Contribution to Structural details on Timber Bridges

Otto Kleppe, Tormod Dyken, Hauke Burkart
Norwegian Public Roads Administration

Overview – Timber bridges in Norway

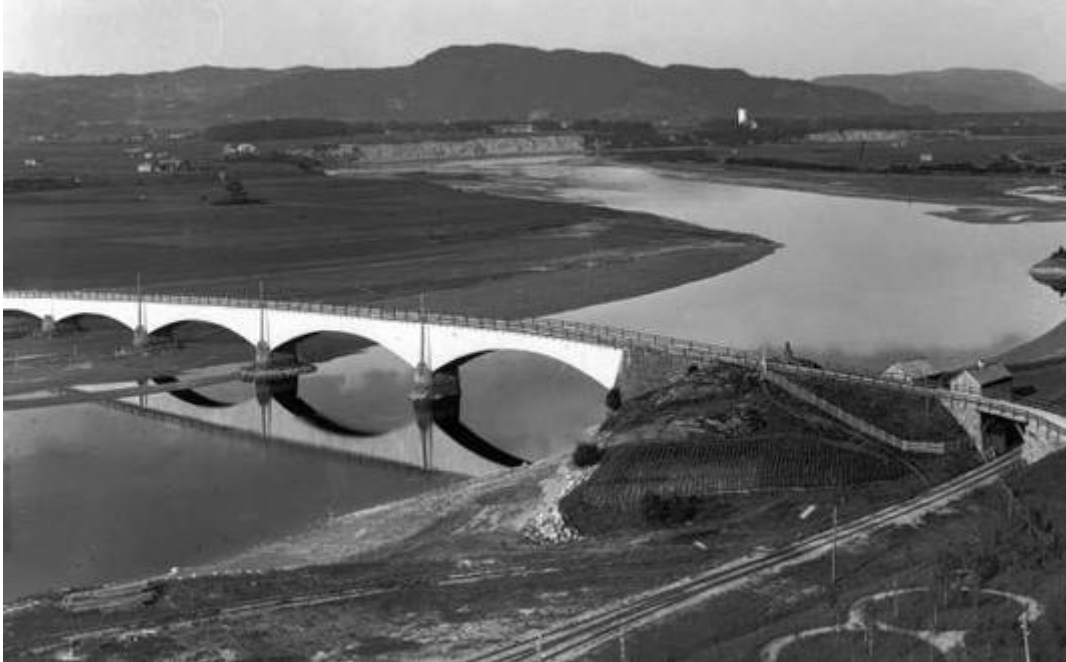
Bridge over Stjørdals River at Sandfærhus – Hell Bridge

- This bridge was constructed in 1856
- and demolished in 1964
- The bridge type was bolt laminated arch
- The vast bulk of the timber was reused by the building of near by houses
- The long service life is due to structural and chemical protection

*The picture is taken in approximately 1890.
© Stjørdal Local History Society*

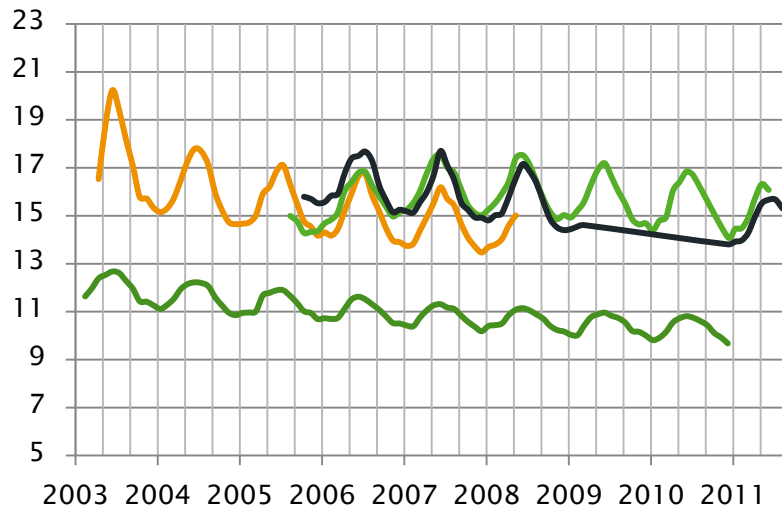
*The moisture content
The average daily value*

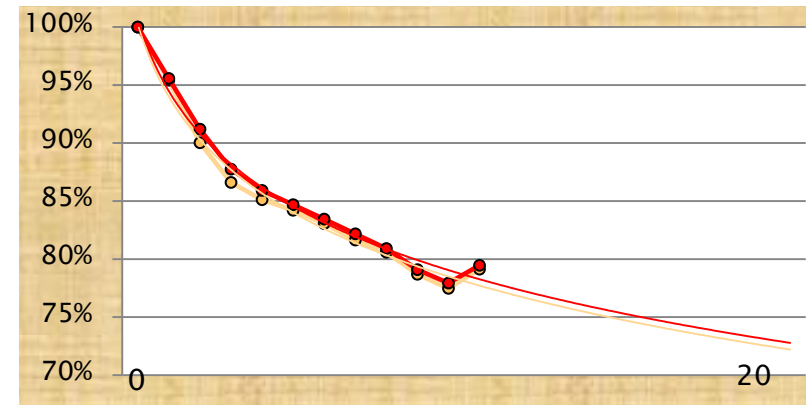
*The force in the tendon bar
The average yearly value in two bars*

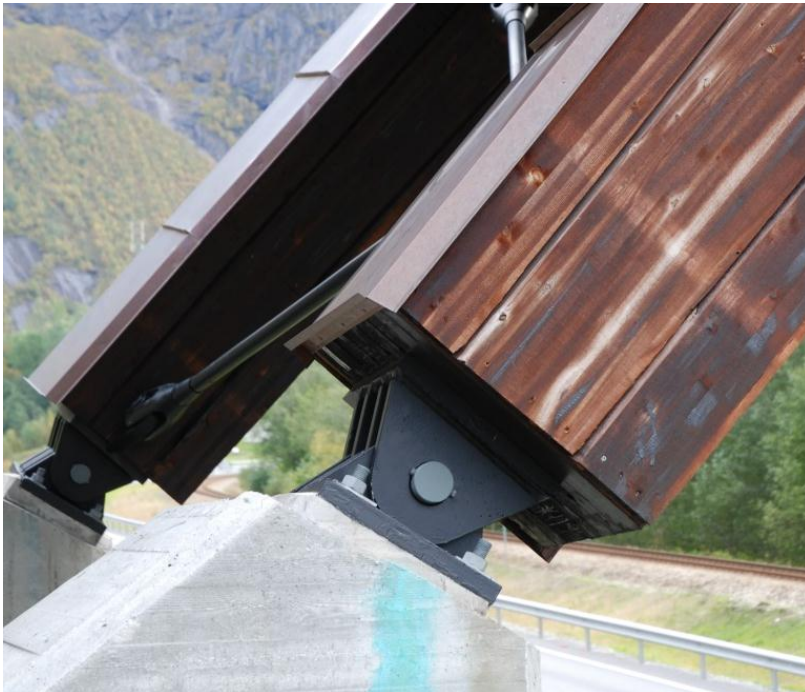
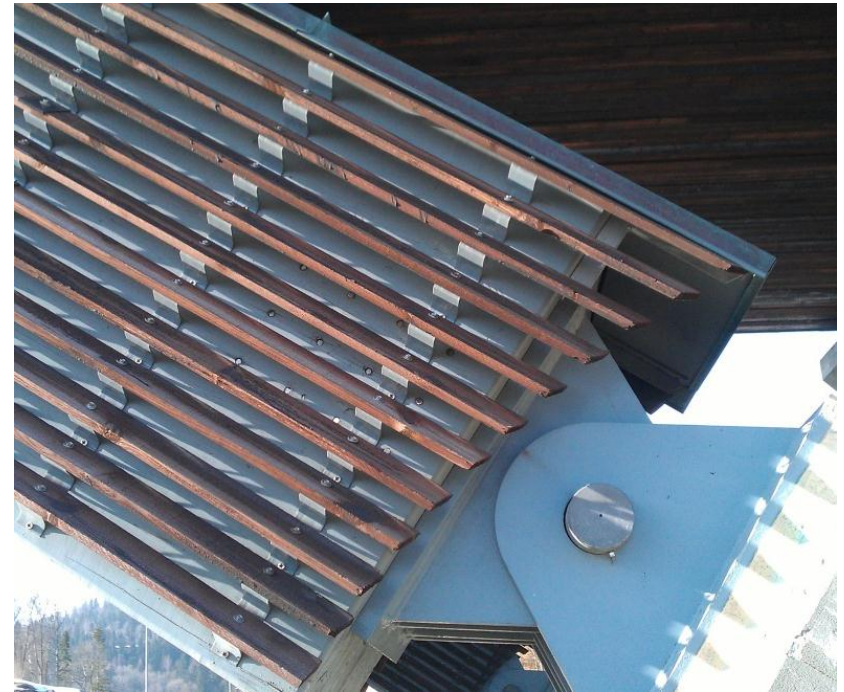
Top and side face structural protection

- All members have structural protection on the top face
- Panels formed by slices of the arch on the side face
- Louvre on the side face
