Contribution to Structural Details on Timber Bridges

Otto Kleppe
Senior Principle Engineer
Norwegian Public Roads
Administration
Oslo, Norway
otto.kleppe@vegvesen.no

The paper makes a contribution to details on timber bridges based on the experience gathered by the Norwegian Public Roads Administration (NPRA). The design errors which are included in this paper are selected because they are important with respect to durability. Most of what is stated in this paper may appear to be obvious. However, the problematic details are still used in the design of timber bridges and are therefore not obvious for all designers.

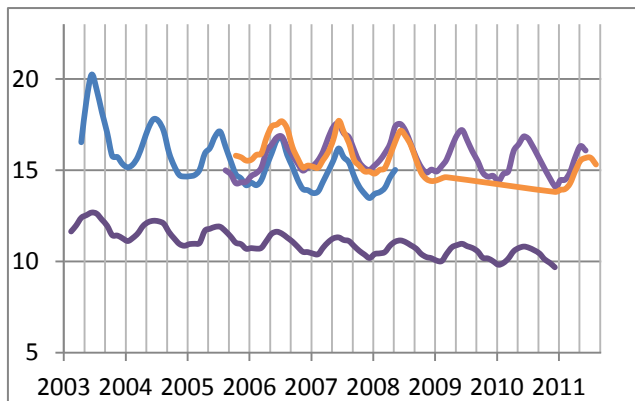
Fig. 2 Moisture content from monitoring of four bridges [1] plus in-house adaptation

Error! Reference source not found. shows the measured moisture content of four different bridges. With the exception of one, the bridges experience very similar moisture levels. However all the measurements show that the moisture content continues to decline after erection, and the lowest graph represents Evenstad Bridge which is also the oldest of the monitored bridges.

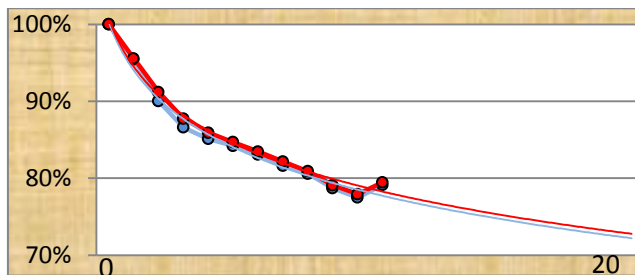
Fig. 3 Yearly average tension forces in steel bars over ten years at Evenstad Bridge [1].

To the left a graph represents the yearly average tension force in three neighbouring bars. The intention of measuring the tension force is to find the point of time where the bars have to be re-stressed. According to the design rules, a loss of bar force of 50% for sawn timber and 40% for glulam beams must be allowed for. The collected data show that 20 years between re-stressing should be sufficient.
