# Inspection of Louisiana Timber Bridges

## Summary

This paper reports the result of a study undertaken to assess the condition of timber bridges in four distinctly different geographic regions in the state of Louisiana. This study was carried out as part of an overall national study spearheaded by the U.S. Forest Products Laboratory to investigate the field performance of timber bridges. Louisiana, with the second highest number of timber bridges in the nation spread across the entire state, was an excellent location to assess the performance of these bridges under different environmental conditions. The bridges inspected were representative of the various types of timber bridges in the state and covered different exposure conditions. The inspections were conducted with the assistance of the Louisiana DOTD (Department of Transportation and Development) bridge inspection team. The inspection teams utilized advanced assessment tools such as the resistance micro-drill and acoustic devices to evaluate the condition of the suspect regions of the timber sub- and super-structure elements. The availability of the advanced inspection tools eliminated the bridge inspection teams from havi

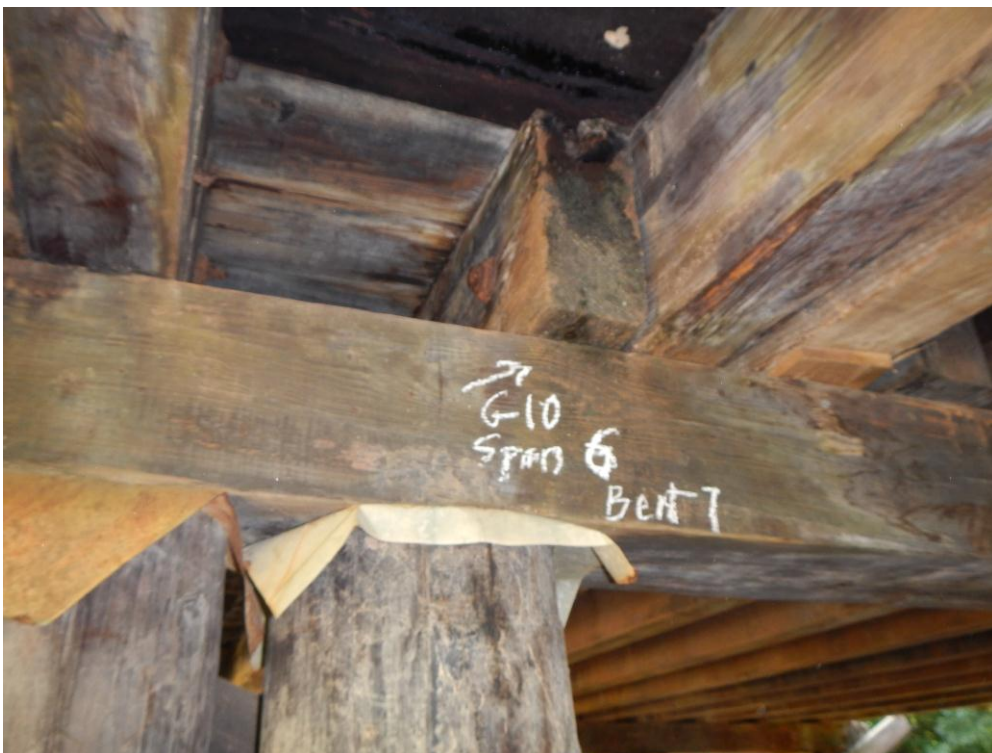
Fig. 7 Labeling of girder locations for reference

Figures 3 - 6 show a member of the bridge inspection team conducting various inspection tasks utilizing the traditional tools and the NDE equipment to assess the condition of the components of the sub- and super-structure. Figure 7 shows the labeling used to identify areas investigated in the bridge.

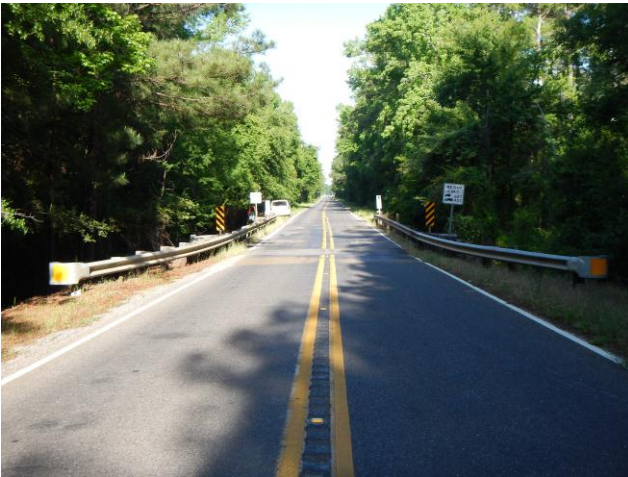
Fig. 8 View of Approach to Bridge 08-4

This timber bridge has been in service for over 70 years and appears to be in very good condition. Though the bridge is load posted for 40T for trucks, it was evident during the inspection that it was carrying significantly higher loads imposed by the logging trucks. The heavy creosote treatment used for the timber members contributed to a longer than expected service life for the structural elements.

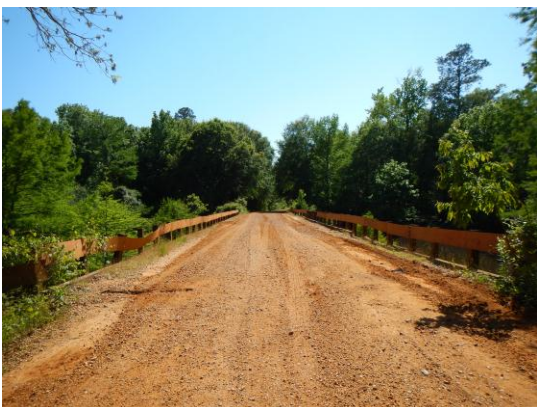
Fig. 14 View of Approach to Bridge 08-2

The following figures present various views of the bridge from above and the underside and clearly show the significant damage caused to the decking primarily by the 41 and is heavily utilized by logging trucks plying on the Highway 126. The following figures present various views of the bridge from above and underside and show the damage caused to the deck by the grader utilized to level the gravel topping on the deck. While the substructure and the stringers are in good condition, the deck is serious state of disrepair.

This major concern with this timber bridge is the loss of deck due to the grader. The inspection clearly indicated the need to replace the gravel topping with timber runners that can provide protection to the deck. The absence of adequate railing was of concern since the railing currently in place only serves the purpose of identifying the edge of the bridge and does not provide any impact resistance. Extreme caution is necessary to cross the bridge in its current condition.
