## Mile Long Boardwalk Enhances Estuary Restoration

**Paul C. Gilham, P.E., S.E.**  
**Chief Engineer**  
**Western Wood Structures, Inc.**  
**Tualatin, Oregon USA**  
[paulg@westernwoodstructures.com](mailto:paulg@westernwoodstructures.com)

### Summary

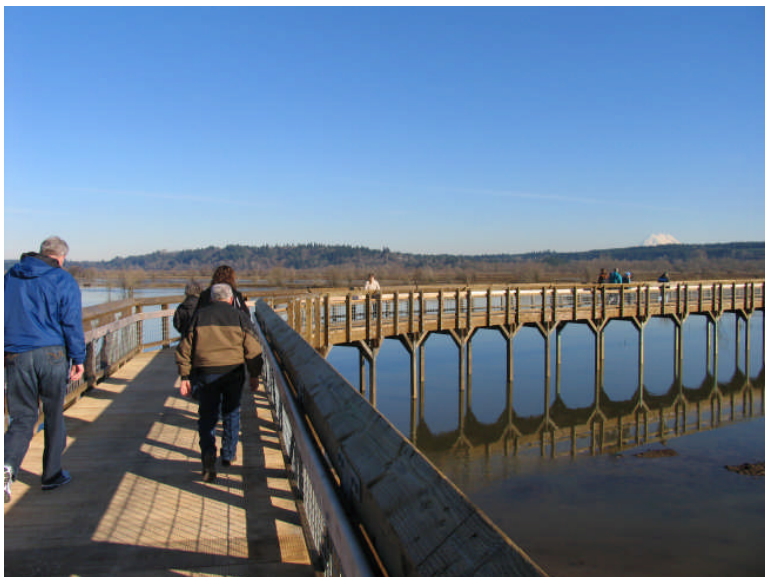
*Figure 1. Boardwalk at high tide*

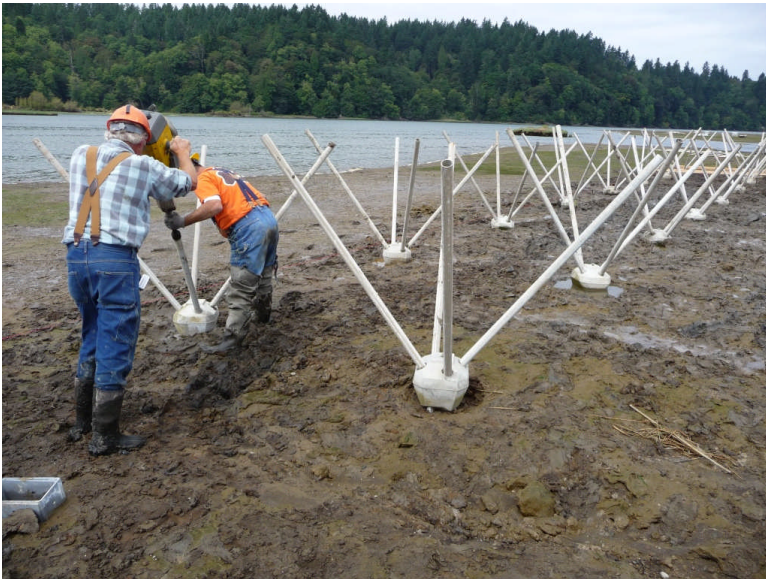
*figure 2. Installation of Diamond Piers.*

The boardwalks are supported by Diamond Piers. These are precast concrete pier blocks with galvanized pipe pins that are driven into the soils. Bearing resistance of the piers is based on the horizontal projected area of the pins. The

length of the pins is determined by the bearing characteristics of the soil and the load to be resisted. These piers are especially suited for sensitive areas such as wetlands and the tidal marsh. They require only a few shovels of soil to be disturbed to set the piers and they can be installed without heavy equipment. A 60 lb. electric jack hammer drives the pins into the soil. The spacing of the timber bents was set at 3.048m (10 foot) on center based on the 30.11 kN (6.72 kips.) capacity of the piers using 2 in. schedule 40 pipes, 2.1336m (7'-0") long. Each pier had a lateral capacity of 8.2kN (1.83 kips.) The maximum lateral load was 1.93kN (432 lbs.) due to seismic loading. A total of 940 Diamond Piers were used on this project.

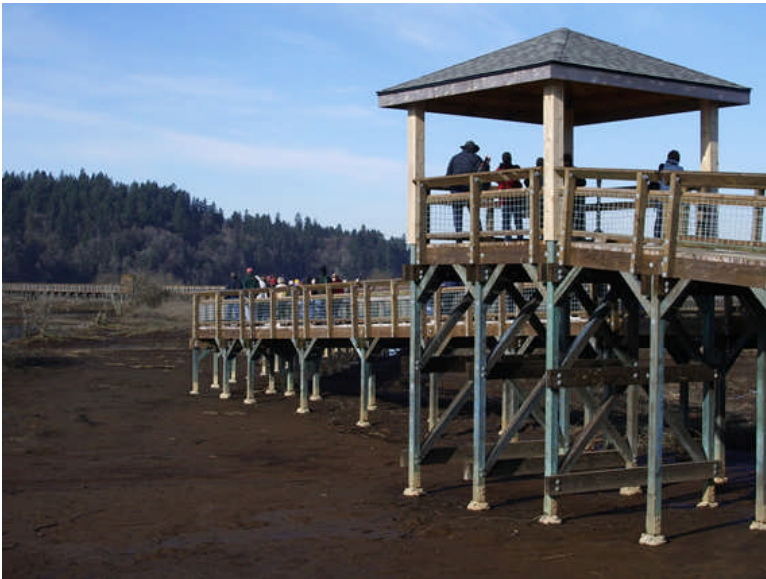
The 3.6576m (12'-0") square observation tower, located at the beginning of the boardwalk has a floor height of 6.096m (20'-0") above sea level. From this height, visitors have a commanding view of the entire estuary. Full height columns at the corners support a gable roof. These columns are wrapped with cedar boards. Ramps slope up to the tower at 8.33% slope to allow handicap access to the platform. The ramp is 20.87m long (68'-6") with two switchbacks and two flat landings at the turns as required by the American with Disabilities Act.

*Figure 4. Observation Tower*

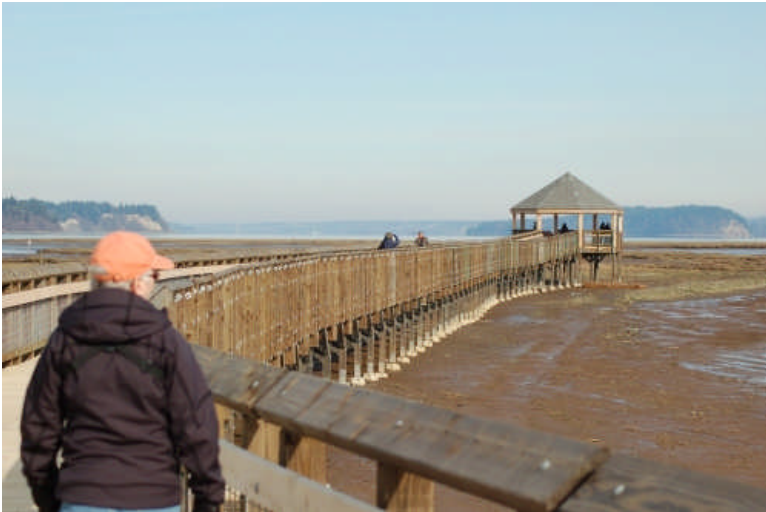
*Figure 5. Octagonal Shelter at end of boardwalk*

The highlight of the boardwalk is an octagonal shelter at the end that provides a 360 degree view of McAllister Creek, the Olympic Mountains to the west, Mount Rainier to the east and several islands in Puget Sound. Measuring 7.3152m (24'-0") corner to corner, this structure provides 36.4m<sup>2</sup> (391.9 ft<sup>2</sup>) of open space. The 6x6 columns in the corners extend to the tension ring at the eave level and support the eight hip beams that meet at a compression ring at the apex.

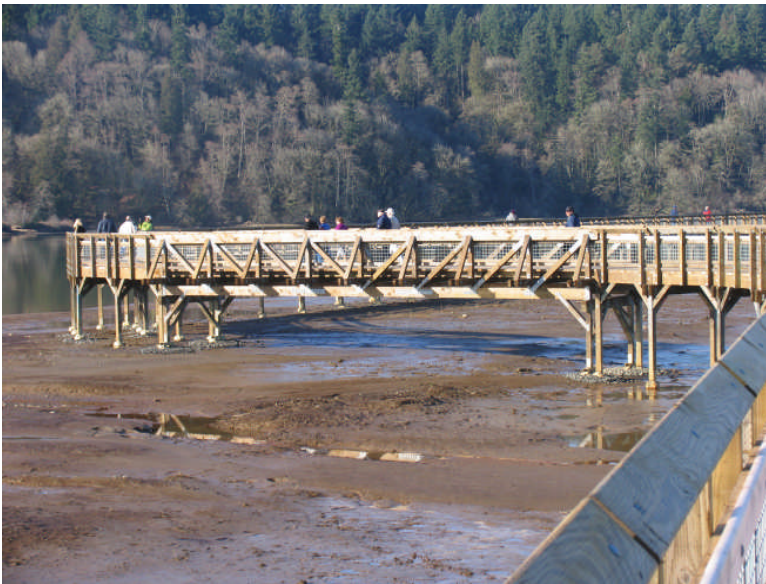
*Figure 6. 15.24m (50'-0") Pony Truss Bridge*

channels were forming in several locations. These had not been accounted for in the layout of the boardwalk and it was not possible to predict where they would be located before the dike was removed. In four locations these channels were too wide to span with the standard 3.048m (10'-0") bent spacing. Timber Pony Truss Bridges were designed and installed to span these channels. These bridges ranged in length from 9.144m to 15.24m (30'-0" to 50'-0"). Each bridge consisted of timber pony trusses using 6x12 chords and 6x6 webs. These bridges were supported on timber bents with two Diamond Piers at each support. The trusses were shop assembled after preservative treating and shipped to the site where they were lifted into place with a helicopter.

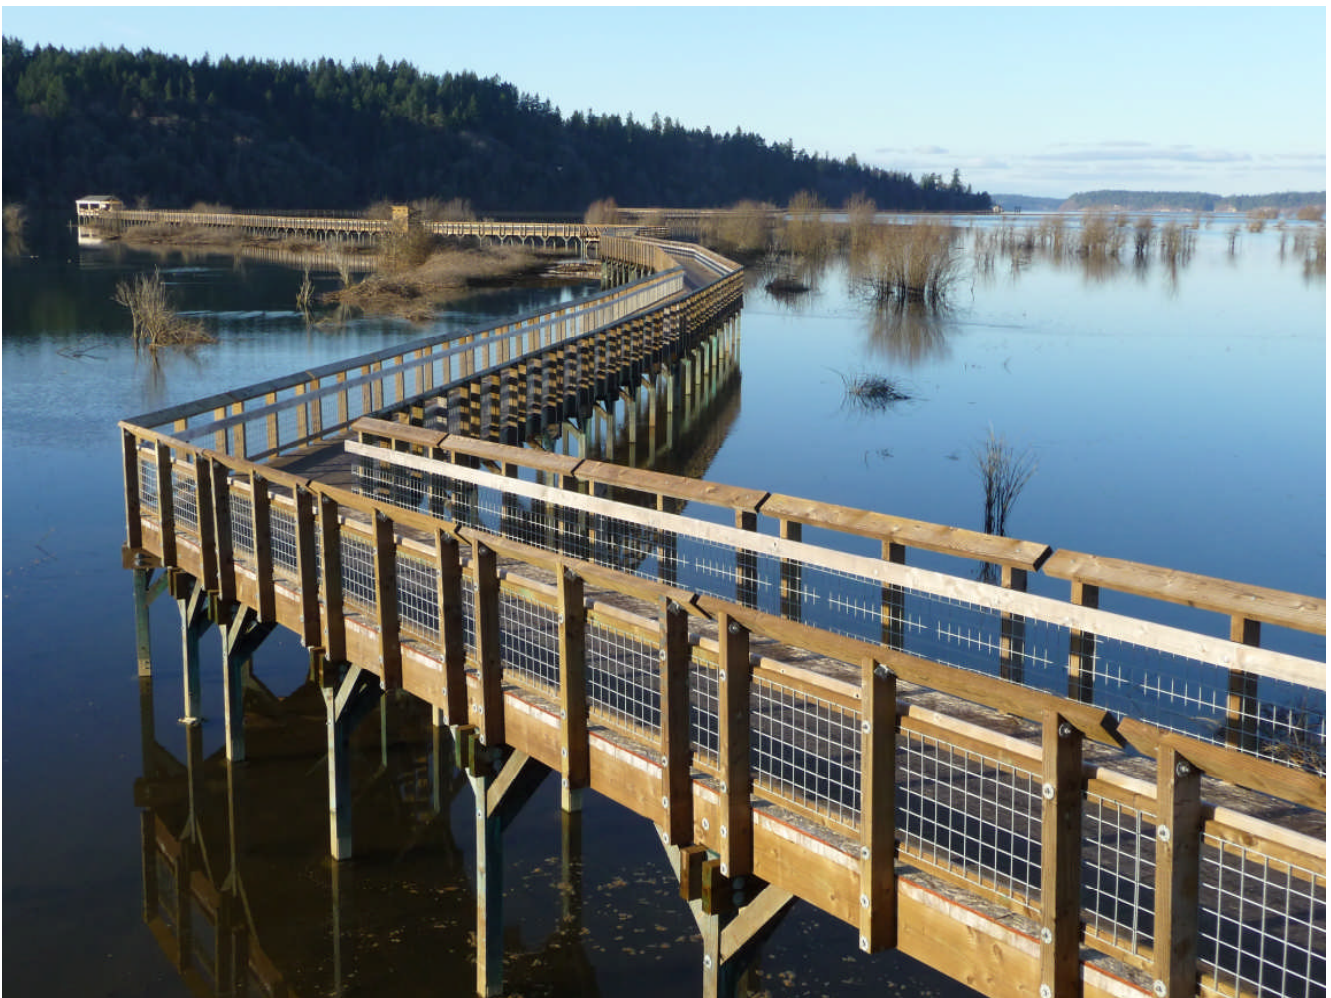
*Figure 7. Boardwalk at high tide with bird viewing blind and viewing platform*

The project included one observation tower, two viewing platforms, two walkway pushouts and a bird viewing blind. Each of these features invites visitors to stop and take in the views using observation scopes or rest on the benches provided by FWS. All of these structures are supported by Diamond Pier foundations and are made with pressure treated DF framing members and POC deck and grab rails. Roofs at the observation tower and viewing platforms provide a place to get out of the rain. DU specified a four sided hip roof for the Observation Tower, a gable roof for the first observation tower and an eight sided roof at the octagonal platform at the end of the boardwalk. Each of these roof structures were design to provide column free space. At the observation tower and octagonal platform, the hip beams acted as arches with a tension ring designed and detailed at the eave and a steel compression assembly at the peak.
