Identification of Practices, Design, Construction, and Repair Using Trenchless Technology

# Practices, Design, Construction, and Repair Using Trenchless Technology

tech transfer summary

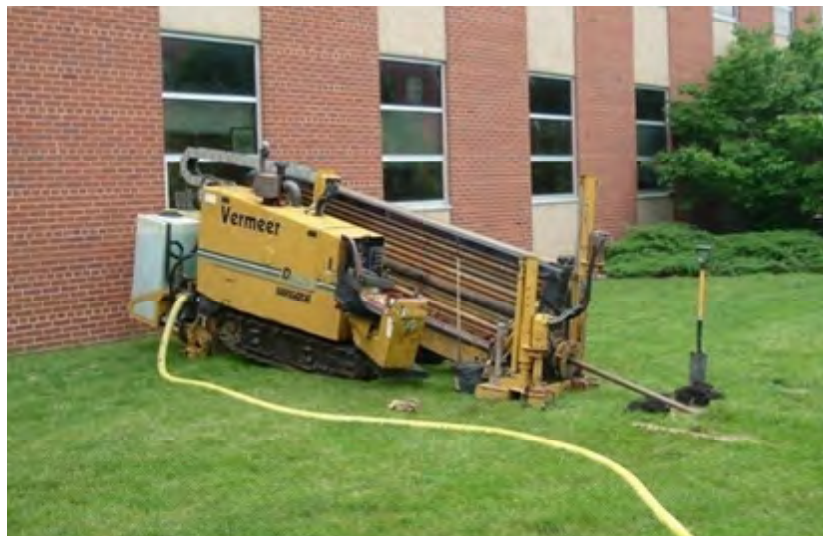
Horizontal directional drilling machine used for a trenchless construction project in Ames, Iowa

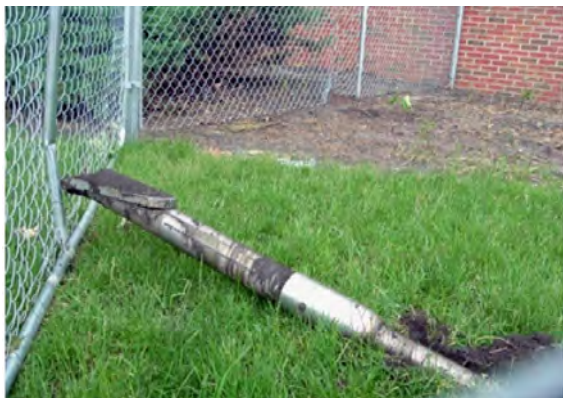
*Five-inch-diameter drill bit emerging from the ground*

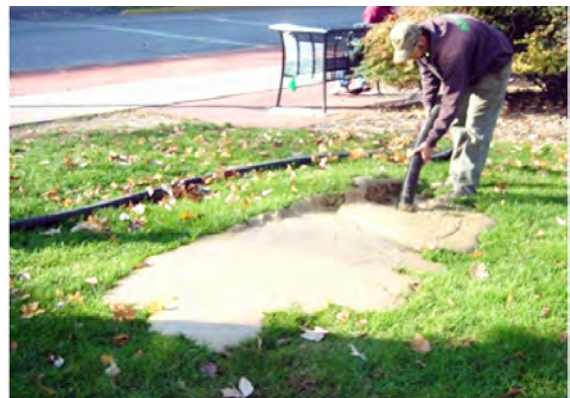
*Drilling fluid at ground surface resulting from frac-out*

- Soil testing should be conducted in areas where soil conditions are unknown or uncertain. Owners and designers should be aware of soil conditions and design limitations that may increase the risk of damage to pavements and nearby structures.
- Trenchless construction methods should continue to be studied so that damage to pavements and other structures can be avoided. Specifications and quality control and quality assurance procedures should be implemented to reduce risks.
- In future trenchless construction research, soil pressure could be monitored during horizontal directional drilling to better understand how trenchless technologies may interact with soils to cause pavement damage and other problems.
- Further understanding the causes of the fluid pressure buildups that lead to soil heave and frac-out can help decrease the risk of these problems.
