ROAD SAFETY AUDIT FOR COUNTY ROAD H-46 FROM REDWOOD AVENUE TO THE SOUTHERLY CORPORATE LIMITS OF FAIRFIELD IN JEFFERSON COUNTY, IOWA

**Final Report
January 2010**

This report documents the findings and recommendations of a road safety audit for a section of County Road H-46 from Redwood Avenue to the south corporate limits (SCL) of Fairfield in Jefferson County, Iowa. County Road H-46 is a paved roadway of asphaltic concrete pavement with curvilinear alignment, approximately 6.5 miles in length. The roadway consists of a 22 ft wide pavement, last overlaid in 2002, with 3 to 4 ft wide earth shoulders and steep foreslopes. The pavement surface was treated in 2009 with a Gilsonite spray application, and new pavement markings were applied. Traffic volume as determined by a 2006 Iowa Department of Transportation (Iowa DOT) estimate indicated volumes ranging from 500 to 1,590 vehicles per day, with numbers increasing as the route nears Fairfield. This roadway was found to be among the highest 5 percent of similar Iowa roadways in terms of severity of run-off-road crashes.

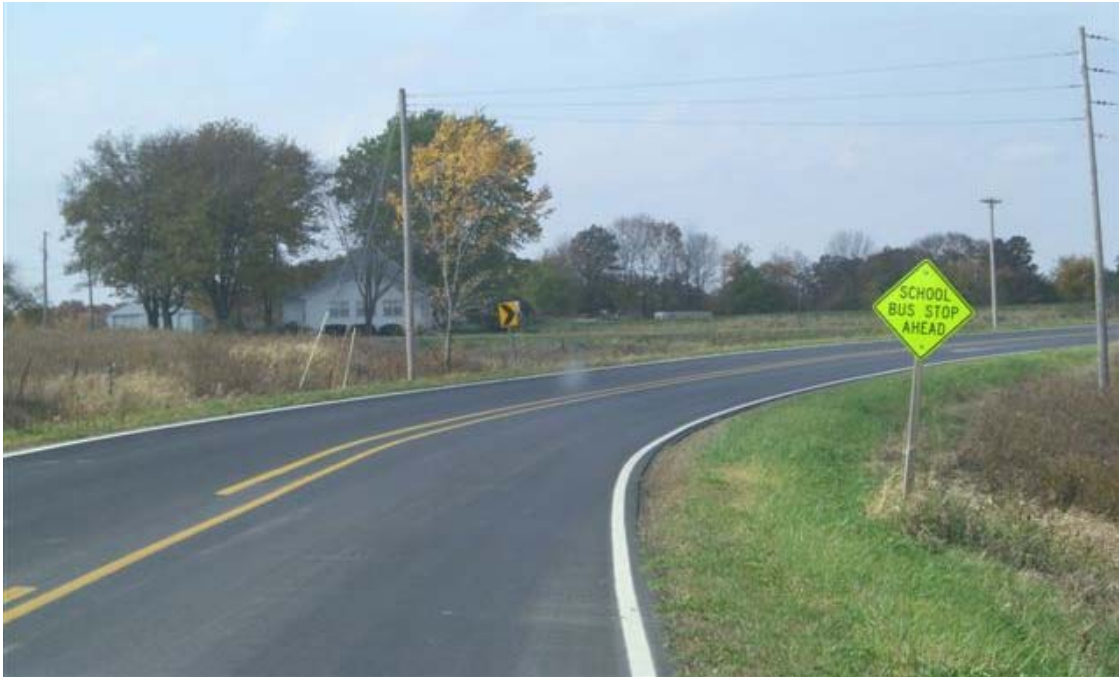
Palm Boulevard intersects H-46 from the south near a horizontal curve. One fatal crash, possibly weather related, was recorded in this area during the review period. Widely spaced, larger size chevron warning signs mounted on brackets are in place through this curve. For northbound traffic approaching this area, a curve warning sign with a 45 mph advisory speed is in place. A School Bus Stop Ahead warning sign is also located in advance of the curve.

Figure A.1. School bus warning sign and chevron along horizontal curve at Palm Boulevard intersection

The existing chevrons along the curve near the Palm Boulevard intersection would be more effective if these devices were repositioned to more closely comply with 2009 Edition of the *Manual on Uniform Traffic Control Devices* (MUTCD) guidelines. In addition, at least one more chevron should be added to enhance visibility of the curve for southbound drivers approaching the area from the north.

- Review the existing chevrons on the curve near Palm Boulevard for needed upgrades, such as adding of mounting brackets, re-spacing to match 2009 MUTCD guidelines, and possibly using fluorescent yellow, microprismatic sheeting. Consider similar sheeting for the curve warning signs at this location.
- Consider installing a hidden driveway warning sign easterly of Palm Boulevard for northbound traffic.
- Discuss with the affected property owner the removal of a large tree that hampers visibility at the Osage Avenue intersection.
- Study the feasibility of deer fencing along the right-of-way between Palm Boulevard and Queenscup Road, where there has been a high concentration of deer crashes.
- Monitor the pavement surface for friction quality.
- With a future resurfacing project, consider installing milled-in pavement markings for better longevity and performance.

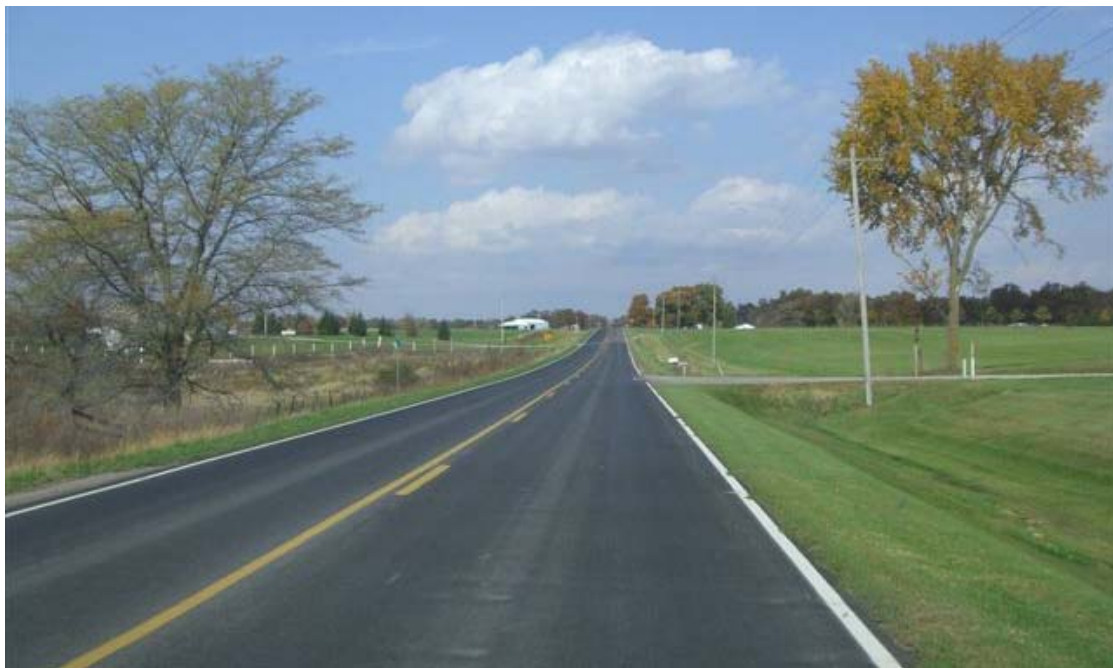
The pavement markings on the newly applied Gilsonite surface treatment were quite visible, with good retroreflection. In addition, the markings beyond the Gilsonite section also appeared very satisfactory.

Figure A.2. Pavement markings on County Road H-46

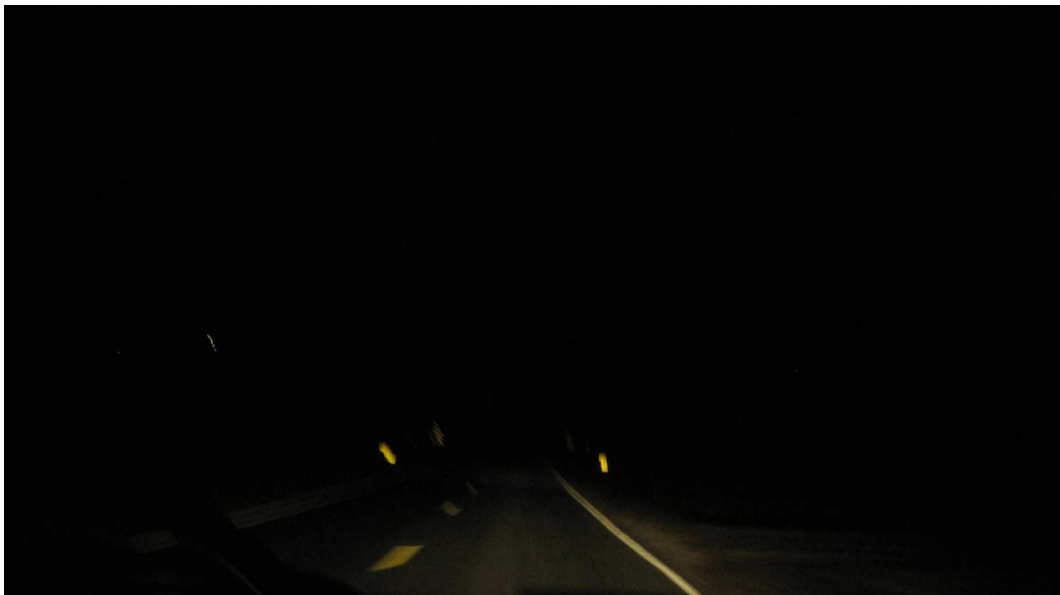
The relatively new bridge over the US 34 bypass did not appear to feature delineation in the guardrail. Nighttime visibility of this structure could be improved with guardrail reflectors and perhaps newer vertical panel object markers.

Figure A.8. Nighttime view of pavement markings and guardrail delineation at bridge
