Rehabilitation of a Two-Lane Covered Bridge

Second National Covered Bridge Conference
June 6, 2013

Hoyle, Tanner
& Associates, Inc.
Manchester, NH USA

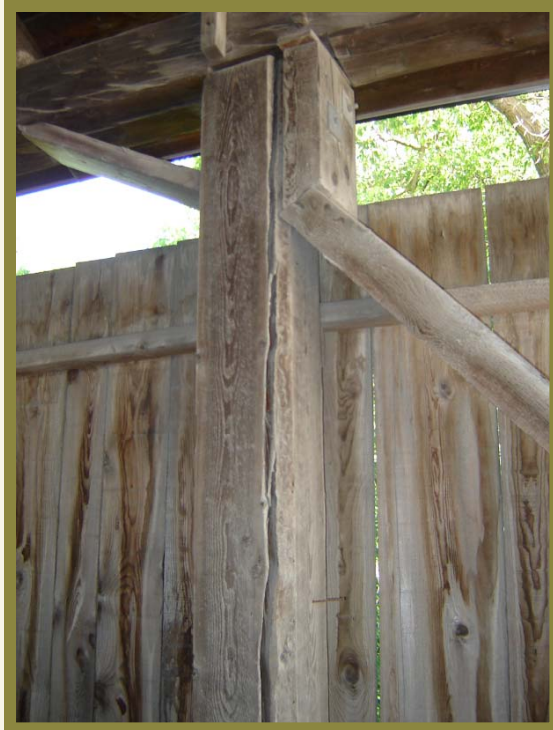
Member Split

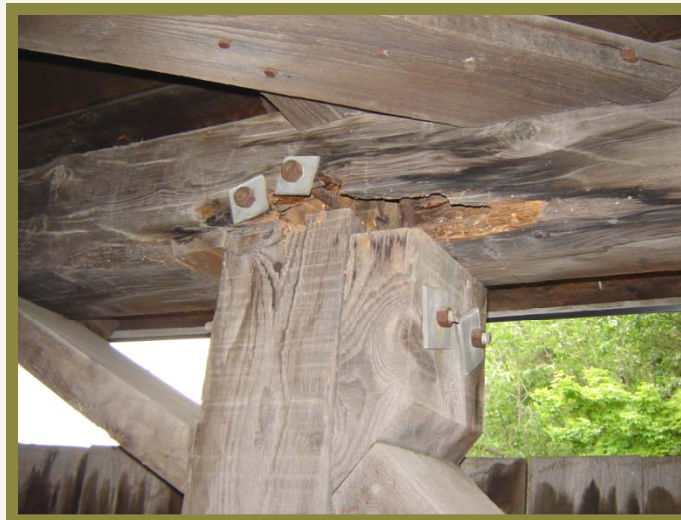
Break

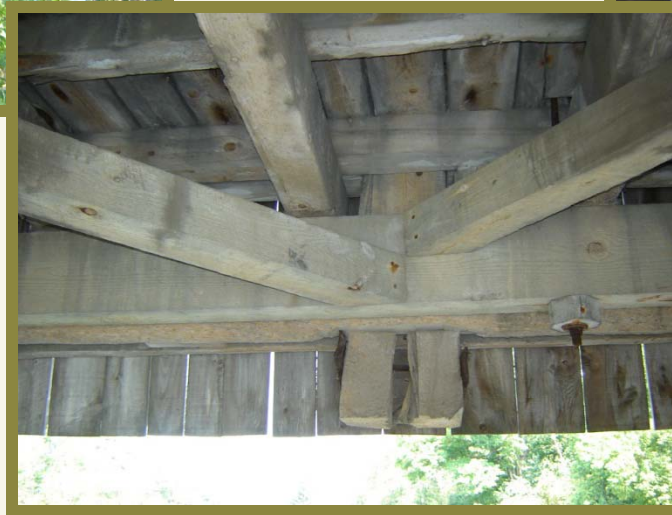
Split Verticals
